Seismic damage of mechanical structures by the 2011 Great East Japan Earthquake

Keywords: Damage investigation, Industrial facilities, 2011 Great East Japan Earthquake

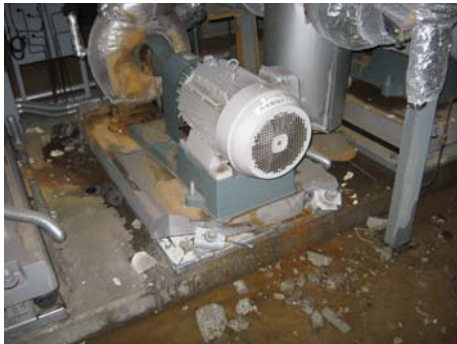
Figure 2 shows the damage at the base of a circulation pump. The concrete basement and cast iron base were broken, and the anchor bolts were deformed by the seismic motion. Figure 3 shows an example of the deformation of an anchor bolt, and Fig. 4 shows the deformation of a steel base of a FRP tank. Equipment installed on the roof of the building, such as air conditioning equipment, was often tumbled or failed because the seismic response of the building tends to be amplified at the tops of buildings. Figures 5 and 6 show examples of such damage. This damage related to basements or anchors mainly occurred due to a lack of consideration of earthquake resistance in setting and fixing the equipment. Figure 7 shows damage of the anti-vibration bar of a boiler. The boiler was suspended only at the upper position in order to release the heat expansion during the operation, so the response grew during the seismic motion, and the body of the boiler collided with the anti-vibration bar and broke it.

Figure 2. Damage at the base of a pump

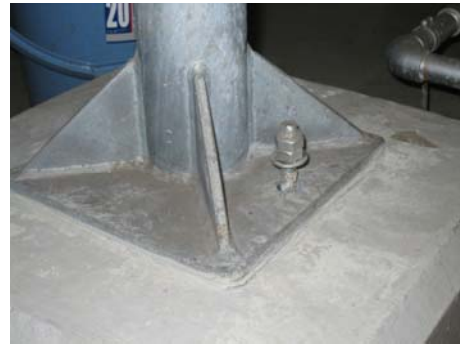
Figure 3. Deformation of an anchor bolt
(Provided by JAXA)

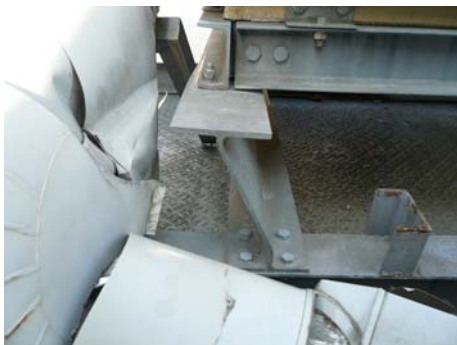
Figure 4. Deformation of the steel base of
FRP tank

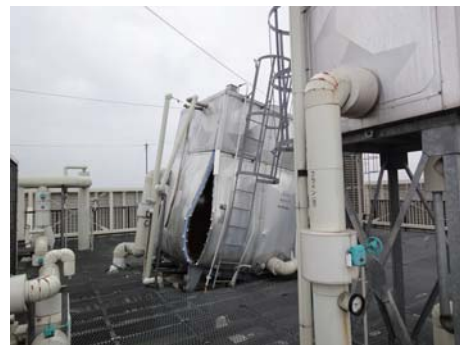
Figure 5. Failure of a water tank installed on
the roof

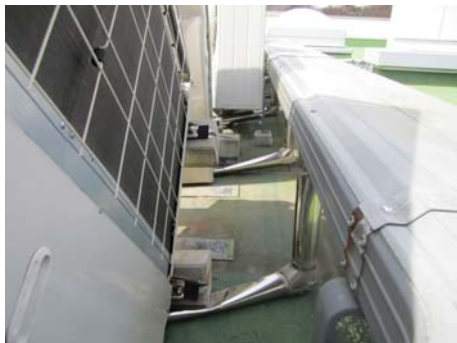
Figure 6. Tumbled equipment set on the roof

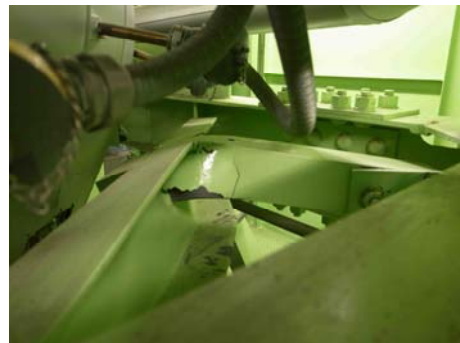
Figure 7. Damage of the anti-vibration bar of a boiler

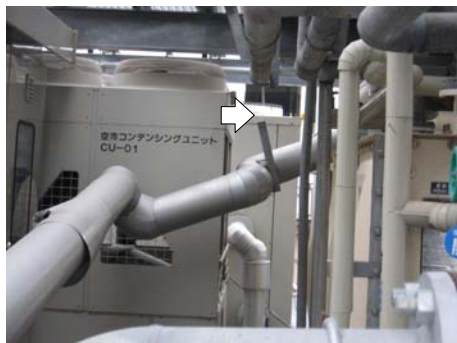
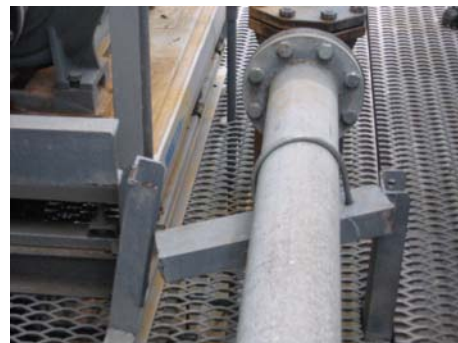
Figures 8 shows the failure of pipe supports and Fig. 9 shows damage of utility pipes. The failure of the pipes occurred mainly at the pipe supports or connections with other equipment. The leakage of water from the damaged pipes often caused secondary damage such as moisture damage of books and documents or problems with electrical equipment. To prevent such secondary damage, it is necessary to consider well the facility layout design in the planning stage as well as the seismic design of the

(a) In-house hanging pipe

(a) Pipe on the roof

Figure 8. Failure at pipe supports

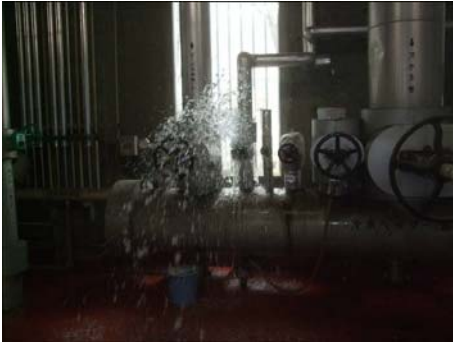
Figure 9. Failure of utility pipe and water leakage
(Provided by JAXA)

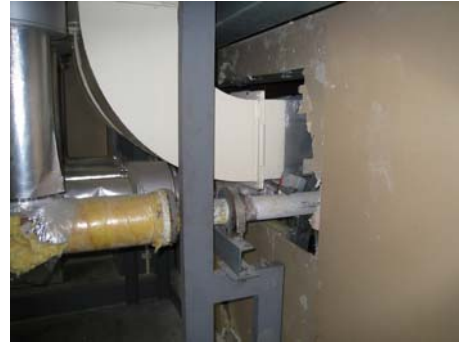
pipng system. Another failure mode of pipes was related to soil deformation. This kind of failure is described in section 3.2. Figure 10 does not show pipe failure itself, but rather failure related to a pipe's seismic response. The different seismic responses of the pipes and the building caused damage at the inner wall.

Figure 10. Damage of inner walls by pipes
(Provided by JAXA)

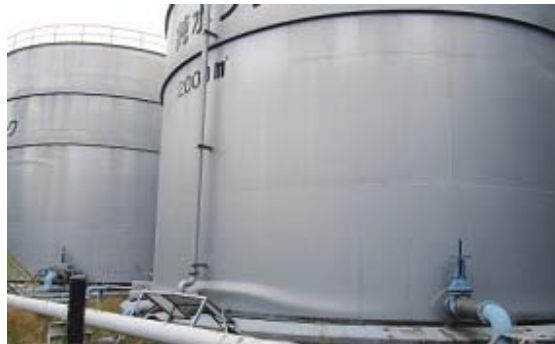
Figure 11. Buckling failure of 2,000 m³ water tank
(Thermal and Nuclear Power Engineering Society, 2011)

The buckling failure of tanks was reported in past earthquakes, such as in the 1995 Kobe Earthquake and in the 2007 Niigataken Chuetsu-oki Earthquake, and this failure mode was also found in the GEJE. Figure 11 shows the buckling failure of a 2,000 m³ water tank (Thermal and Nuclear Power Engineering Society, 2011). This failure was caused by the aftershocks on April 11 and 12. There were some tanks without damage, though they were located in the same prefecture as the failed tanks. So it is necessary to investigate the cause of these failures taking into account the characteristics of the input motion, and other factors. The damage investigations of hazardous material facilities were conducted and summarized by the National Research Institute of Fire and Disaster. According to this report, the damage due to sloshing behaviour occurred in the Tokyo Bay area and the Sea-of-Japan side of North Japan (Nishi, 2012). Cranes and unloaders were also damaged by the earthquake. From the result of the damage investigation by the Japan Crane Association (JCA) (Japan Crane Association, 2011), overhead cranes were mainly damaged by seismic motion. Figure 12 shows one typical failure of an overhead crane. The hook bolts which held the crane rail deformed or fractured. Figure 13 shows another failure mode of an overhead crane. The failure occurred at the welding point at the suspension of the crane rail.

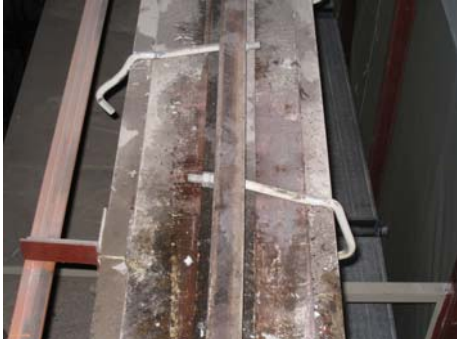
Figure 12. Failure mode of overhead crane
(Damage of hook bolts, provided by JAXA)

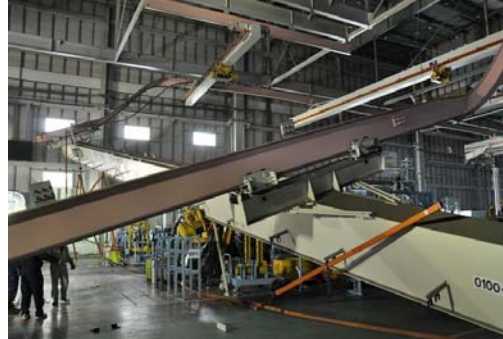
Figure 13. Failure mode of overhead crane
(Fallen crane rail)

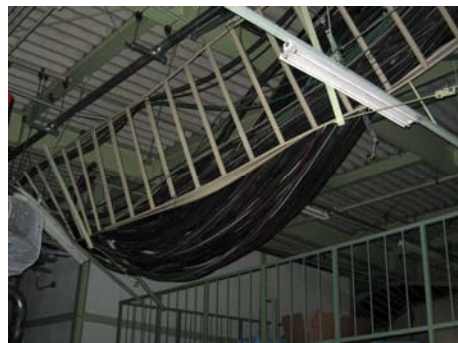
Figure 15. Failure of cable racks

The ceilings and walls of factory buildings and equipment hung from the ceilings such as cable racks and air-conditioning machines were also damaged. Figures 14 and 15 show examples of these types of damage. Such damage led to human suffering and secondary damage of machines, and it has been an obstacle to business recovery.

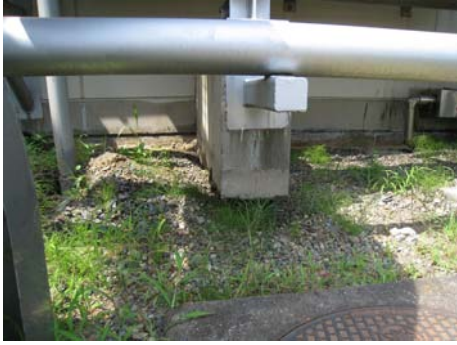
Figure 16. Pipe support hanging from a pipe due to subsidence of the soil

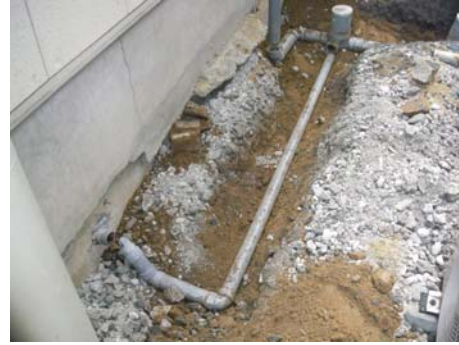
Figure 17. Buried utility pipes broken due to soil deformation

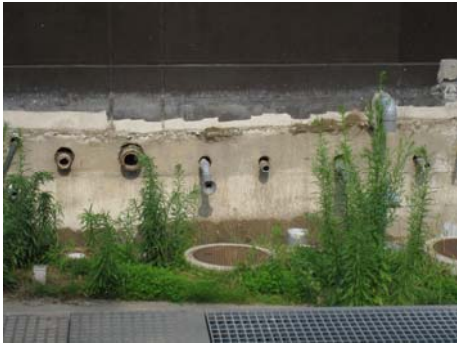
Figure 18. Pipes fractured at the connection point of the building and soil

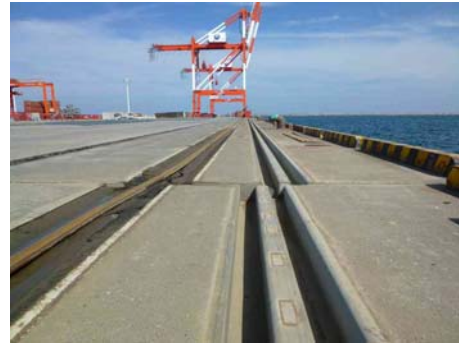
Figure 19. Quay wall deformation and misalignment of the unloader rail

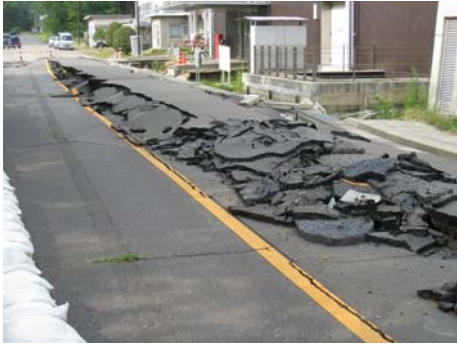
Figure 20. Damage of a road in a research facility

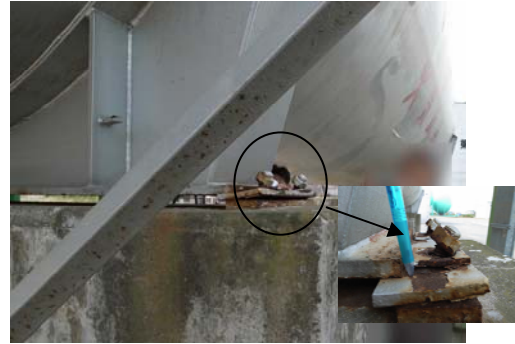
Figure 21. Lifting damage of LPG tank by tsunami

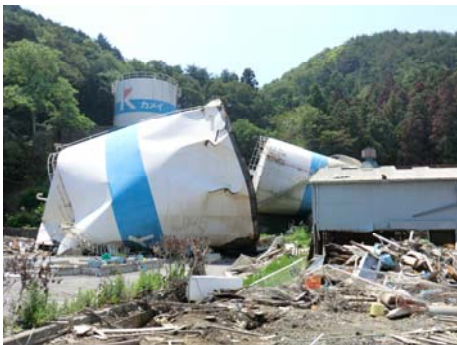
Figure 22. Tanks washed away by the tsunami

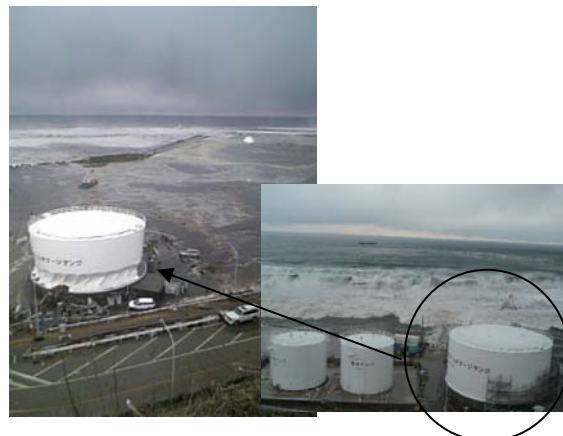
Figure 23. Buckling failure of a water tank due to the pressure of the water (Provided by TEPCO)

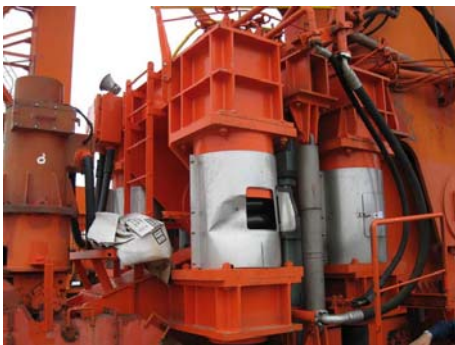
Figure 24. Damage due to collisions with floating objects (Provided by JCA)

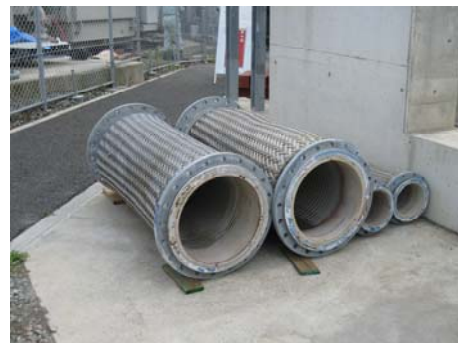
Figure 25. Flexible pipes

pipes such as those shown in Fig. 25 were effective.
