# Seismic vulnerability of churches in Faial and Pico islands, Azores

**J. M. Magalhães, R. Vicente, T. Ferreira, A. Costa & H. Varum**  
*University of Aveiro, Portugal*

**15 WCEE**  
LISBOA 2012

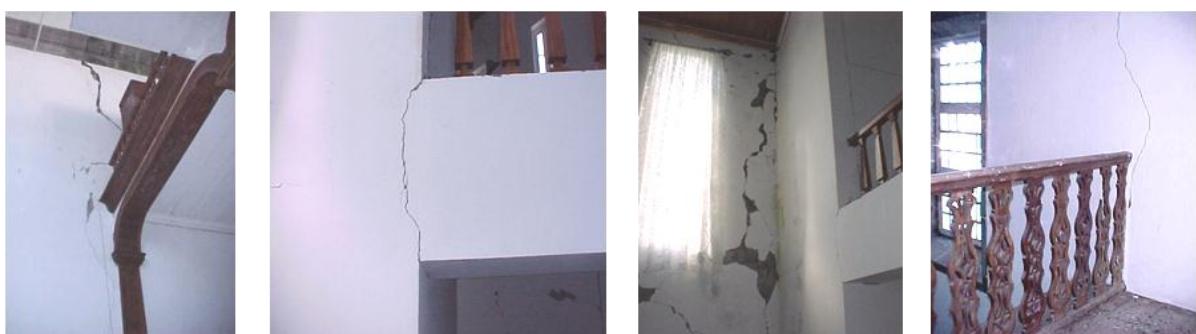
However, during evaluation of the photographic register and inspection reports made by Costa and Vasconcelos (1999), it was detected that all these churches contain a high choir and, most of them had damages related to the seismic behavior of this macro-element (Figure 3). This structure constitutes a second floor of the church, which normally includes access to the bell towers, and is a typical macro-element in Portuguese churches.

**Figure 3.** Consequential damages of the interaction between high choir and sidewalls of Azores churches [Costa and Vasconcelos, 1999]

The study of this macro-element is extremely important due the register of serious damages (Figure 3) that may result from its interaction with other parts of the structure, for example, the sidewalls, arches that support the structure or the façade. For this reason it was introduced as the 29th damage mechanism on the methodology corresponding to this macro-element. Figure 4 presents all the damage mechanisms considered in this work.

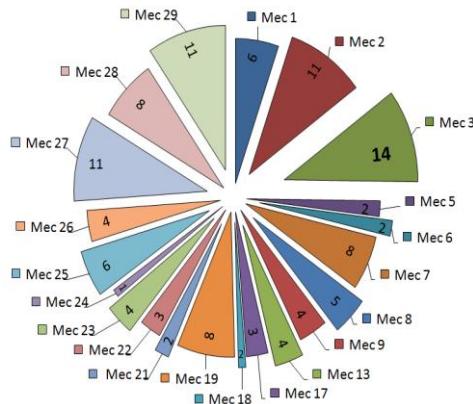
Figure 6 represents the damage mechanisms identified in the sixteen studied churches. This figure indicates that the cracking caused by shear effort in the façade wall (mechanism 3), the overturning of the top of the façade (mechanism 2), damages in the high choir (mechanism 29) and the cracking in bell towers (mechanism 27), have been identified in a large number of the study cases. Analysis of this figure allows an indirect perception of the main weaknesses in these buildings.

**Figure 6.** Pie chart of the identified damage to the 16 churches of Azores after the July, 9<sup>th</sup> 1998 earthquake

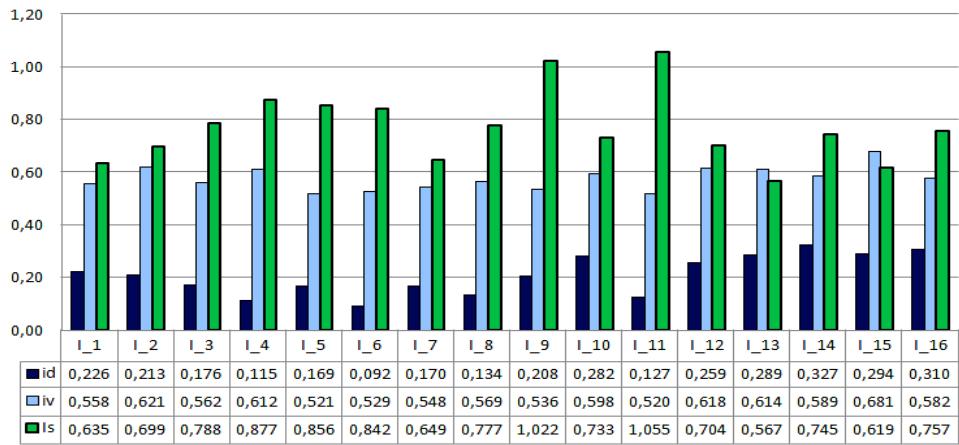
**Figure 7.** Values of  $i_d$ ,  $i_v$  and  $I_s$  obtained for the 16 studied churches

As discussed previously, according to the reference document, churches with a damage index higher than 0.3, do not gather the necessary conditions for normal use. In this study, the value of this index was typically quite low, being equal to or greater than 0.3 in only in two of the sixteen churches.

The global seismic behavior of these buildings is statistically represented by the vulnerability index ( $i_v$ ) (variable between 0 and 1), which is an average of the behavior of different parts of the church (Linee Guida, 2006). As shown in figure 7, all of the churches examined have a high vulnerability index ( $i_v$ ) between 0.5 and 0.7

Regarding the seismic security index ( $I_s$ ), in most cases the values achieved were less than one (Figure 7), which, according to Linee Guida (2006), means that these churches are not able to support an earthquake with the reference ground acceleration considered for this region ( $a_{gR} = 2,5 \text{ m/s}^2$ ) (NA, 2008). It is important to stress that the results obtained for the seismic security index ( $I_s$ ) concern the reference acceleration ( $a_{gR}$ ) off the seismic region and depends also of the assumed values of ground amplification factor ( $S=1$ ) and importance factor ( $\gamma_1=0.80$ ).

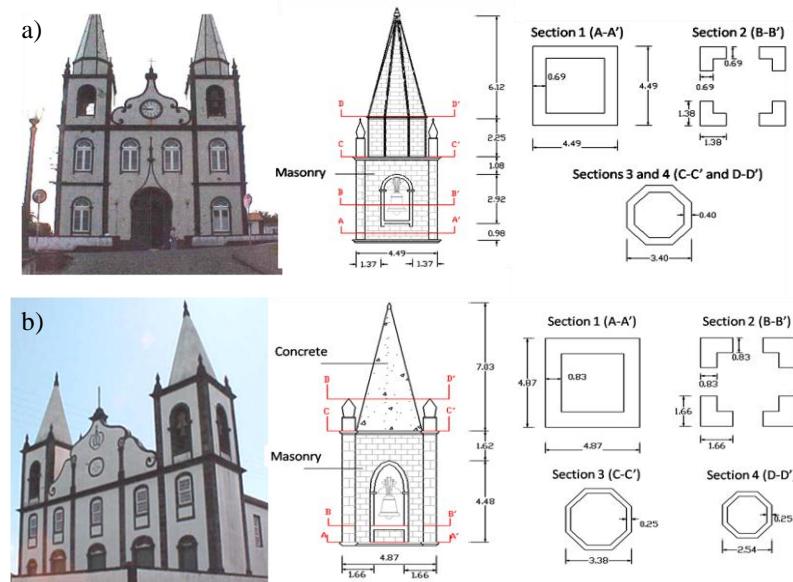
**Figure 8.** a) Church and belfry of Madalena – Pico; b) Church and belfry of Bandeiras – Pico

In both cases it was verified that the critical section corresponds to the base of the columns on the belfry, easily explainable by the reduced dimensions in plant of the elements besides of the reduced axial load at this level. Comparing the resistant bending moment ( $M_{res}$ ) with the bending moment corresponding to the reference acceleration ( $M_u$ ) of the critical section (Table 1), it was concluded that this condition was verified. In addition, the results obtained by the critical ground acceleration corresponding to the ultimate limit state ( $a_{ELU}$ ) are lower than the reference ground acceleration ( $a_{gR}$ ) for this region ( $a_{gR} = 2.5 \text{m/s}^2$ ) indicating their high vulnerability.

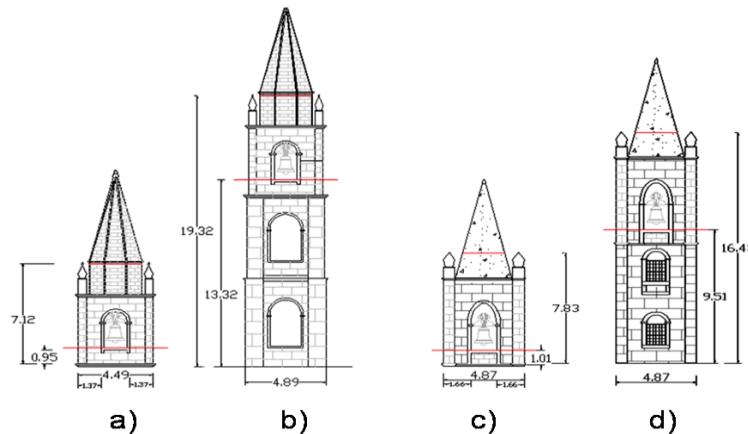
**Figure 9.** Critical sections in the two considered situations: a) Church of Madalena only considering the belfry; b) Church of Madalena considering the isolated tower; c) Church of Bandeiras only considering the belfry; d) Church of Bandeiras considering the isolated tower.

The results obtained for the critical ground acceleration showed that both the belfries have high vulnerability to seismic action, and the ground acceleration corresponding to the collapse in the critical section diminishes when the real altitude of the belfry is considered. This increase in vulnerability is caused by the amplification of ground acceleration at the real altitude of the belfry.

The biggest increase of vulnerability corresponds to the church of Bandeiras (lower tower). These results are justified by the number and dimensions of considered openings providing to this tower a higher seismic vulnerability, and to the fact of its lower fundamental vibration period, being in this case the response spectrum more severe.
