2011 Sikkim Earthquake: Effects on Building Stocks and Perspective on Growing Seismic Risk

D.C. Rai, G. Mondal, V. Singhal, N. Parool, & T. Pradhan

Dept. of Civil Engineering, Indian Institute of Technology Kanpur, India

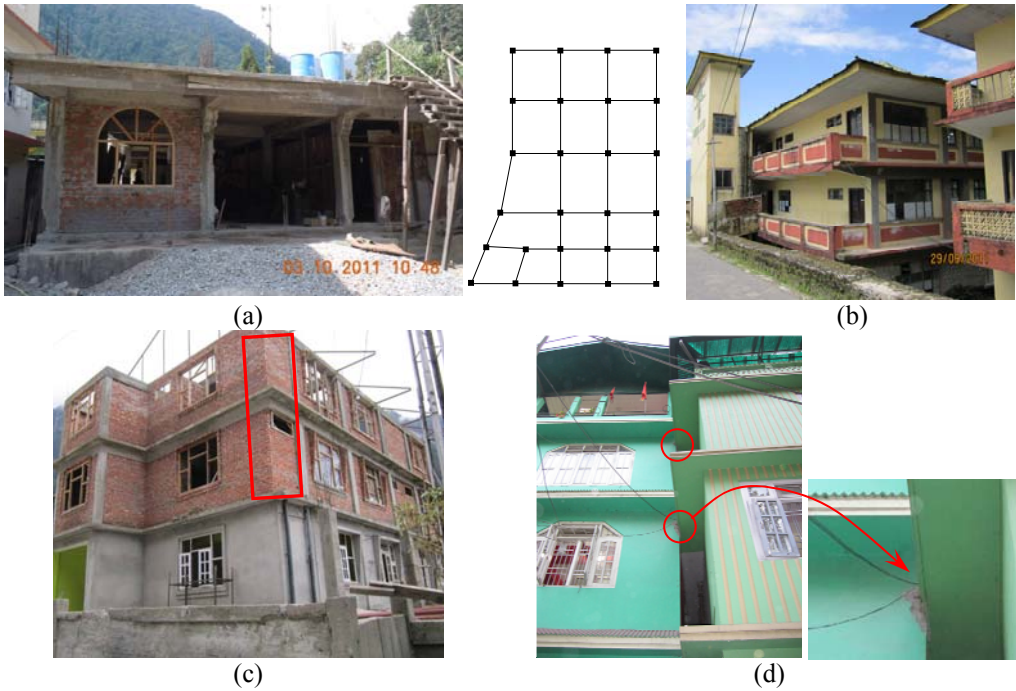
Modern buildings in RC-frame are mostly planned on rectangular grid of columns at relatively smaller bays which had significantly helped their earthquake resistance, though in some cases irregular grid of columns was observed as shown in Fig. 4.2a. Rising housing demand and limited availability of good land for the construction has forced the adoption of structural configurations, which suffer extensively from many plan and vertical irregularities, for both new buildings as well as unplanned extension of existing buildings (Fig. 4.2b). Indiscriminate use of unsupported partition wall for functional purpose has resulted in various plan irregularities leading to unacceptably large torsional stresses. *Jettying* (horizontal cantilever projection) is often employed in urban areas to create greater floor plan area in upper stories of buildings as shown in Fig. 4.2c. Most of the buildings constructed on sloped land are connected at multiple levels with the ground unlike the houses built on flat lands. The ground motion input at multiple levels of the building cause complex dynamic response, which is usually not analyzed and rarely, accounted for in the design of such structures. In addition, buildings are

constructed too close to each other, sometimes with no gap separating adjacent buildings, making them vulnerable to pounding damage (Fig. 4.2d).

Figure 4.2 Construction practices (a) Building on irregular column grid (b) Multi-level connection of buildings with ground (c) Unsupported masonry wall at corners (d) Adjacency of buildings

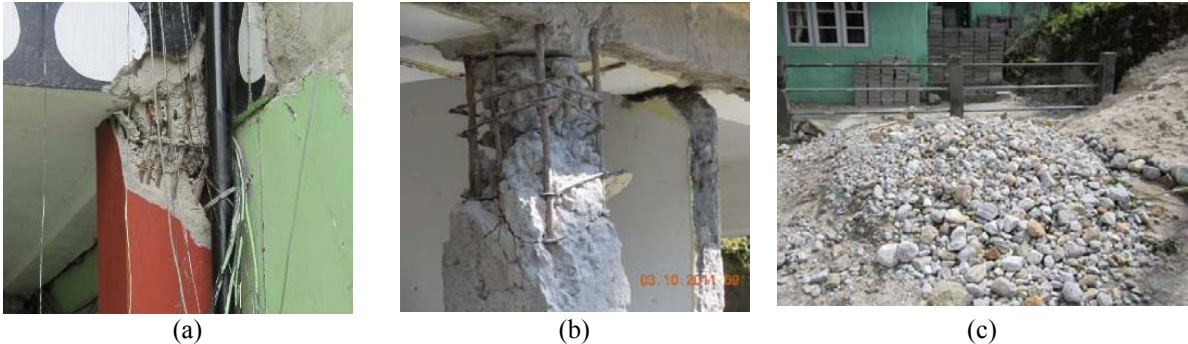
The RC buildings are mostly designed to carry gravity load only and no provision is made to resist earthquake loads. Dimension of the columns varies from 200 mm to 300 mm. Main reinforcement bars in beam and columns consist of both mild steel and deformed steel bars. Seismic detailing was not observed in the main components, i.e., beams, columns, beam-column joints of the buildings. Shear reinforcement of insufficient length having ties with 90° hook, lapping of reinforcement at critical section of the beams and columns and splicing of all reinforcement at the same location was observed (Fig. 4.3a-b). Due to ease of construction, the construction joints at columns were located at the critical locations, i.e., at the top and bottom ends of columns as shown in Fig 4.3b. The common deficiencies present in buildings which increase their seismic vulnerability is listed in Table 4.2.

Figure 4.3 Poor detailing (a) Lapping at beam column joint (b) Widely spaced stirrups with 90° hook (c) Inferior quality of construction material

Other common problems are related to poor quality of construction material like inferior and round river stone as coarse aggregate, weak and locally made concrete blocks as infill materials (Fig. 4.3c). Concrete is commonly mixed with hands resulting in heterogeneous batches and inconsistencies between batches. The concrete mix proportion was frequently observed to have high water content in

order to increase workability and it is often poured directly into formwork with no vibration or consolidation.

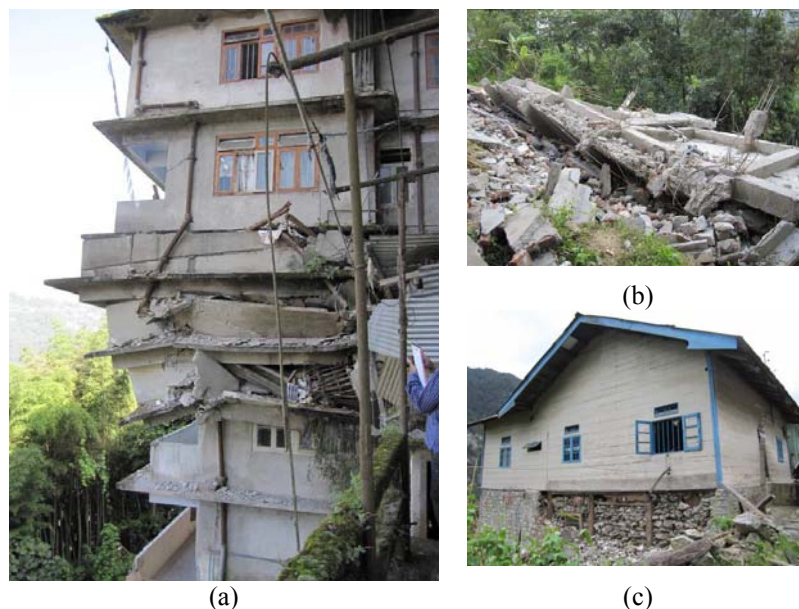
Figure 5.1 (a) Pan-caking of middle two storeys in a 9-storey building, Gangtok (b) Collapse of a building near Balwakhani, Gangtok (c) Collapse of random rubble masonry wall at the foundation level in *Shing khim*.

observed and reported in these light weight structures. Damage was only observed at the foundation level to the R/R masonry in most of these buildings as shown in Fig. 5.1(c). Presence of wooden frame at close intervals resulted in an excellent earthquake resistant feature that performed well. Moreover, the closely spaced studs prevent propagation of diagonal shear cracks within any single panel, and reduce the possibility of the out-of-plane failure of panels.

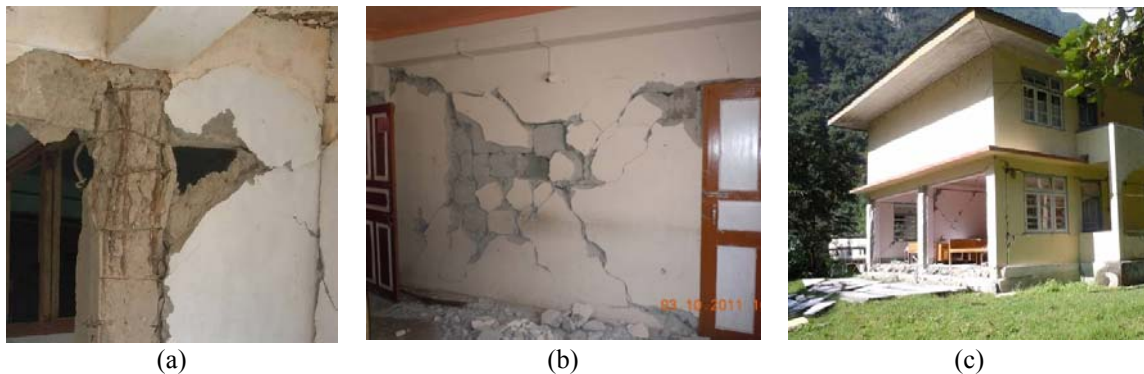
Unlike traditional houses, many government and private RC buildings sustained severe damage and even collapsed mainly due to lack of earthquake-resistant features in combination with poor quality of concrete and construction practices. Most of the RC buildings at major towns suffered damages of some form or the other, the most common being shear and/or flexure failure at column ends, shear failure of beam-column joints, in-plane failure of weak infills and out-of-plane failure of slender walls. Fig. 5.2 shows damage to buildings due to some of these common deficiencies.

Failure of infill walls in RC frame structure was commonly observed due to poor quality of infill material (low density/strength concrete blocks), and poor connection between walls and supporting frame element. Most of these infill walls failed in out-of-plane direction due to their higher slenderness ratio; as thin concrete blocks (80-100 mm), half-brick thick wall and even brick on edge was used. Moreover, indiscriminate use of unsupported partition wall and exterior walls for functional purpose has resulted in unacceptably large torsional stresses causing failure of these walls.

Figure 5.2 (a) Typical column failure (b) In-plane failure of weak infill masonry and (c) Out-of-plane collapse of concrete block masonry walls.
