# Damage to Steel Educational Facilities in the 2011 East Japan Earthquake: Part 2 Damage to Minor Structural Components and Damage due to the Tsunami

On 11 March 2011, the strong ground motion and tsunami caused by the East Japan Earthquake, which occurred off the coast of Miyagi Prefecture, induced extensive damage along the Pacific coast. A series of reconnaissance on steel educational facilities were conducted in Iwate, Miyagi, Fukushima, Ibaraki, Chiba, and Tochigi prefectures from April to June 2011. In this paper, the damage to roof braces, non-structural components and foundation as well as the damage due to the tsunami are discussed. The typical types of damage observed are introduced along with their distribution of occurrence

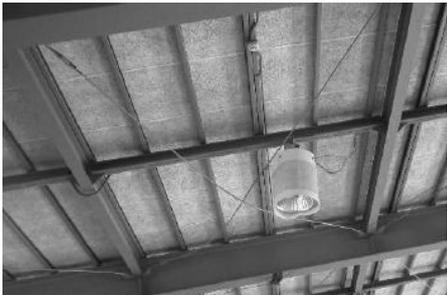
Figure 2.6. Elongation of turnbuckle braces

Figure 2.6 shows the elongation of a turnbuckle brace, and Figure 2.7 the elongation and buckling of an angle section brace. The turnbuckle braces fractured in most cases and angle section braces fractured in only one “Post 1981” building. Typical fracture modes observed in turnbuckle braces are shown in Figures 2.8, 2.9, and 2.10.

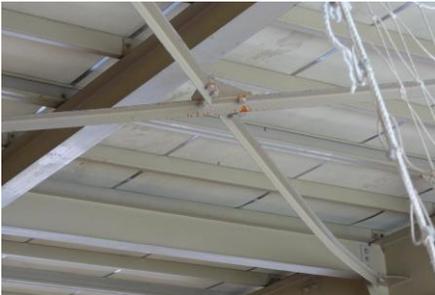
Figure 2.7. Elongation and buckling of angle braces

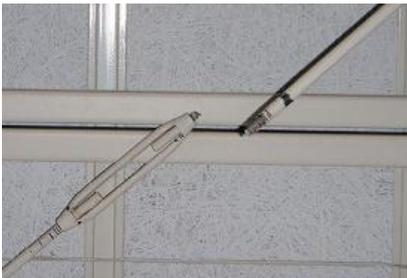
Figure 2.8. Fracture at the screw of a turnbuckle brace

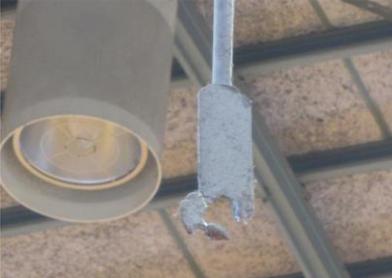
Figure 2.9. Pull out fracture of a turnbuckle brace

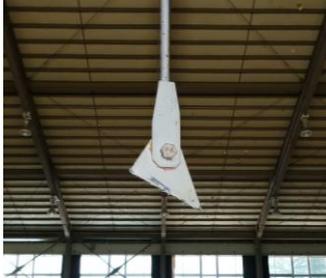
Figure 2.10. Fracture at the weld of a turnbuckle brace

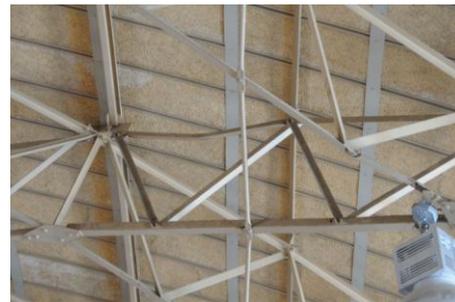
In general, the roof with a 3-dimensional structure has sufficient stiffness and strength to withstand damage from severe earthquakes. Only one gymnasium in the “Retrofitted” group has a damage rank above I. Its roof structure is composed of several arch-shaped trusses crossing each other diagonally as shown in Figure 2.11. The buckling of several truss components was observed as shown in Figure 2.12. The cause of the damage is still under investigation, but the damage of the buildings near the site lead one to believe that the seismic input exceeded the demanded level.

**Figure 2.12.** Buckling of the truss element

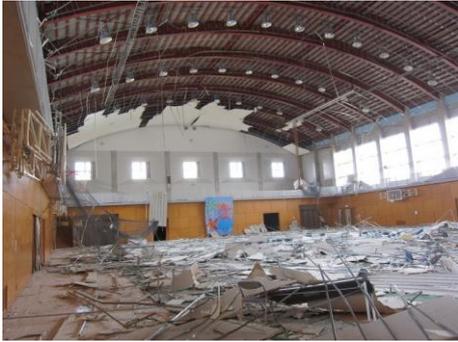
The vulnerability of suspended ceilings has been mentioned for a long time. Since suspended ceilings are fairly heavy, the inertial force under earthquake acceleration is large. When the connections, which suspend the ceilings, are not strong enough, the ceilings have a danger of falling. The damage observed in the survey reinforces this claim. In Figure 3.1, the ceilings which had a rank IIw or higher damage were those suspended. From Figure 3.2, which shows the damage rank with respect to whether or not the ceiling is suspended, one clearly sees that little or no damage occurs if the ceiling is not suspended. The majority of buildings without a suspended ceiling are gymnasiums. Such a gymnasium is shown in Figure 2.11. On the other hand, 5 of the 8 buildings with a rank IIIw or IVw damage are gymnasiums with suspended ceilings, which imply that suspended ceilings in gymnasiums can be vulnerable to strong ground motions. Figure 3.5 shows the complete fall of the ceiling of a gymnasium which suffered a rank 7 earthquake based on the Japanese Meteorological Agency seismic intensity scale. Figure 3.6 shows partial falling of ceiling boards in a classroom.

**Figure 3.5.** Fallen ceiling in a gymnasium

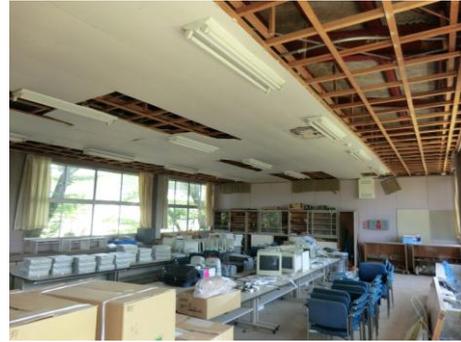
**Figure 3.6.** Fallen ceiling in a classroom

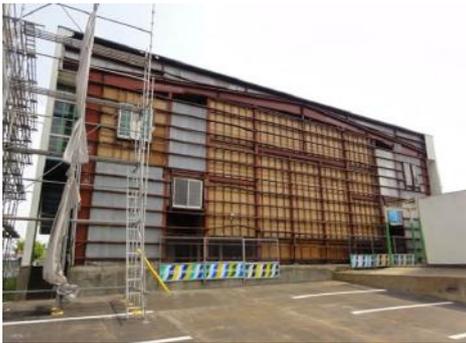
The types of damage observed in the exterior walls depend strongly on the material and method of construction. These were organized into 4 groups: “sidings” (metal siding, plastic siding), “boards” (asbestos cement board, plaster board, calcium silicate board), “AAC/EPC” (Autoclaved Aerated Concrete(AAC) panel, Extruded Cement Panel (ECP) ), and “metal lath and mortar”. The distribution of the damage rank organized into the 4 groups is shown in Figure 3.3. “Metal lath and mortar” and “panels” combined make up most of the severe rank IVw damage. “Metal lath and mortar” exterior walls are extremely vulnerable to damage, since they have a lower deformation capacity compared to the steel structure, and may completely fall off as in Figure 3.7. The same can be said about exterior

**Figure 3.7.** Complete fallen metal lath and mortar wall

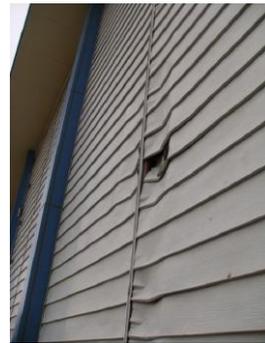
walls using AAC panels fixed to the structure without a mechanism to allow deformation. On the other hand, “sidings” have a high deformation capacity and generally had slight or no damage. Even in the worst case, as shown in Figure 3.8, there is only some out of plane deformation. Figure 3.4 shows the year of construction of the buildings with respect to the type of exterior wall. The use of metal lath and mortar was popular in the 1960s and 70s, but because of the reason stated above, its usage has declined. The use of boards has also declined and they seem to have been replaced by siding.

**Figure 3.8.** Out of plane deformation of the metal siding

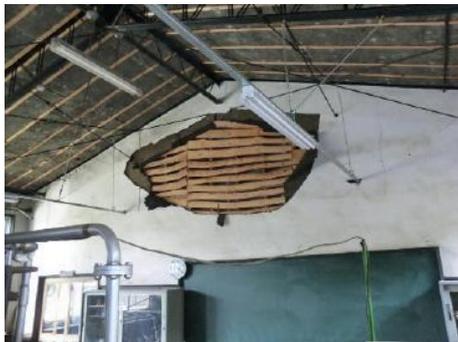
The damage to the interior of most steel buildings has been slight, as can be read from Figure 3.1. The types of damage that occurred were cracking and falling off of mortared walls as in Figure 3.9 and peeling or falling of boards from boarded walls as in Figure 3.10.

**Figure 3.9.** Mortar falling off of mortared interior walls

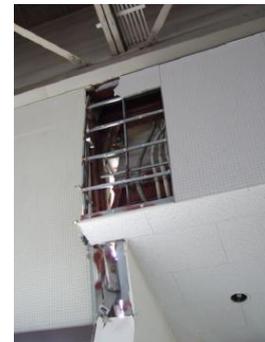
**Figure 3.10.** Board falling off the interior wall

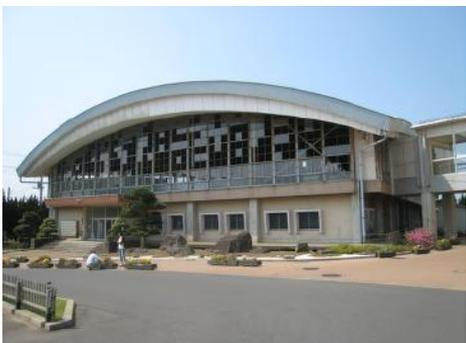
The majority of the damage observed in the openings was due to the window glass shattering, as in Figure 3.11, or the window panel falling off, as in Figure 3.12. Many of the shattered windows had glass panes secured to the metal frame using hardening putty, which transfer the deformation of the window directly into the glass.

**Figure 3.11.** Shattering of glass windows

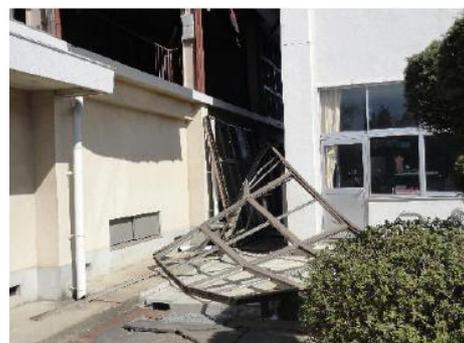
**Figure 3.12.** Fallen window panel

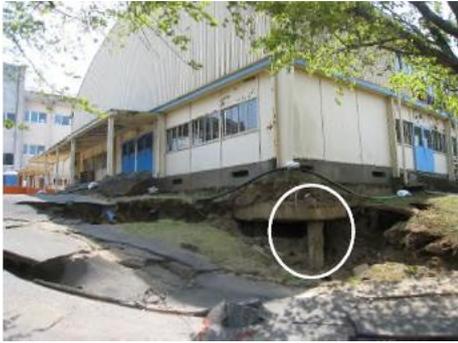
Figure 4.2 shows a building damaged by a landslide. The pile of this building has fractured, as shown in Figure 4.3, and the whole building has tilted. Uneven settlement can cause damage to the structure above the foundation. Such examples are shown in Figures 4.4 and 4.5. The former shows the tilt of the column caused by landslide of the sloped site. The latter shows the tilt of a foundation caused by subsidence of the flat site, resulting in cracks in the outer wall.

Figure 4.2. Damage due to a landslide

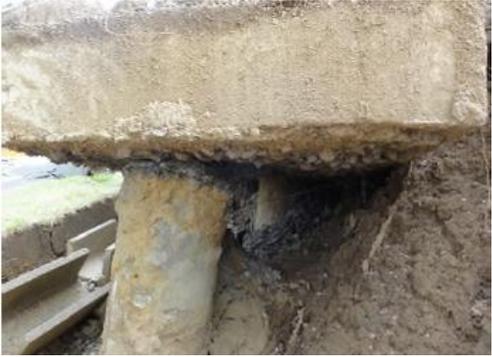
Figure 4.3. Fracture of a pile at the top

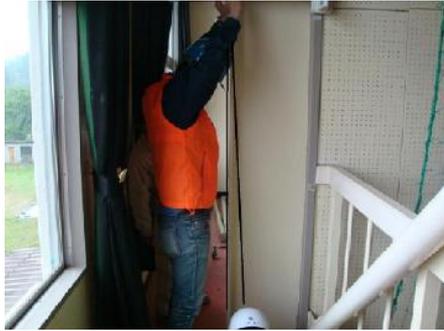
**Figure 4.4.** Tilt of a column

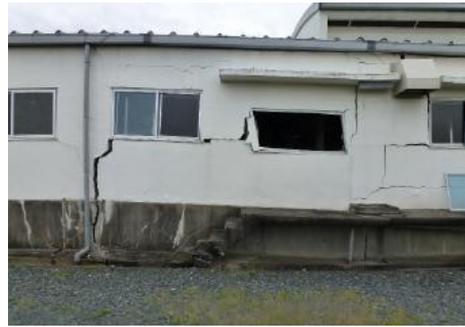
**Figure 4.5.** Tilt of a foundation
