# Statistical Damage Survey of the 2010 and 2011 Christchurch Earthquakes

**T. Lai, & A. Nasser**

## SUMMARY

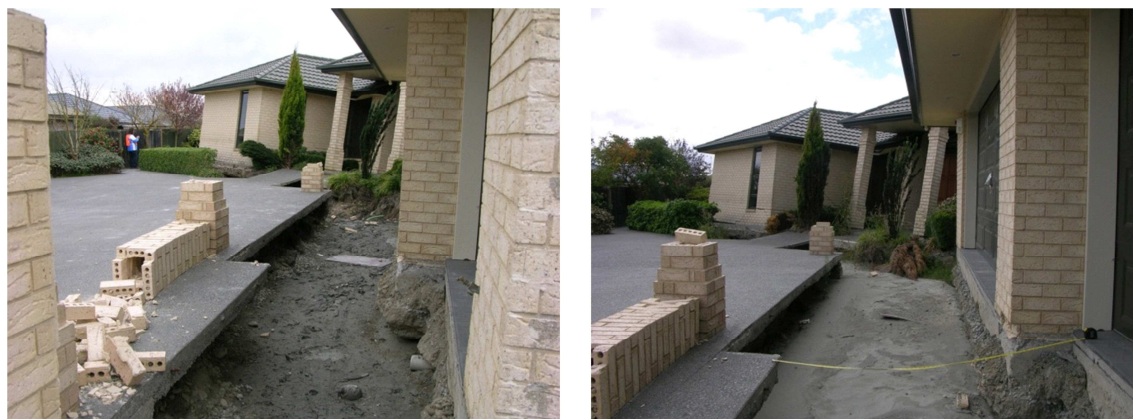
15 km north of Christchurch, the Courtenay Drive area in Kaiapoi which is located right along wetland, was hit severely by liquefaction during the main shock. Although this area is quite far from the epicentre, recorded ground motions at the nearby Kaiapoi North School indicated moderate shaking probably due to soil amplification. The liquefaction broke water main and drainage system, and sand residual was extensive on yards, private driveways and public roads. One dwelling slid toward wetland as much as 1.2m. Interestingly, lateral spreading and liquefaction damage showed considerable spatial variations within close distances. Out of the 24 building units along Raven Quay, six might need to be demolished while another six looked intact from exterior. The remaining had varying levels of damage. During the February 2011 aftershock, although the shaking severity was much less than the main shock, the liquefaction damage in the area was further exaggerated. The observations clearly indicated high liquefaction susceptibility in this area. A dwelling, that previously slid 1.2m, moved another 0.6m away as shown in Fig. 2.

**Figure 2.** Damage due to sliding in Courtenay Dr.

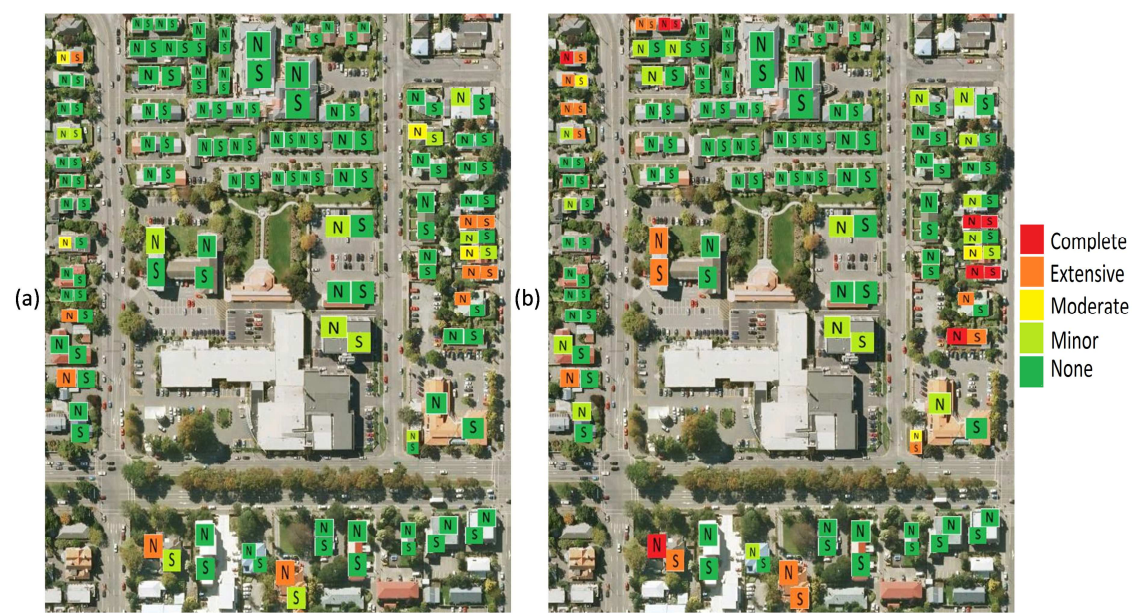
Each building in the studied region was assigned a damage state as defined in section 2.2. Fig. 5 shows, for both 2010 and 2011 earthquakes, the distribution of structural and non-structural damage over the surveyed area using colour codes that represent each damage state. As can be seen in the figure, the pattern of damage in the two earthquakes is similar; both events caused more non-structural damage than structural damage, and both created comparable spatial distribution. Severity of the damage, however, is somewhat higher in the 2011 event. This can be visualized by contrasting the colour codes of the two panels in Fig. 5.

**Figure 5.** Damage distribution near Southern Cross Hospital: a) September 2010 b) February 2011 S: structural damage and N: non-structural

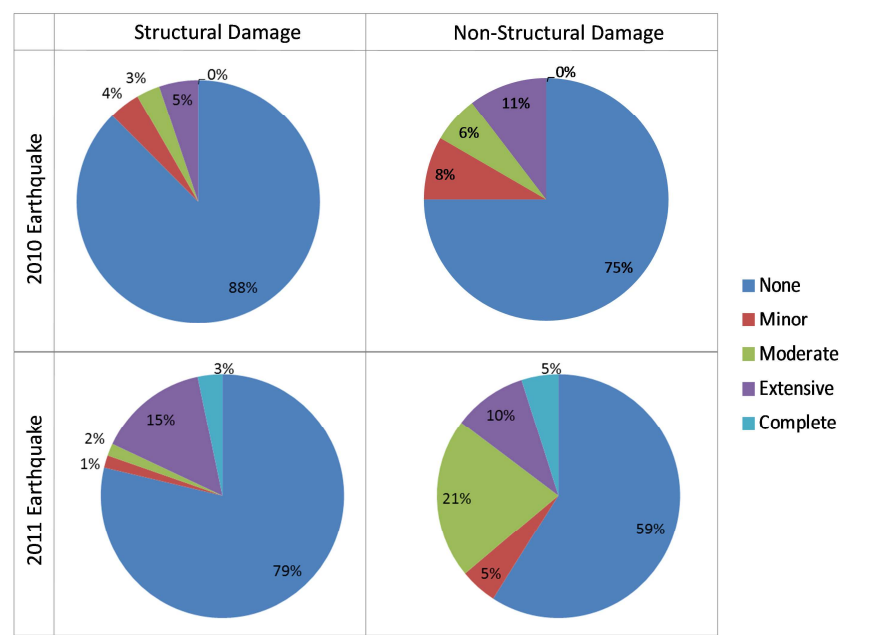
Statistics of the observed damage states for the entire building stock (not separated by construction type) is shown in Fig. 6 for the 2010 and 2011 events. During the 2010 earthquake, as much as 88% of the buildings in the surveyed area did not suffer any visible structural damage. Only 3% experienced moderate damage and 5% suffered extensive damage whereas no building was completely damaged. With regards to non-structural damage, 75% of the buildings were found to be unscathed while 11% sustained extensive damage. No complete damage was observed in non-structural component either. In the 2011 earthquake the percentage of buildings that experienced structural damage rose to 21%. Out of all the damaged buildings, 15% suffered extensive and 3% complete damage. Nevertheless, still 79% of the buildings did not experience any notable structural damage. Examination of non-structural

components shows that about 41% of the buildings suffered some levels of damage among which 10% experienced extensive damage and 5% sustained complete damage.

**Figure 6.** Statistics of the observed damage in the surveyed area for the 2010 and 2011 Earthquakes

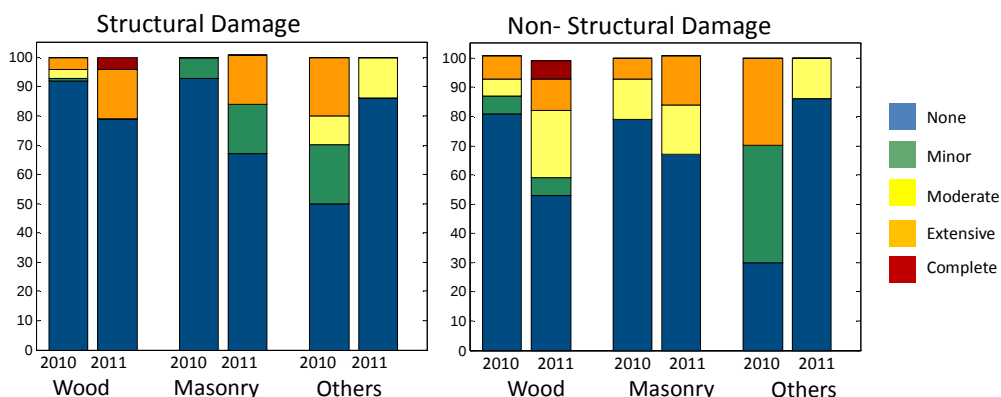
distribution of damage states in each category follows the one presented previously for the entire stock; i.e. the majority of the buildings did not sustain damage that was noticeable from the exteriors. In the 2010 event, 8% of “wood” and 7% of “masonry” buildings suffered structural damage. These numbers for non-structural damage were respectively 19% and 21%. No complete structural damage was seen in the either wood or masonry buildings. In the 2011 earthquake, 21% of “wood” and 34% of “masonry” experienced structural damage. In 4% of the ‘wood” buildings damage was considered complete. Non-structural elements in 47% of “wood” and 34% of “masonry” buildings experienced varying levels of damage with 17% in both “wood” and masonry being classified as extensive or higher. In general, one can conclude that the 2011 earthquake caused higher damage in this area than the 2010 earthquake, and that damage in masonry buildings was higher than in wood dwellings. As mentioned previously, higher uncertainty in the statistics for the “other” due to smaller sample size does not allow reliable comparisons.

**Figure 7.** Breakdown of damage state for different construction types

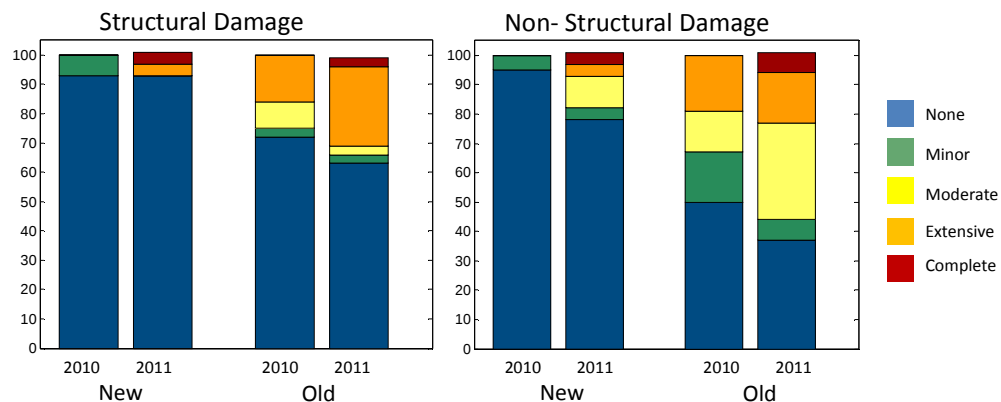
Breakdown of damage states for buildings of different age, namely, “old” (pre-1980) and “new” (post-1980) is illustrated in Fig. 8. The outcome of this illustration is not surprising; old buildings have experienced higher damage states than did new buildings. In the 2010 earthquake, 28% of the old buildings experienced structural damage and 50% suffered non-structural damage. The percentage of those with extensive to complete damage was 16 and 19 respectively for structural and non-structural damage. None of the new buildings suffered moderate or higher damage. In the 2011 earthquake, 37% of the old buildings suffered structural damage while 63% experienced non-structural damage. Among those, 30% of structural damage and 23% of non-structural damage was classified as extensive to complete. From the “new” buildings only 8% suffered extensive and complete damage.

**Figure 8.** Breakdown of damage state for different age

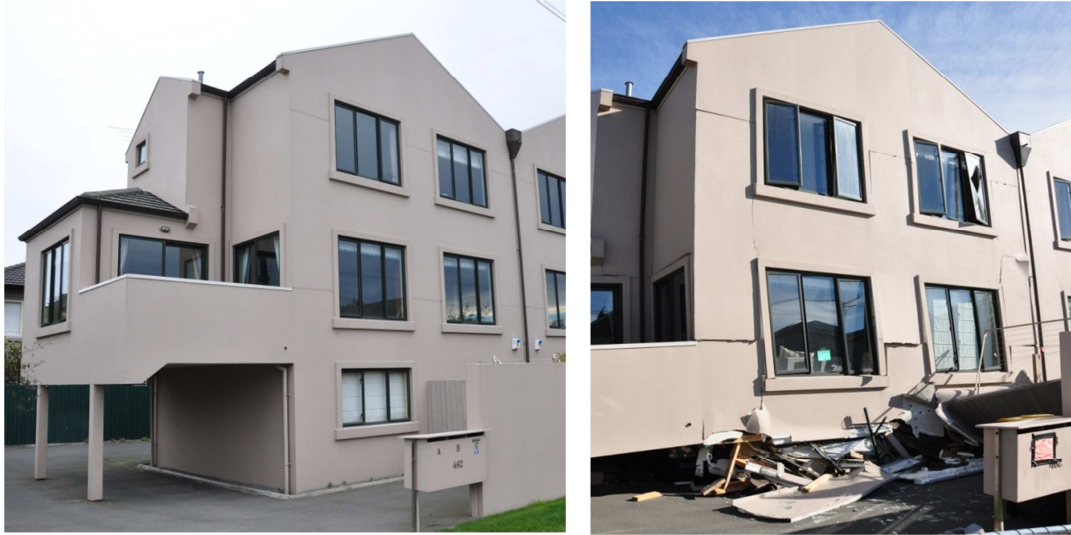
However, the author's perspectives changed after the February earthquake regarding the perceived value of collecting higher resolution images during the September surveys. In a few cases upon further review, high resolution images taken in September captured tell-tale signs of minor damage that manifested into much more severe damage in February.

**Figure 9.** a) Modern wood frame home in Christchurch that experienced subtle dimpling in its finish at attachments and along edges around wall panel perimeters after the September 2010 earthquake.  
b) Severe damage from the February 2011 earthquake
