Damage Analysis of Water Supply Facilities in the 2011 Great East Japan Earthquake and Tsunami

M. Miyajima
Kanazawa University

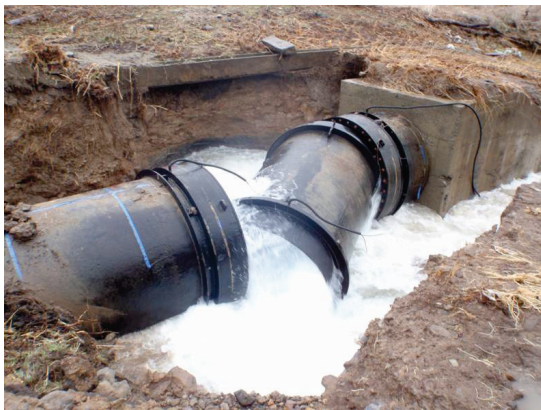
The damage caused by the earthquake and tsunami seems to be classified into five categories. Firstly the causes of damage are divided by earthquake and tsunami. Causes of damage by earthquake are classified into ground shaking itself and ground failure such as liquefaction, slope failure and etc. Fig. 1 shows damage to expansion joint of steel pipe with 2400mm diameter. This damage seems to be caused by ground shaking and/or ground deformation. Fig. 2 shows an uplift of underground water tank induced by liquefaction.

Figure 1. Damage to steel pipe with 2400mm diameter (Miyagi Pref.).
(<http://www.pref.miyagi.jp/kigyo/>)

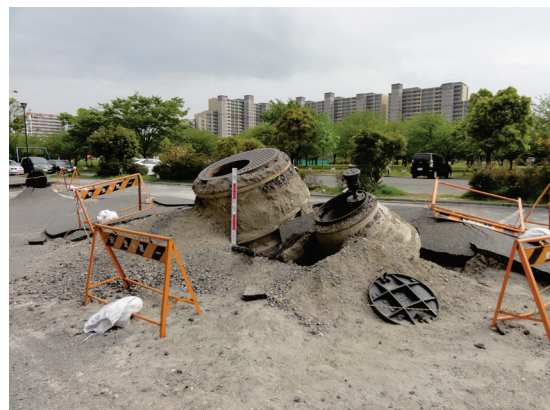
Figure 2. Uplift of underground water tank (Chiba Pref.).

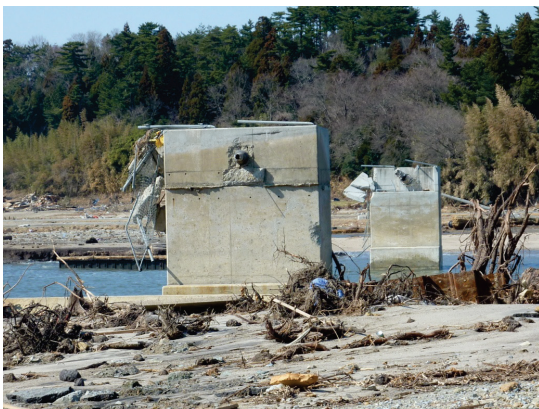
Causes of damage by tsunami are classified into three categories; inundation, washing away and scouring of surface ground. Some intake facilities were inundated by tsunami and became malfunction for long time because of high density of calcium chloride in water. Fig. 3 shows damage to a water pipe bridge by tsunami. The water pipe bridge was completely washed away. Fig. 4 shows damage to a buried pipeline. The pipeline appeared above ground after tsunami because of scouring caused by tsunami. The mechanism of damage to pipeline, that is, how much force acts on a pipeline is not sure. The mechanism of this kind of damage must be clarified in the future.

Figure 3. Damage to water pipe bridge (Miyagi Pref.).

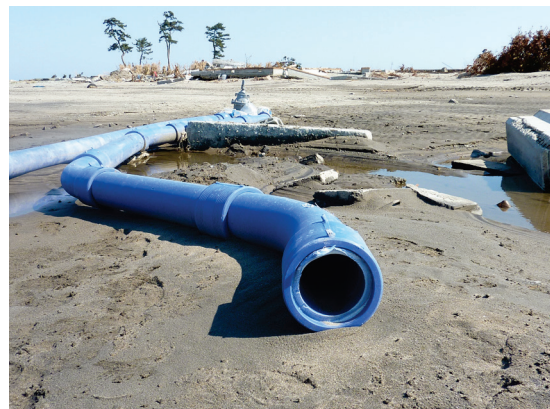
Figure 4. Damage to pipe by scouring of tsunami (Miyagi Pref.).

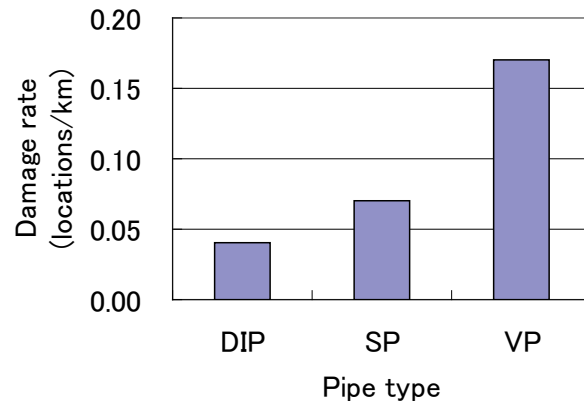
The total number of damage to transmission main, distribution main and branch pipelines was 264 except the flooded areas, and the piping length is 3,761km. The damage rate of transmission main, distribution main and branch pipelines was, therefore, 0.07 (locations/km). The damage rate in relation to pipe type and pipe diameter is shown in Figs. 5 and 6, respectively. Fig. 5 indicates that the damage rate of polyvinyl chloride pipe (VP) is high. Fig. 6 reveals that the smaller the pipe diameter is, the higher the damage rate.

Figure 5. Damage rate related to pipe type.

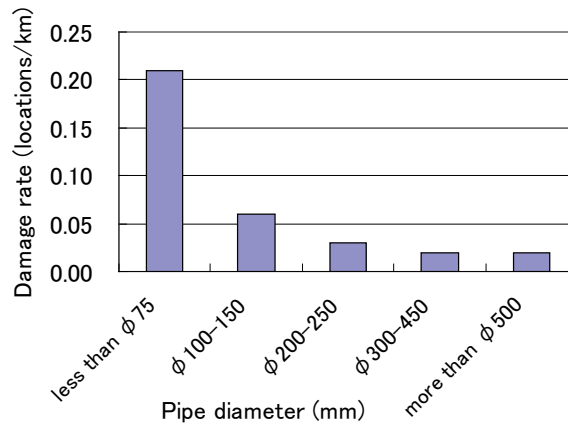
Figure 6. Damage rate related to pipe diameter.

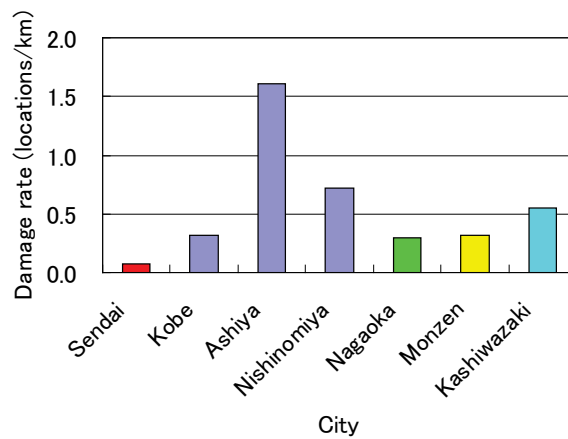
Fig. 7 illustrates a comparison of damage rate of Sendai City with those of other cities suffered damage to pipeline in the past earthquakes in Japan. Kobe, Ashiya and Nishinomiya Cities suffered damage to water supply pipeline in the 1995 Hyogo-ken Nambu Earthquake, Nagaoka City in the 2004 Niigata-ken Chuetsu Earthquake, Monzen Town in the 2007 Noto-hanto Earthquake and Kashiwazaki City in the 2007 Niigata-ken Chuetsu-oki Earthquake, respectively. This figure reveals that the damage rate of Sendai City was very low in comparison with another cities. Magnitude of earthquake and seismic intensity in each city were different. PGA of K-NET Sendai observation station was, however, not small; 1,808 (cm/s/s). This value is higher than most of cities listed in Fig. 7. One of reasons of low damage rate in Sendai City seems to be high earthquake-proofing rate. The earthquake-proofing rate is defined as the piping length of ductile cast iron pipe with earthquake resistant joint and welded steel pipe divided by the total piping length. The earthquake-proofing rate of Sendai City is 51.2%.

Figure 7. Comparison of damage rate.

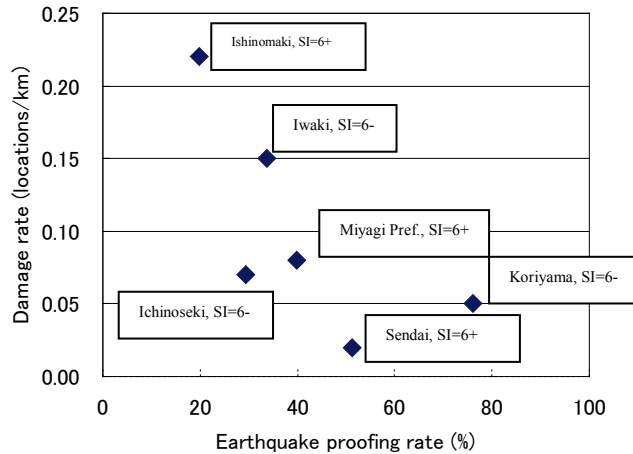
Fig. 8 illustrates the relation between the earthquake-proofing rate and damage rate of each waterworks bureau suffered damage in the 2011 great east Japan earthquake. The damage rate shown in this figure is calculated by using the damage to transmission and distribution main pipeline, that is, distribution branch pipeline is not included. This figure shows JMA (Japan Meteorological Agency) seismic intensity scale in each area. This figure indicates that the higher the earthquake-proofing rate, the lower the damage rate is. There was no damage to the ductile cast iron pipe with earthquake resistant joint. Effect of earthquake-proofing pipe was, therefore, verified by the earthquake.

Figure 8. Relation between earthquake proofing rate and damage rate.

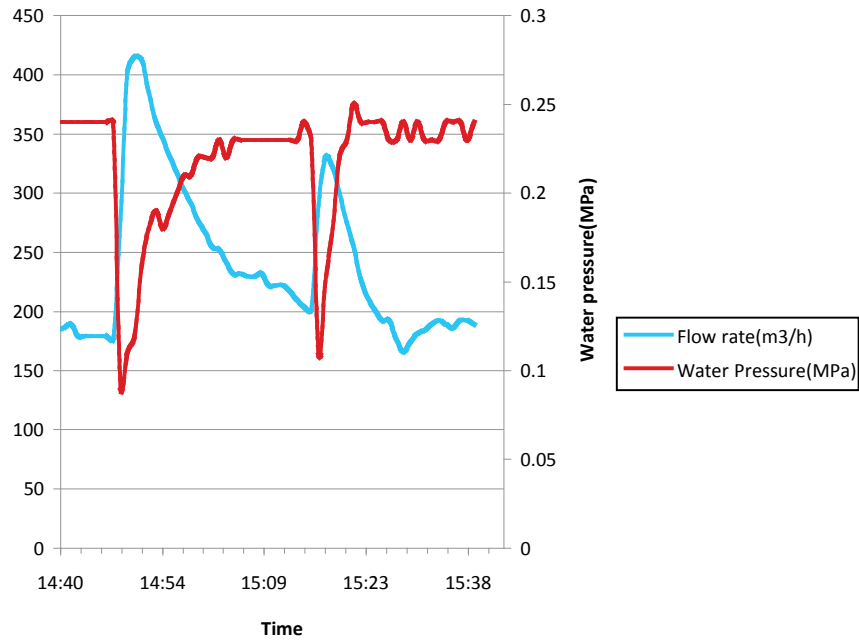
Unusual phenomena such as an abrupt increase in flow rate and a decrease in water pressure of water distribution system in spite of no damage to pipeline was occurred in several cities during the great east Japan earthquake. Fig. 9 shows time histories of the flow rate and water pressure at a water distribution plant of the Bureau of Waterworks Tokyo Metropolitan Government. The flow rate increased and water pressure decreased rapidly just after the earthquake. The higher flow rate and lower water pressure were recovered after about 20 minutes. The similar phenomena were occurred again by the aftershock.

Figure 9. Time histories of the flow rate and water pressure at a water distribution plant of Tokyo.

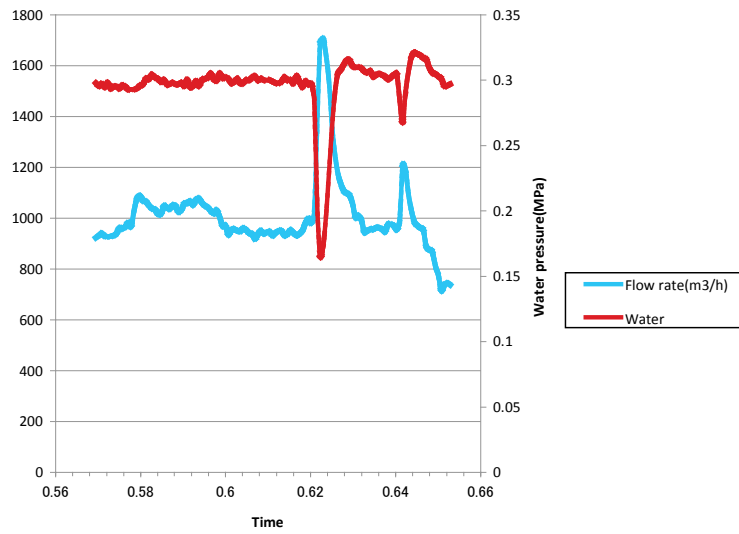
Figure 10. Time histories of the flow rate and water pressure at a water distribution plant of Osaka.

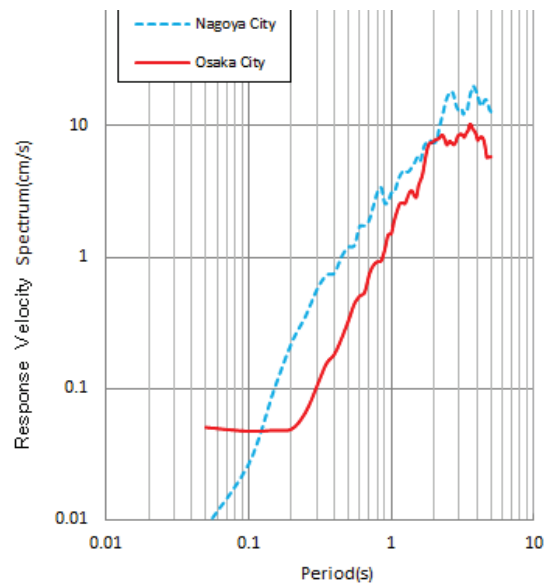
Figure 11. Response velocity spectra of recorded waveform at Nagoya City (K-NET AIC004) and Osaka City (K-NET OSK005).

Fig. 11 illustrates response velocity spectra of recorded waveforms of the great east Japan earthquake at Nagoya City (K-NET AIC004) and Osaka City (K-NET OSK005). This figure indicates that the predominant periods are more than one second.

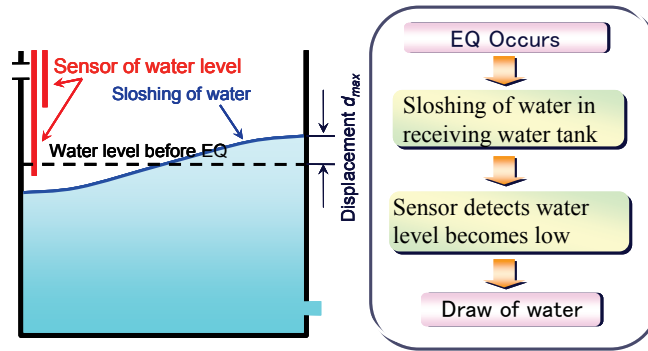
Figure 12. Mechanism of draw of water from distribution pipe to receiving tank by sloshing during earthquake.

Murata and Miyajima have considered that one of the causes of the unusual phenomena seems to be sloshing of water in receiving water tank. If sloshing of water in receiving water tank is occurred by an earthquake, draw of water to receiving water tank from a distribution pipelines starts by error of a sensor of water level in the receiving water tank as shown in Fig. 12. If sloshing of water in many receiving water tanks occurred simultaneously, an abrupt increase in flow rate and a decrease in water pressure in the distribution pipeline may be occurred. Occurrence of sloshing of water in receiving water tank depends on the dimensions of receiving water tank and the height of water in the tank. Murata and Miyajima have investigated dimensions of receiving water tank in a water distribution block of Osaka City and estimated the natural period of sloshing of the water. Fig. 13 shows cumulative percentage of natural period of water in receiving water tank in case that the height of water is 3/4 and 1/2 of the height of water tank. The height of water is variable and depends on use of water. The natural period of sloshing is more than 1.0 second of more than 80% of the water tank in the direction of long side in the water distribution block in Osaka City. This is one example, but long period ground motion more than one second can be caused sloshing of water in receiving water tank. However, the further study is needed to clarify the cause of an abrupt increase in flow rate and a decrease in water pressure of water distribution system in spite of no damage to pipeline and its effects to emergence response just after large scale disaster.

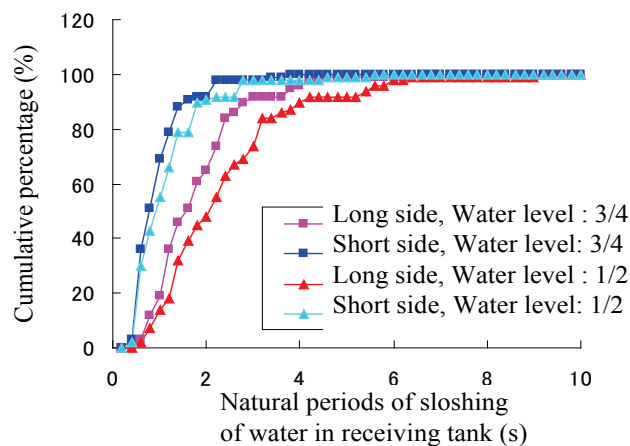
Figure 13. Cumulative percentage of natural period of water in receiving water tank
