Impact and Recovery of the Kaiapoi Water Supply Network following the September 4th 2010 Darfield Earthquake, New Zealand

Stuart Knight, Sonia Giovinazzi, and Miao Liu

*Department of Civil and Natural Resource Engineering
University of Canterbury,
Christchurch, New Zealand*

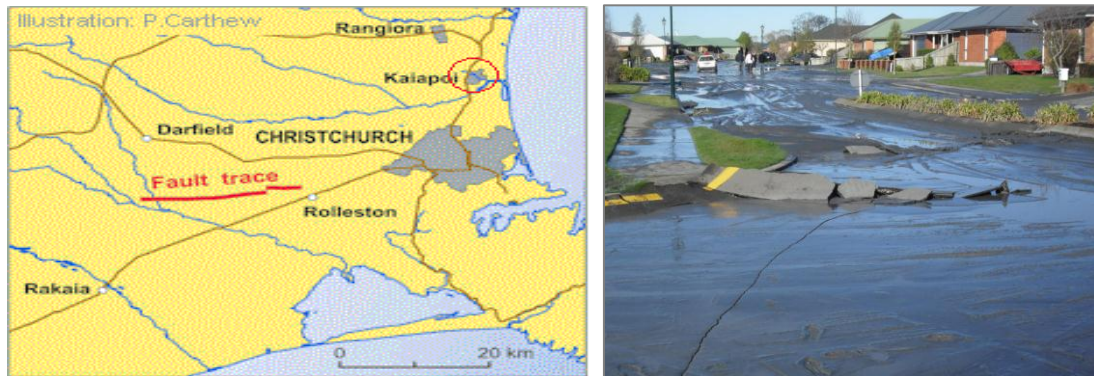
Figure 1. September 4th, 2010 Darfield earthquake: a) Location of Kaiapoi in relation to the Greendale fault trace, Darfield town and Christchurch city (GNS Science, 2011); b) evidences of liquefaction in Kaiapoi.

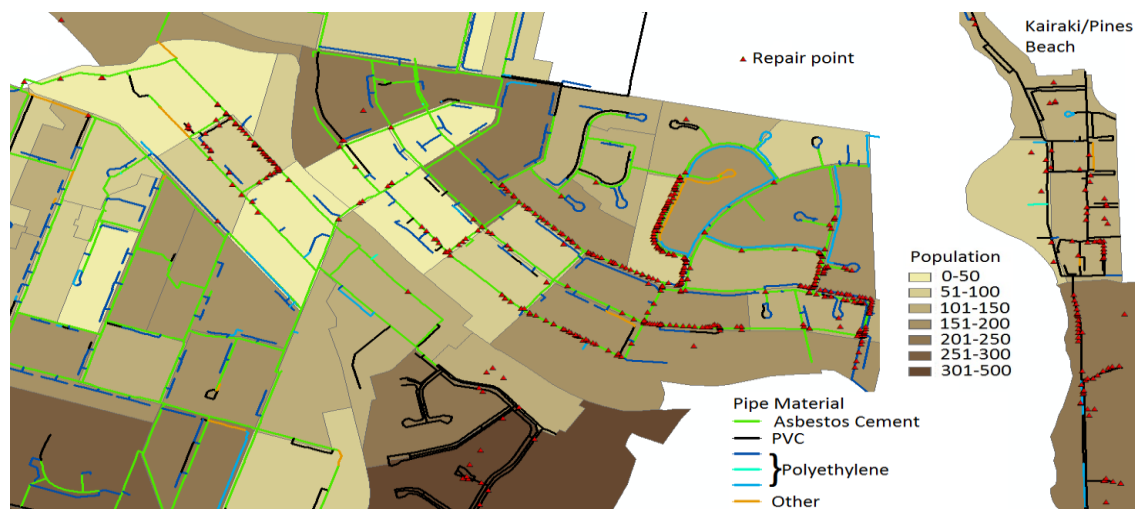
of damage which occurred to the reticulation of Kaiapoi and nearby Kairaki/Pines Beach water systems. Table 2 shows the number of repairs for the main components of the distribution network namely: main and rider main, house lateral, tody and valve. 140 repairs targeted the damage which occurred to mains or rider mains, 174 repairs addressed problems occurred to house laterals. Figure 3 presents the location of damage survey assessment points and following repairs made to the potable water distribution of Kaiapoi (left) and Kairaki/Pines Beach (right) network following the 4th September 2011 Darfield earthquake. The damage to pipes was spread across Kaiapoi with higher density of repairs near the Kaiapoi River, most significantly on the northern side of the town (Figure 3). To gain a first understanding of the performance of different pipe materials, the map of damage survey points and repairs was overlaid to the map of the water distribution network differentiated per pipe material. Table 2 presents the break-down of pipe repairs made to mains and rider mains for different material types, showing that more than 70% of the repairs targeted Asbestos Cement, AC pipes. 15% of the repair addressed damage to PVC pipes (Figure 4a). AC pipe in the Kaiapoi potable water distribution systems sustained massive damage (Figure 4b) being exposed up to 2 to 4 inches of settlements or 12 to 40 inches of lateral spreads (Eidinger *et al.* 2011).

Figure 3. Map of repairs (red triangles) made to the potable water distribution of Kaiapoi (left) and Kairaki/Pines Beach (right) network following the 4th September 2011 Darfield earthquake overlaid to: i) potable water distribution network differentiated per pipe material; ii) population at mesh-block level.

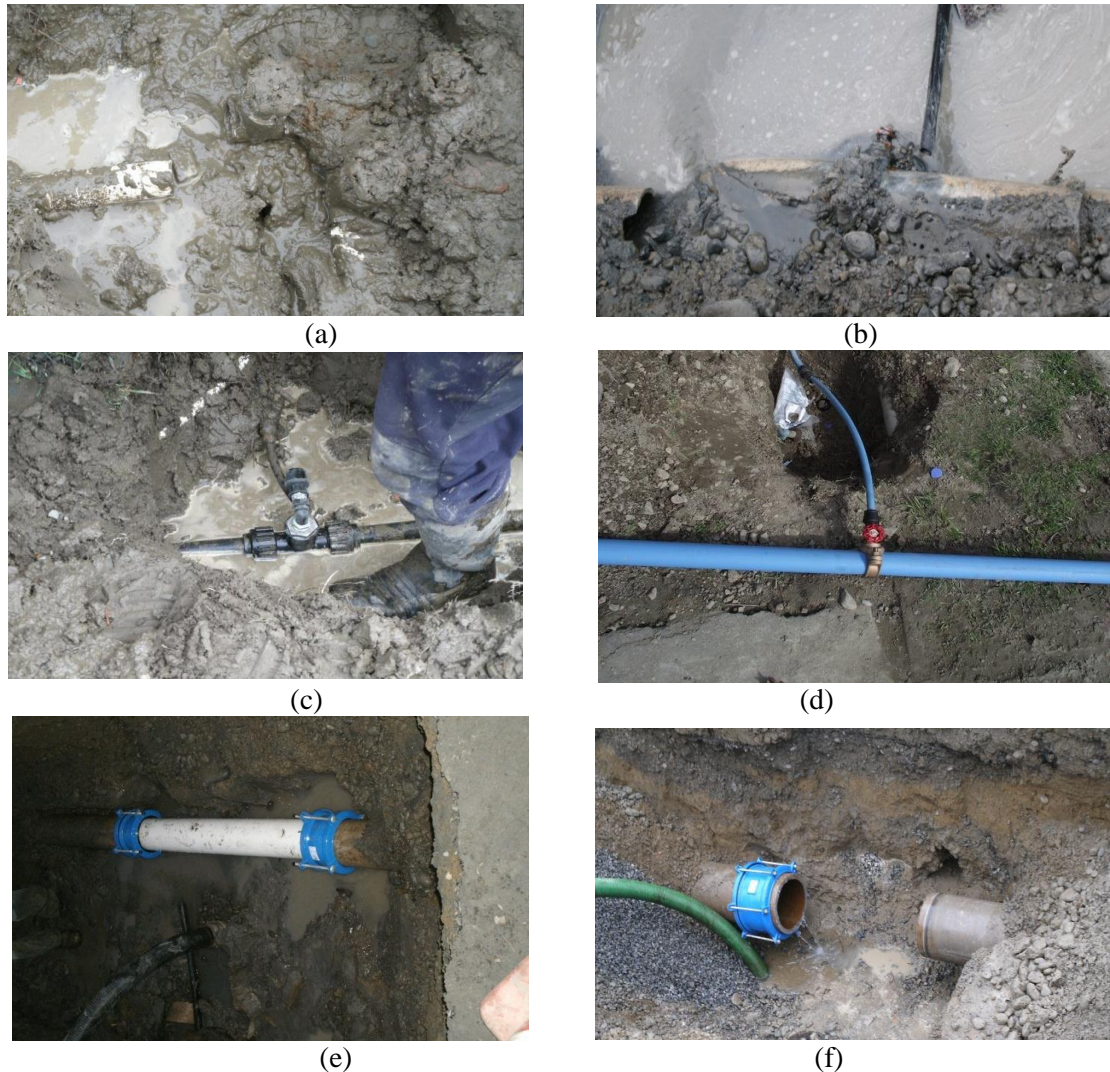
Figure 4. Pictures of damage sustained in Kaiapoi; (a) PVC main pulled away from joint due to severe lateral spreading; (b) AC main broken with broken house lateral connection; (c) disconnected house lateral; (d) temporary PE rider main installed above ground; (e) AC pipe repaired with a section of PVC; (f) water flowing out of cut open section of AC main being repaired (pictures courtesy of Ric Barber, WDC).

A prompt restoration of the potable water service functionality was the first priority set by the local Council (Section 4) following 4th September 2010 Darfiled earthquake. To this aim temporary repairs were put in place where possible, including: i) installation of temporary PE rider main above ground (Figure 4d); ii) installation of external clamps and insertion of a new sections of PVC pipe cut into damaged pipes, where the damage was limited (Figures 4e and 4f). AC pipes had to be entirely replaced where the damage was more extensive. Nine crews, comprising of over 30 people, were employed in the immediate recovery phase following the 4th September earthquake. Six affected areas were identified in the territory of Kaiapoi and Kairaki/Pines Beach. Each of the six areas had one or more crews assigned to perform repairs. The crews were asked to report back three times daily on their progress to the Utility Manager at the emergency management centre, EQC, set up by the Council (Figure 8a). The repairs made along with any new required repair were updated daily (Gary Boot and Rick Barber, WDC, personal communication) on both the "Criticality" plan, which showed the most critical mains in WDC network and on the reticulation map (Figure 8b). This enabled WDC Utilities Managers to: get an updated picture of where they were up to; set intervention priorities; and make decision on resources redirection, when and where necessary. While managing the emergency, the local Council did not have an established procedure and/or available tool for assessing and quantifying: 1) the number of costumers that lost access to the potable water service following the earthquake; 2) the number of costumers reconnected to the service after each set of repair; 3) how different repair strategies could have possibly increased or speeded up the restoration of the functionality. However, based on expert judgment the Council was able to estimate that 85% of the water was restored on day one, following the earthquake and 90% of the service was restored on day two (Gary Boot and Rick Barber, WDC personal communication).

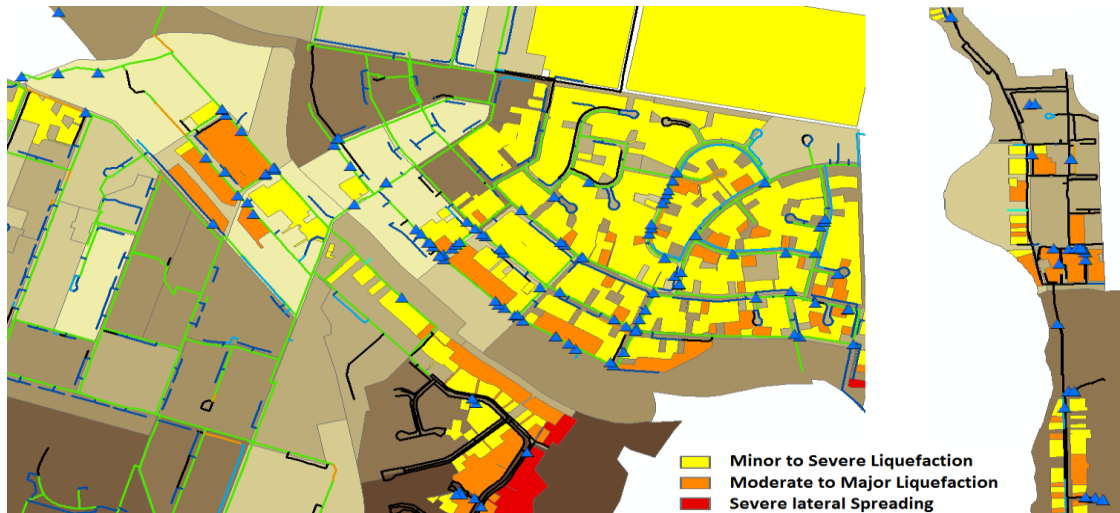
To further investigate the vulnerability of different pipe materials to liquefaction-induced land deformation, maps of the potable water networks and of the repairs undertaken after the 4th September Darfield earthquake were overlaid to a map representing the observed land damage deformations (Tonkin and Taylor, 2011). On behalf of the Earthquake Commission (EQC), Tonkin and Taylor (2011) assessed the liquefaction-induced land deformations which occurred in residential areas, following the 4th September 2010 earthquake and designated qualitative levels to describe it, namely: 1) minor to severe liquefaction; 2) moderate to major liquefaction; 3) severe lateral spreading (Figure 5).

Figure 5. Repairs (blue triangles) made to the potable water distribution of Kaiapoi (left) and Kairaki/Pines Beach (right) network following the 4th September 2011 Darfield earthquake overlaid to the map representing different levels of observed land damage according to Tonkin and Taylor (2011).

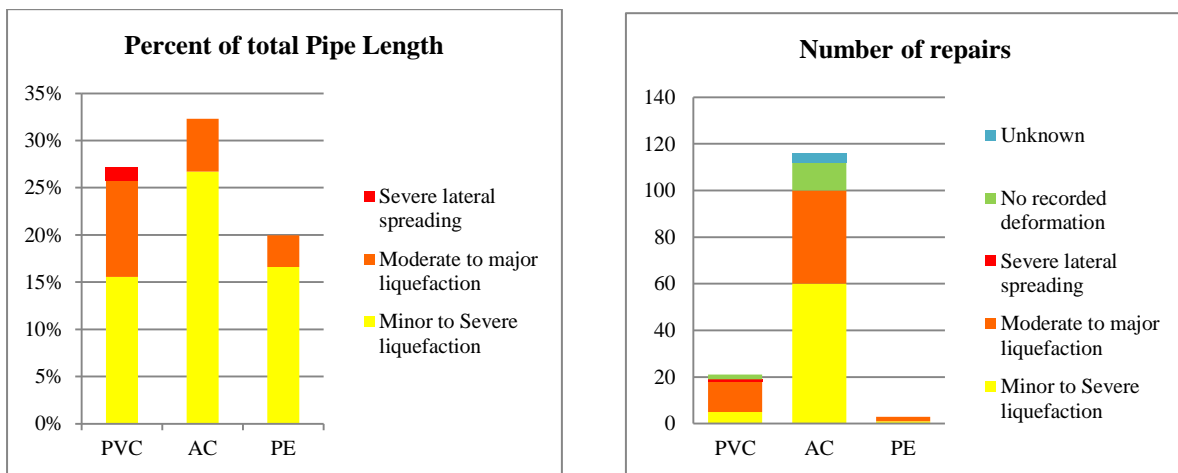
The largest proportion of pipes was located in areas that suffered minor to severe liquefaction, with Asbestos Cement AC pipes showing the higher level of exposure (Figure 6a). PVC pipes had the highest exposure to moderate to major liquefaction areas and were the only material present in areas affected by severe lateral spreading. Figure 6b presents the number of repairs made to each material for the same land deformation level. As seen in Table 2, AC pipes clearly had a higher number of repairs compared to the other pipe materials. The same trend was observed even in areas of moderate to major liquefaction where PVC pipes were more exposed (Figure 6a). AC pipes required a comparatively large number of repairs in areas where no land deformation was recorded. Focusing on PVC pipes, although they were more exposed to minor liquefaction, the greatest numbers of repairs resulted in areas of moderate to major liquefaction, (Figure 6). This could suggest a general good performance of PVC pipes when subjected to minor to moderate land deformation, starting to be affected at higher level of land deformations. PE pipes showed, relatively, the best performance with

only one repair required in areas affected by minor to severe liquefaction, where PE pipes had an exposure similar to PVC pipes (Figure 6). Two repairs for PE pipes resulted in areas of moderate to major liquefaction. Data reported as “Unknown Results” in Figure 6b is data missing location information and coordinates, which could not therefore be used within the preliminary Geographical Information System, GIS analysis presented in this paper.

Figure 6. Vulnerability of different pipe materials to different levels of land damage: (as for Tonkin and Taylor, 2011 land damage map): a) percent of total length of pipe exposed to different level of land damage; b) number of repairs made to mains and rider mains of three most common pipe materials (namely, PVC, AC and PE) in Kaiapoi in areas of different land damage.

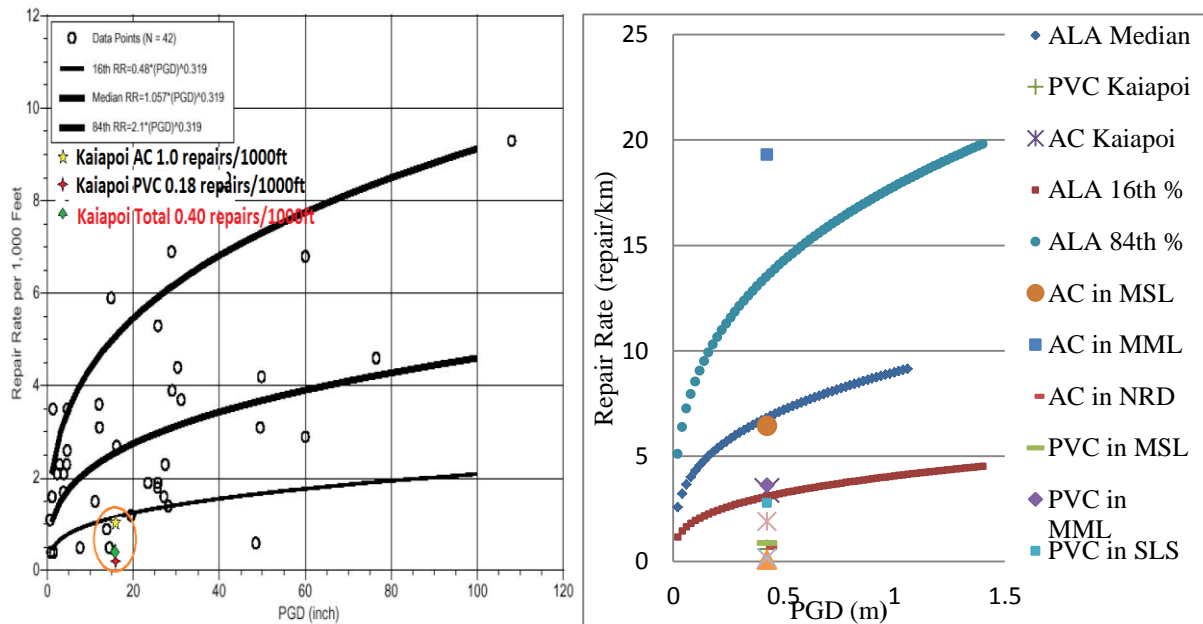
Figure 7a shows the ALA backbone RR curves for PGD mechanisms and the data set used for deriving the curves through regression analysis when assuming $K_2=1$ that generically represents all kinds of pipe materials, joints and diameters (Figure 7a) and recorded PGD=0.45m in Kaiapoi during 4th September Darfield earthquake (Cousin et al. 2010).

Figure 7. Comparison between observed Repair Rate for Kaiapoi and Kairaki/Pines Beach potable water networks following the 4th September Darfiled and ALA repair rate predictive models: a) ALA backbone RR curve for PGD mechanisms and $K_2=1$; b) ALA curves for AC and PVC pipes with rubber gasket joints and repair rates of different materials for each level of land deformation (Table 3) ($K_2=0.8$).

both Asbestos Cement, AC and for PVC pipes with rubber gasket joints (ALA 2001). As a matter of fact, due to the lack of empirical data on PVC pipes, ALA (2001) proposes to consider the performance of PVC pipes, and therefore the expected repair rates similar to AC ones. . Figure 7b shows ALA RR curves for PGD mechanisms, represented in metric system, and when assuming a modification factor $K_2=0.8$. The repair rates observed in Kaiapoi (converted to repairs/1000ft for Figure 7a) were plotted in the same graphs. The repair rate observed in Kaiapoi for AC pipes is just within the 16th percentile curve. Observed repair rate for PVC pipes is lower than 16th percentile and lower of any data set point. The assumption of PVC pipes, behaving similarly as AC one might be too conservative. It is worth highlighting that the PGD descriptor ignores any variation in the amount of ground displacement and the direction of ground displacement relative to the pipeline. If this level of details is desired, then site-specific analytical methods should be used instead of area-wide vulnerability functions (ALA 2001). Also it is important to remember that ALA models are conceived and designed as area wide functions, providing a repair rate for the whole area as a function of a maximum level of hazard expected in a certain area. Existing repair rate functions may lead to over-estimate the expected repair rate for Kaiapoi and Kairaki/Pines Beach water networks that include 60% PVC and PE pipes.

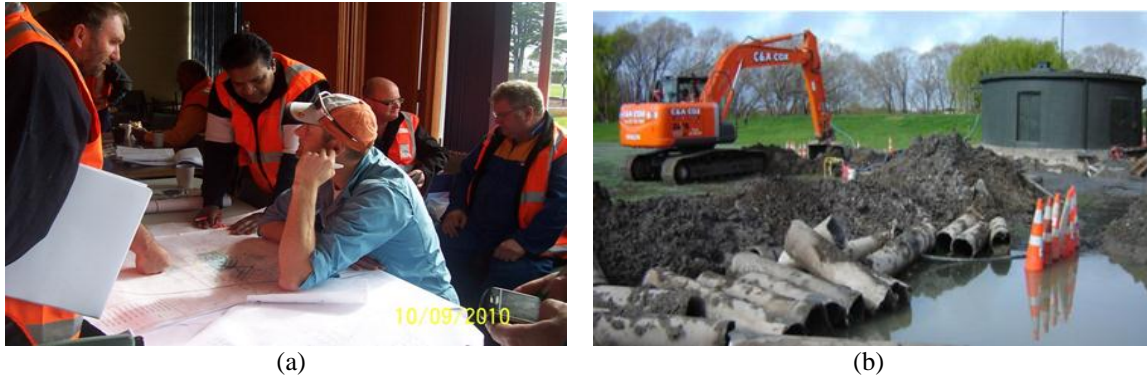
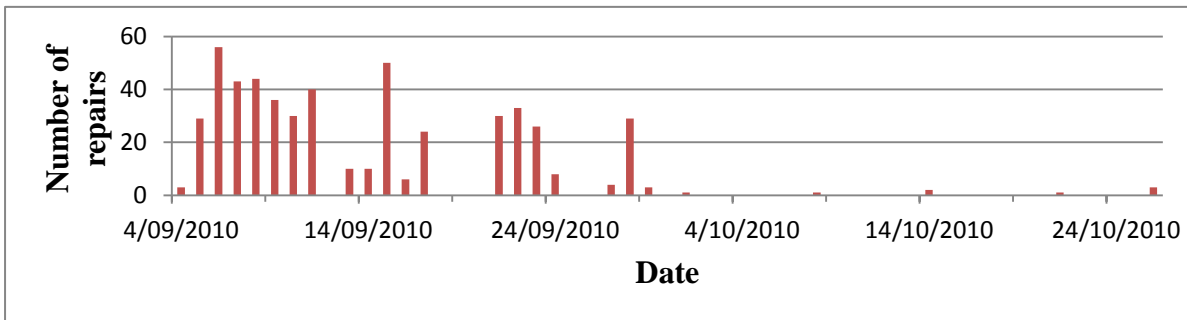
Figure 8. Post-event restoration of functionality of WDC water-system: a) meeting at EQC to record and discuss repair progresses; b) works in progress to repair fractured AC sewer rising main pipe in Kaiapoi; c) Number of repairs made in Kaiapoi and Kairaki/Pines Beach from September 4th 2010 to November 2010.

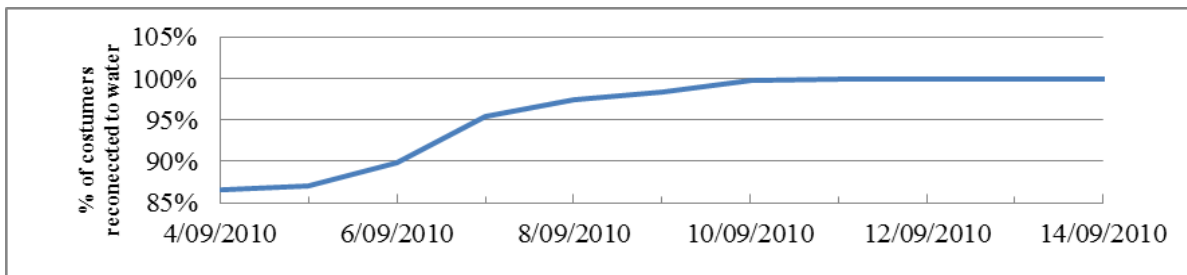
Figure9. Percentage of Kaiapoi population without water over time from September 4th 2010 estimated by combining observed repairs and population data from 2006 Census (according to Statistic NZ).

The cumulative population restored each day was recorded and compared to the total population of Kaiapoi. Figure 9 shows the percent of total population with water as it was restored, with only repairs within Kaiapoi considered (i.e. not Kairaki/Pines Beach). Assuming 5th of September as day one, the numbers resulting from the aforementioned simplified analysis resulted in: 86% of functionality restored on day one; 89% restored on day two. According to this analysis, water was restored to 99.9% of the population by the 11th of September (7 days after the earthquake). These results are very
