Assessment of bridges in non liquefiable soils following Canterbury earthquakes: comparison between observations and numerical analyses

SUMMARY:

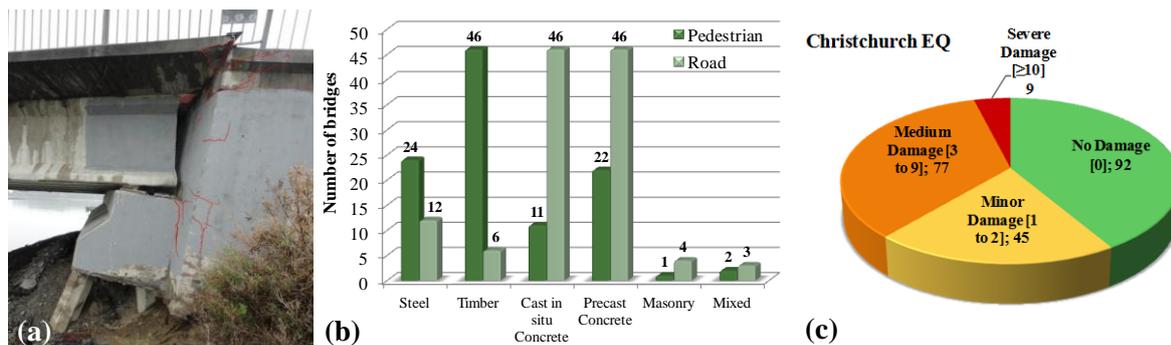
Figure 2. a) Example of damage to the abutment: rotation at Bridge Street Bridge; b) Proportions of the bridge category of use for each structural material type. c) Christchurch Bridges stock grouped on the basis of the damage severity after the February 22 earthquake

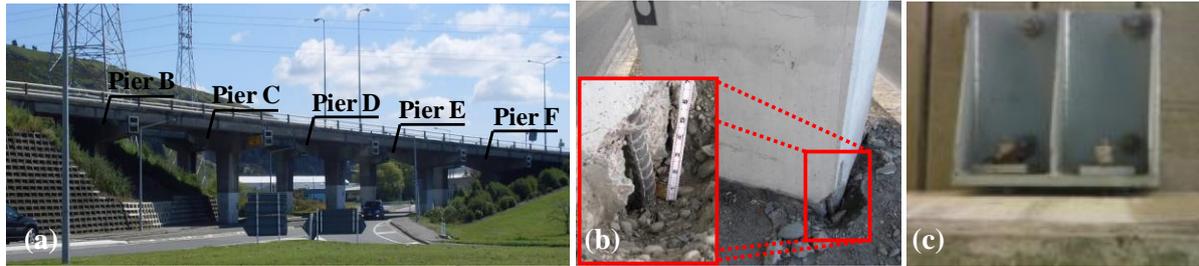
Figure 3. a) Overall view of Port Hills Road Overpass b) Buckling of reinforcing steel at the base of the piers [Courtesy of OPUS]; c) Elongation of the links between the spans [Courtesy of OPUS].

In the Christchurch earthquake, flexural cracking developed in the lower halves of all pier stems of both bridges except those adjacent to the abutments. In fact, despite the presence of the linkage rods increased the deck stiffness, this was not enough to control the higher displacement demands occurring in the central piers. Soil gapping at ground level occurred at the faces of most of the pier stems with separation cracks up to 15 mm wide. Spalling occurred at the base of the central pier, and the longitudinal bars started to buckle (Figure 3b). The damage increased during the June 13, 2011 aftershock. The nominal 10mm gaps between the new shear keys and the abutment face at the South-East abutment closed up with no clearance on two of the four keys.

Slope failure at the abutment slopes under the bridge resulted in wide cracks in the soil and at the interface between the soil and abutment face under the South-East abutments. There was also minor settlement and displacement of the approach pavement and back-fill at the abutments.

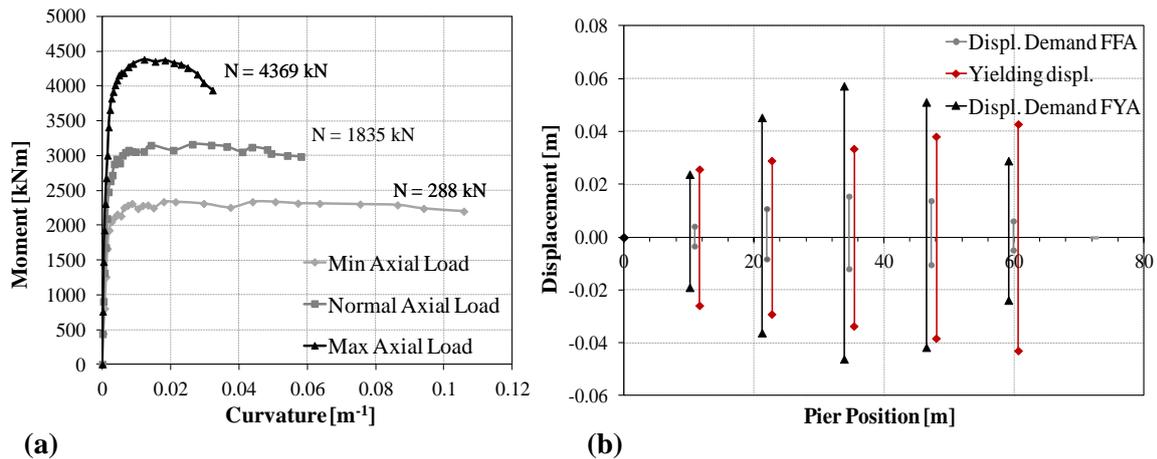
This led to a significant variation of the axial force on the columns, which caused ductility reduction of the piers as shown in Figure 4a for the central pier (Pier D). When the axial load variation (HVSC record) caused by the earthquake sums to the static load there is an increment of 38.60 % in the moment capacity but a reduction of 49.24% curvature ductility respect to the situation with no axial variation effect. Vice versa for lower total axial load (N-ΔN) the moment capacity reduces of 28.09% while the ductility increases of 93.69%.

good correspondence between the numerical analyses and the reality is found subjecting the structure to the HVSC records. However, the “real” axial load variation in the bridge was probably smaller since accelerations of HVSC incorporate seismic amplification effects. Figure 4b shows that the displacement demand for the model with fully fixed abutment (FFA) is lower than the displacement at the yield of the base section of the piers. On the contrary, the model with the superstructure pinned at the abutment locations develops plastic hinges at the bottom, with top displacements greater than the yielding ones. The real response of the bridge is hence likely to have been between the ones of the two “limit cases” model. In fact, since the bridge is prefabricated with post-installed mechanical connections, the fully fixed model overestimates the stiffness of the retrofit linkages between the abutment and the deck.

Figure 4. a) Evolution of the moment-curvature with varying axial force. b) Comparison between the displacements of the top of the columns subjected to HVSC records.

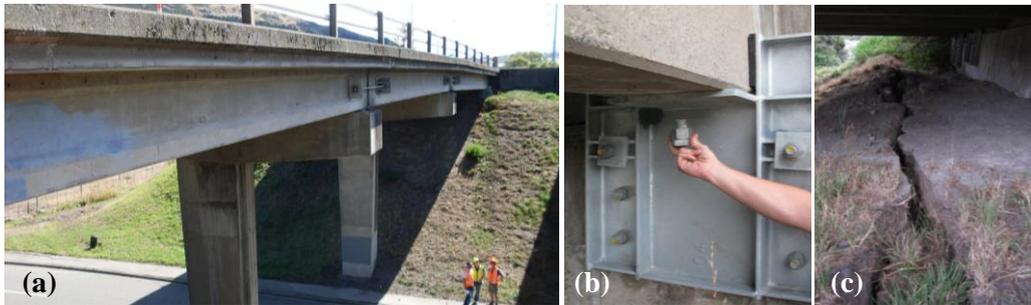
Following the Christchurch earthquake, fine horizontal cracking was observed on the lower half of all four piers, located between about 500 to 2600 mm above ground level. The east end of the No 2 Bridge displaced horizontally about 100 mm in a southwards direction. This resulted in severe vertical cracking at the junction between the abutment seating and the abutment wall between the two bridges. There was minor spalling at the ends of beams where they were seated on the abutments.

All four abutments appeared to have moved forward by up to 20 mm. This movement caused severe shear cracking in the backwall and shearing of two of the bolts on the new linkage brackets (loaded in shear) at the west abutment of the No 1 Bridge (Figure 5b). Bolts on the new linkage brackets also sheared on both abutments of the No 2 Bridge. The west abutments had settled by about 60 mm. This was particularly visible on the south side of the No 2 Bridge. Surface sliding of soil was evident under the west abutments and wide cracks and separation gaps between the soil and abutments were evident at the east abutments indicating significant down-slope movements (Figure 5c).

Figure 5. a) Overall view of Port Hills Road Overpass, looking west; b) Sheared bolt at the abutment retrofit [Photo by J. Allen]; c) Slope failure at the abutments [Photo by J. Wood].

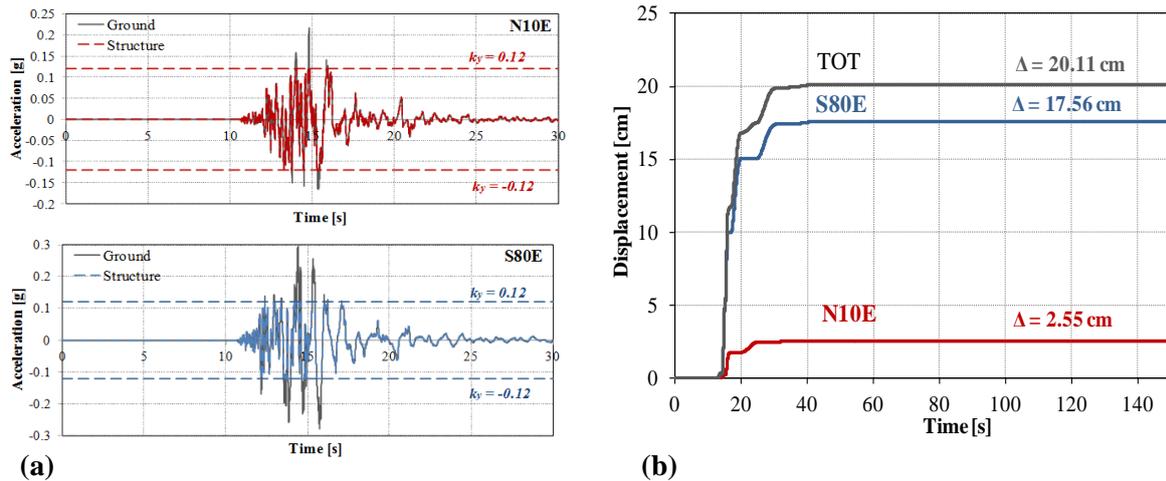
Figure 6a shows the accelerograms for soil (continuous line) and structure (dashed line) for the two components of CMHS record, in the longitudinal axis of the bridge. The corresponding relative structure displacements are shown in Figure 6b. The displacements in the same direction are added together to find the total displacement of each abutment equal to 20.11 cm.

Figure 6. a) Acceleration Time Histories for ground and structure, CMHS components; b) Displacement Time History relative to soil, CMHS records

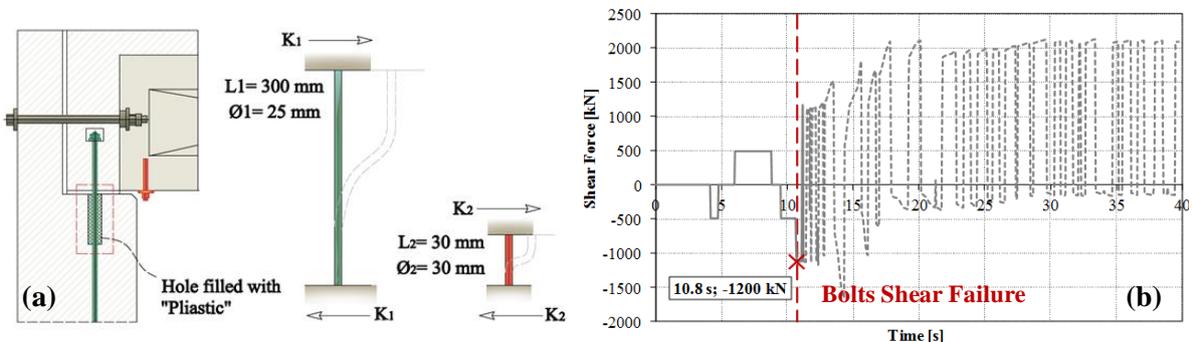
The determination of the actual length of the beam for the retrofit bolts was less immediate. As shown in Figure 7a, they are fully fixed in the concrete all the length of the bolt. For numerical analyses a length of 30 mm was assumed.

Results of the analysis show that, adopting an elasto-plastic rule to represent the behaviour of the bolts, it was possible to pick out the brittle failure of retrofit bolts, as expected from a shear failure, at ~1120 kN (sum of four bolts). Figure 7b shows the shear force time history with the indication of the instant when the shear failure occurs (~11 s).

Figure 7. a) Schematization of the bolts for numerical analyses; b) Time History of the Shear Force acting on retrofit bolts, with the indication of the breaking point.

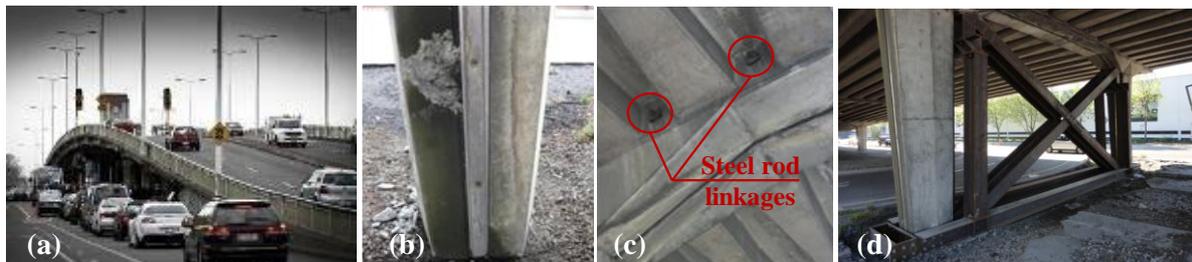
Figure 8. a) Overall view of the bridge; b) Pier expansion joints [Courtesy of OPUS]; c) Steel rod linkages [Courtesy of OPUS]; d) Temporary repair solution.

To prevent further damage a repair solution consisting of dual cross-bracing units at each of the weakest piers was constructed (Figure 8d). The bracing was designed in order to have the same lateral stiffness of the existing piers and not modify the loading path in the other existing parts.

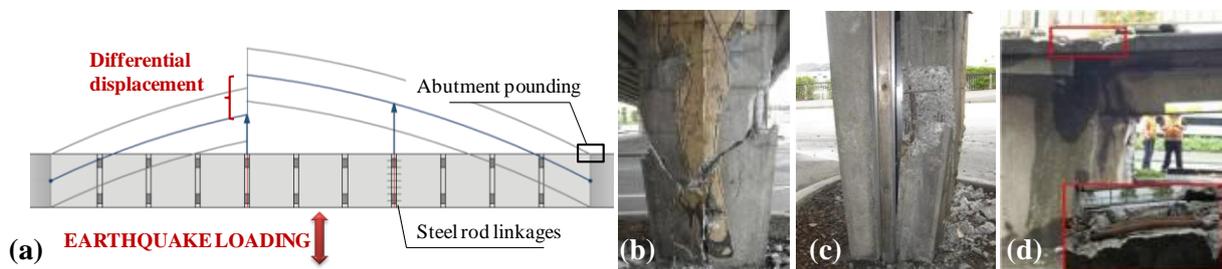
The performance during the February event was unsatisfactory. The mechanism of damage is shown in Figure 9a: west piers were significantly damaged with shear cracking and buckling of longitudinal rebars. The bridge sustained damage to one column near the North-East approach where a deck expansion joint was located. The insertion of steel rod linkages in the deck only at the expansion joint between the west and the central part of the bridge caused irregularity in structure (Figure 8c): the pier at the East expansion joint suffered extensive displacement demand. The slenderness of the pier affected the vertical load carrying capacity of the structure along with the lateral capacity. The columns had also widely spaced transverse reinforcement, making the structure susceptible to a brittle failure mechanism (Figure 9b).

Observations after the Christchurch event indicated that the damaged columns had started to buckle putting the central span at risk of collapse (Figure 9c). Due to the higher displacement demand in the West-Central part of the bridge, the deck pounded against South-West abutment of the bridge causing extensive spalling and bar buckling (Figure 9d).

Figure 9. a) Plan on bridge showing qualitative displacement profile under transverse loading; b) Shear failure mechanism of the pier [Photo by A. Palermo]; c) Longitudinal bars buckling of the pier d) Concrete spalling and bar buckling at South-West side abutment [Photo by A. Kivell]

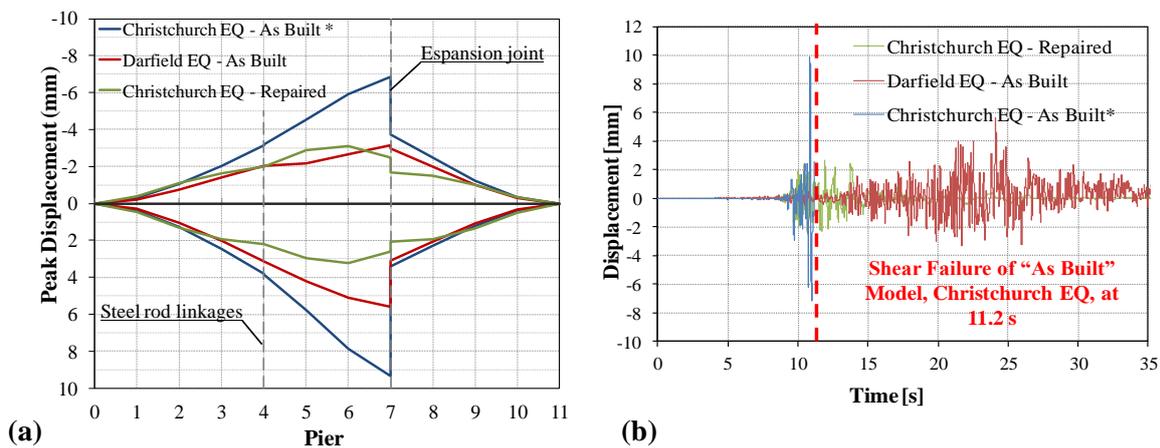
Figure 10a shows the peak displacement profiles of each model: the pier located at the expansion joint without the steel rod linkages underwent the largest displacement demands in the As-Built model during the last seismic event, reaching 9.85 mm; in fact it exhibited the most severe damage in assessment inspection. A shear failure occurred in the As-Built model after 11.2 s when subjected to the Christchurch earthquake as expected (Figure 10b). No failure occurred in any of the other analyses, indicating that the repair method was effective in preventing failure of the bridge. The displacement profiles show a larger peak displacement in the South direction than the North direction which is consistent with the damage to the west abutment where spalling occurred on the Southern side of the abutment, but not the Northern side. Moreover the peak displacement and shear force of the As-Built model during the Christchurch earthquake were approximately 1.6 times those that occurred during the Darfield earthquake.

Figure 10. a) Displacement profile of each model; b) Time History displacement with the indication of the instant in which the shear failure happened according to the numerical analyses.
