Investigation of Liquefaction-induced Damage to Wooden Houses in Urayasu City Caused by the Great East Japan Earthquake

Kohji Tokimatsu & Kota Katsumata

Tokyo Institute of Technology

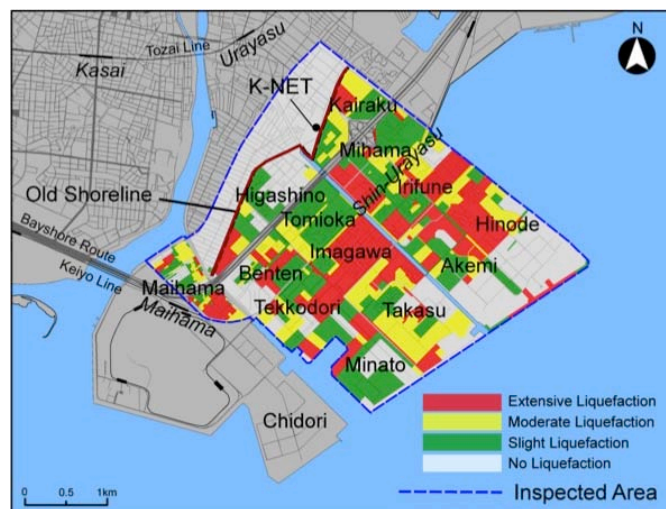
Figure 4.1 shows a damage distribution map in which the extent of soil liquefaction is classified into four categories (i.e., no, slight, moderate, and extensive), based on the field performance of soils and buildings including ground settlements as well as settlements and tilting of houses. It can be confirmed that, liquefaction-induced damage was not seen on the north of the old coastline as of 1964 but was widely developed in the area reclaimed after that year. The areas that had experienced liquefaction in

Figure 4.1. Map showing extent of liquefaction Damage (Tokimatsu et al., 2011, 2012)

the 1987 Chiba-ken Toho-oki Earthquake did re-liquefy. The degree of damage varied from place to place within the reclaimed areas. In particular, some of the reclaimed zone escaped any liquefaction damage probably due to ground treatment including remedial measures against soil liquefaction.

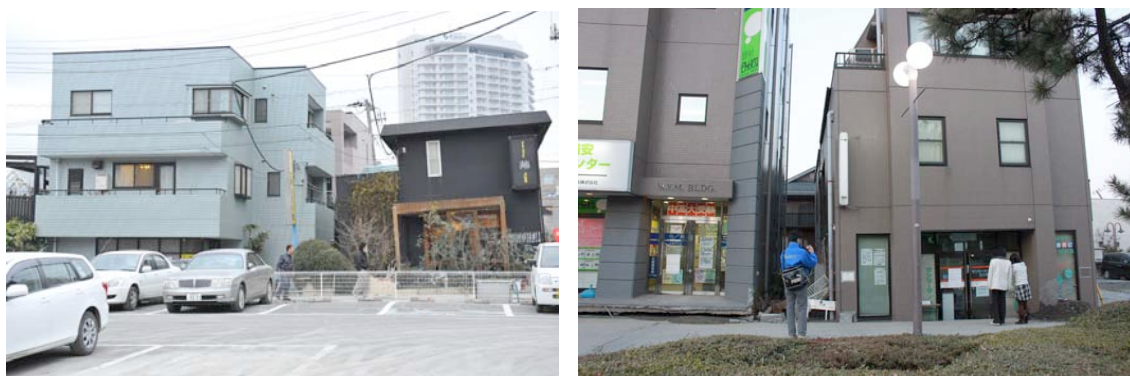
1) In areas where liquefaction occurred, many sand boils, ground settlements up to 60 cm as well as settlements and tilts of building and houses on spread foundations (Figure 4.2) were observed

Figure 4.2. (a) Buildings suffering large settlement and tilting (left) and (b) buildings experiencing different gaps against subsiding ground (right) (Tokimatsu et al., 2011)

4) When buildings face each other across a street, they tend to tilt backward, away from each other, as in Figure 4.4. When two buildings stand closely together, they often tilt toward each other, as shown in Figures 4.2(a) and 4.4. Such unique tendency was probably caused by building-soil-building interaction effects in which the combined loads of the two adjacent buildings increased their settlements on the neighboring side.

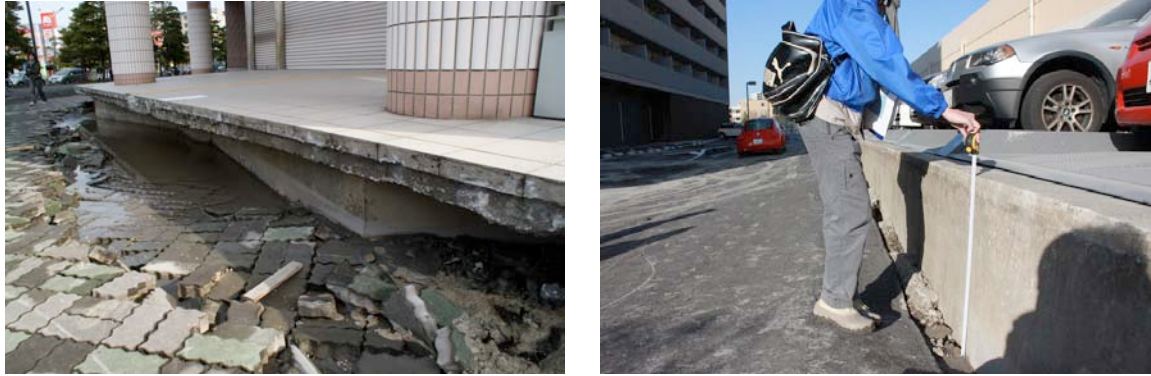
Figure 4.3. (a) Pile-supported buildings suffering large ground settlement (left) and (b) uplifted underground parking garage (right) (Tokimatsu et al., 2011)

everywhere. Vertical gaps were created around pile-supported structures due to ground settlements (Figures 4.2(b) and 4.3(a)), causing damage to piping and other facilities. Underground facilities, such as manholes, emergency water tanks and parking lots were uplifted (Figure 4.3(b)), damage was done to tap water and sewerage systems, roads had dents and utility poles were toppled. But little or no damage to superstructures induced by seismic force was observed.

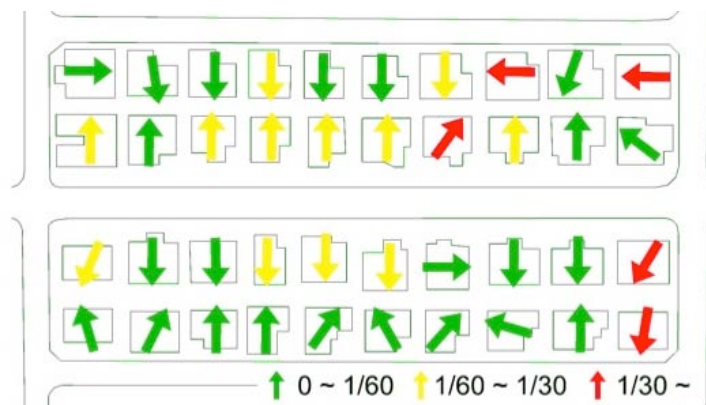
Figure 4.4. Typical result of tilting angle and direction of houses in a district (Urayasu city, 2012)

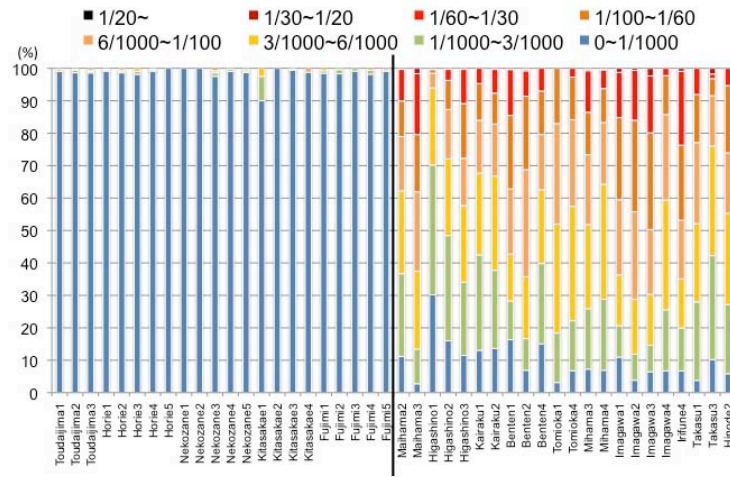
Figure 4.5. District by district distribution of inclination angle of houses (Urayasu city, 2012)

Figure 4.5 shows the distribution of average inclination angle of residential houses supported on spread foundations in each district, based on the survey on about 9,000 houses conducted by Urayasu city government. Figure 4.6 summarizes the district-by-district distribution of damaged houses in terms of inclined angle. The figures show that the houses located on the non-liquefied north side of the old coastline had no damage, while those located in the reclaimed area suffered extensive damage. In particular, about 1/3-1/2 of the houses in the residential areas of Maihama 3-chome, Benten 1-chome, Imagawa 1 to 3-chome, and Irifune 4-chome tilted more than 1/100. These areas are classified in the category of extensive damage in Figure 4.1.

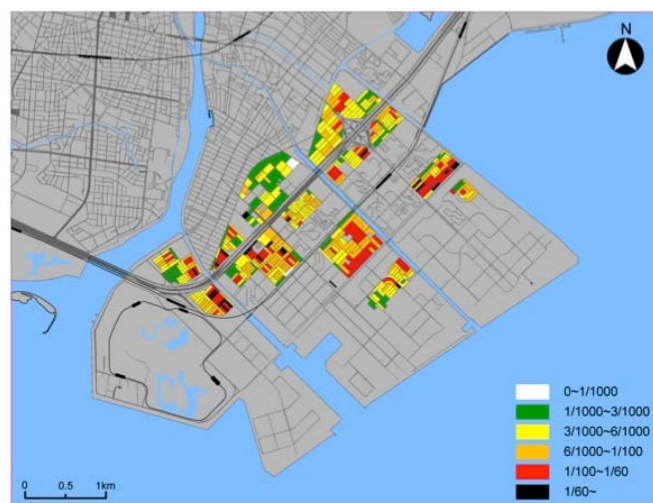
Figure 4.6. District by district distribution of inclination angle of houses (Urayasu city, 2012)

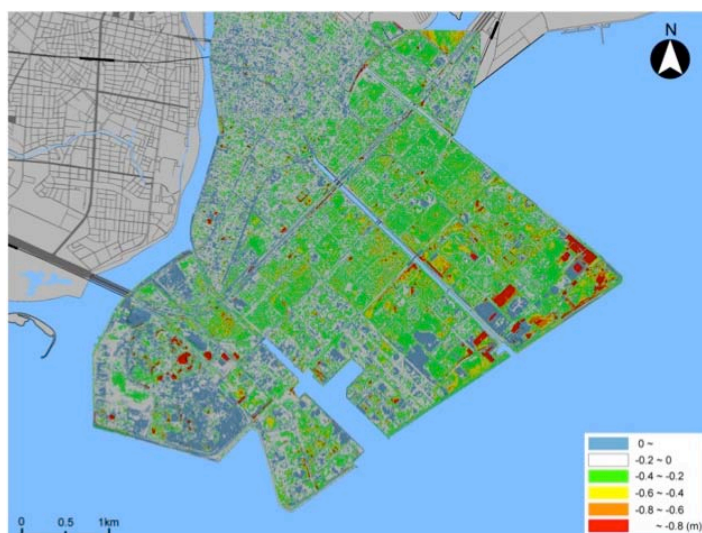
Figure 4.7 shows ground settlements estimated from the difference between the altitudes obtained before and after the quake using airborne laser scanning survey. The ground in the liquefied area after the quake has settled 0.2 to 0.4 m on the average, with smaller settlements on the roads. The value of subsidence reached as much as 0.6 to 0.8 m in some areas. These ground settlements from the laser scanning survey appear to be consistent with the ground settlements observed in the field. Comparison of Figure 4.7 with Figures 4.2 and 4.6 suggests that the area with larger ground settlements experienced more severe liquefaction damage to buildings.

Figure 4.7. Map showing vertical ground settlement between 2006 and 2011 (Tokimatsu & Katsumata, 2012)

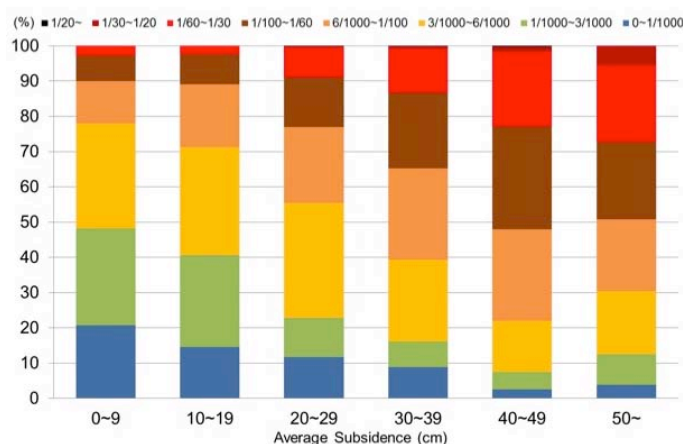
Figure 4.8. Relation between ground settlement and angle of inclination (Tokimatsu & Katsumata, 2012)

Figure 4.8 shows the distribution of inclination angle of residential houses with respect to ground settlement, prepared from Figures 4.6 and 4.7. Figure 4.8 apparently shows that the inclination angle tends to increase with increasing liquefaction-induced ground settlement. For example, about 10% houses tilted more than 1/100 if the liquefaction-induced settlement (S) is on the order of 10-20 cm, whereas about 50% houses tilted when S becomes greater than 40 cm.

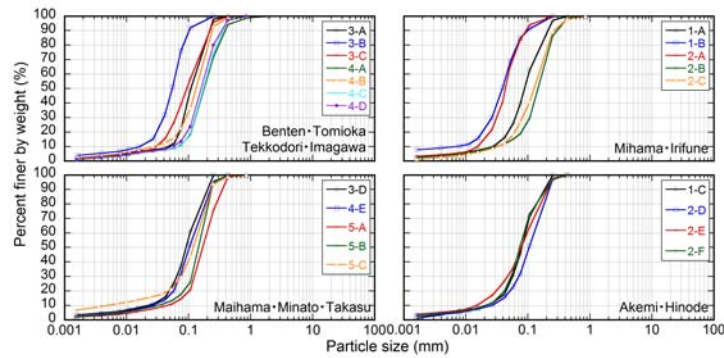
Figure 5.1 shows grain size distribution of boiled sand samples collected at several locations in Urayasu. The samples each have high fine-grain content ratios, at 15 to 70 percent. Those fine grains are believed to be non-plastic fine sand or silty sand, which correspond to the composition of the sand layer in reclaimed land up to 10 meters below the sea level. This suggests that the reclaimed sand layer liquefied during the earthquake.

Figure 5.1. Grain size distribution curves of boiled sands (Tokimatsu et al., 2011)

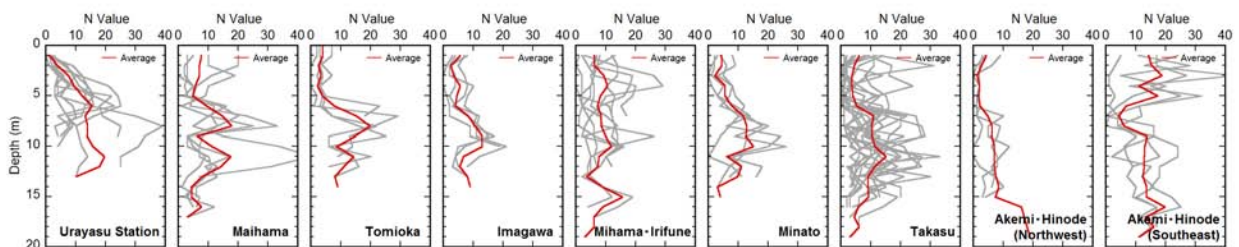
Akemi-Hinode area, separate graphs were given for the northwestern and southeastern districts, because the extent of the damage was distinctively different between them. It can be seen in the figure that the N-value in the sand layer was extremely small in Tomioka, Imagawa and Akemi-Hinode (northwest), but large in the neighborhood of Urayasu Station, which is not reclaimed land, and in Akemi-Hinode (southeast), which is reclaimed land but which is the highest altitude in the city. The thickness of earth filling and sand layers was different from place to place, with Maihama, Mihama-Irifune, Takasu and Akemi-Hinode marking high figures.

- 1) On the landside of the old coastline of 1964 or before, no liquefaction was observed even though the altitude is low and so the groundwater level is shallow. The N-value in this area is higher than in recently reclaimed land where liquefaction occurred. These facts suggest a possibility that “aging effect” of soil may have worked in mitigating liquefaction.

- 2) In Akemi-Hinode area (southeast), the N-value is relatively high and liquefaction damage was minor. It could be surmised that differences in reclamation materials and method of reclamation may have affected the degree of damage. Furthermore, the area’s altitude is rather high, indicating a possibility that differences in altitude may have also affected the extent of damage. This may be because, when the altitude is high, the groundwater level becomes relatively low and the consolidation of the silty sand layer below the groundwater table has progressed.

Figure 5.2. Distribution of SPT-Value with depth at selected districts (Tokimatsu et al., 2011)

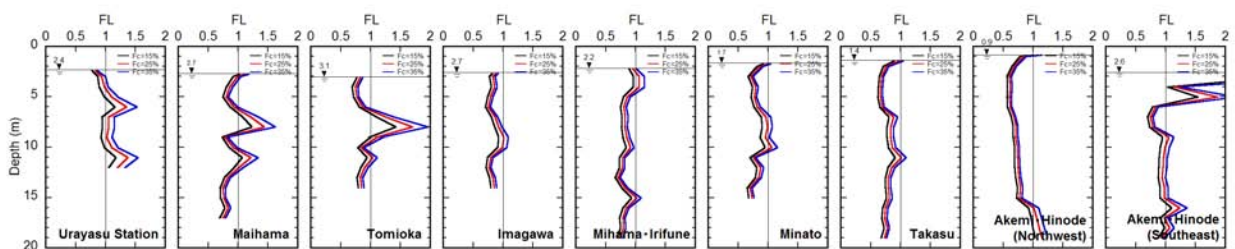
Figure 5.3. Result of SPT-based liquefaction evaluation at selected districts (Tokimatsu et al., 2011)

Figure 5.3 shows the results of liquefaction evaluation made according to the Recommendations for Design of Building Foundations (Architectural Institute of Japan, 2001), using the average N-value for each area (Figure 5.2), a peak ground acceleration of 2.0m/s^2 and at magnitude 9.0. The ground water level is set at the average for each area, and the fines content was set at three different levels—15%, 25% and 35%, as it was unknown in many areas.

The FL-value (safety factor against liquefaction) came to 1 or more at most depths in the neighborhood of Urayasu Station, where no liquefaction damage was observed, and in the Akemi-Hinode (southeast) area, where only minor damage was seen. But in other places, the FL-value turned out to be lower than 1. Especially in Mihama-Irifune, Takasu and Akemi-Hinode (northwest), there is a sequence of layers with the FL-value of lower than 1 down to the bottom of sandy soil. These results appear to be consistent with the field observation.
