Effect of Design and Detailing Deficiencies on Seismic Performance and Vulnerability of Indian RC Frame Buildings

SUMMARY:

Keywords: Reinforced Concrete, Multistorey Buildings, Seismic Deficiencies, Vulnerability

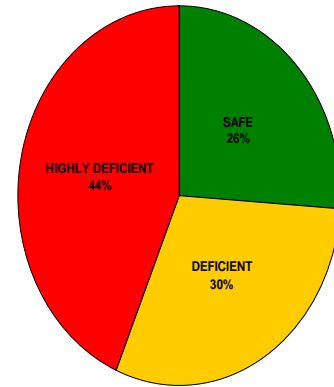
Many buildings during survey were found to have irregular plans. Based on IS 1893 Part-1 (2002), buildings having projection less than 15% of its plan dimension has been considered safe, buildings having projection between 15% to 20% has been considered deficient and the buildings having projection more than 20% have been considered highly deficient. Expected building damage due to re-entrant cornerd can be seen from Fig. 2.2. Only 26% buildings were found to be safe for re-entrant corners, 30% buildings belong to the deficient category and 44% belongs to highly deficient category.

Figure 2.2. Expected building damage due to re-entrant corners

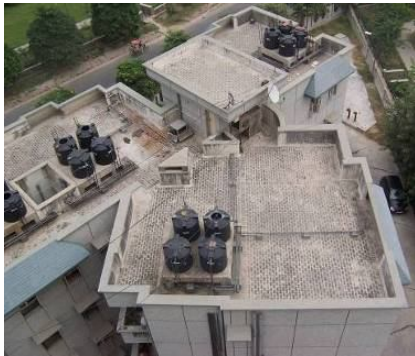
Figure 2.3. An existing building with acute plan irregularity

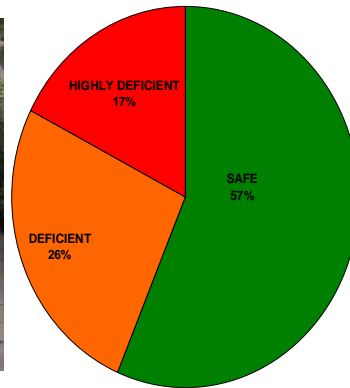
Buildings are considered safe for torsion irregularity in a direction if the eccentricity ratio is less than 0.15, deficient if the eccentricity ratio is between 0.15 to 0.3 and highly deficient if eccentricity ratio is more than 0.3. As shown in Figs. 2.4 and 2.5, survey revealed that independently 57% buildings are safe in longitudinal direction and 65% buildings are safe in transverse direction. But while considering the torsion irregularity in both directions simultaneously, only 38% buildings are safe in both the directions. 17% buildings were found to be highly deficient in longitudinal direction but no building was found highly deficient in transverse direction.

Figure 2.4. Torsion Irregularity (Longitudinal direction)

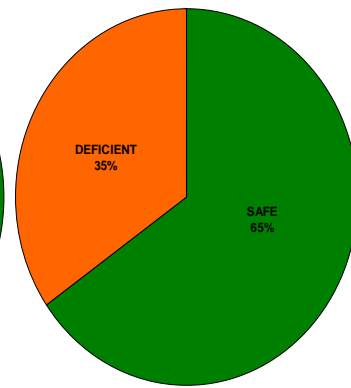
Figure 2.5. Torsion Irregularity (Transverse direction)

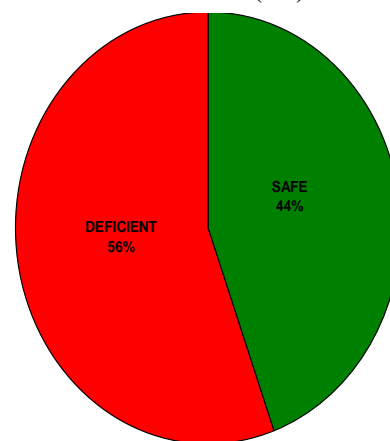
During survey, it has been found that in many buildings separation between different blocks are too small to accommodate drift during earthquake. It is expected that these buildings may suffer severe pounding damage during earthquake. According to FEMA 310, a distance of at least 4% of building height from adjacent structure should be maintained for life safety. In most of the surveyed buildings, adjacent blocks were separated by very small gaps, perhaps, considering only thermal expansion. In most of the buildings, different blocks were having matching floor levels, but in some cases height of blocks were different. The of drift ratio has been calculation as,

This equation does not consider the effect of infill and shear walls. In the analysis, it is assumed that during strong shaking, infills will crack/collapse making the frame bare. From analysis, as shown in Fig. 2.6, it is found that 56% of surveyed building may get affected due to pounding.

Figure 2.6. Expected Building damage due to seismic pounding

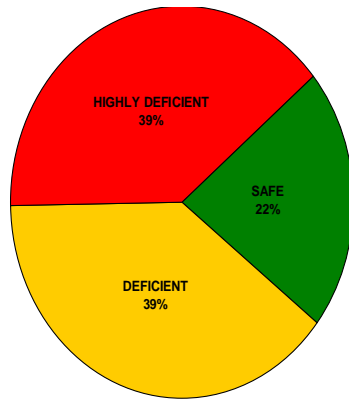
Buildings having $V_{average}$ less than $0.15\sqrt{f_{ck}}$ have been considered to be safe, buildings having $V_{average}$ between $0.15\sqrt{f_{ck}}$ to $0.225\sqrt{f_{ck}}$ are considered deficient and building falls in highly deficient category if $V_{average}$ is more than $0.225\sqrt{f_{ck}}$. As shown in Fig. 3.1, only 22% buildings were found to be safe for shear stress in ground storey columns, 39% were found deficient and another 39% were found to be highly deficient.

Figure 3.1. Expected building damage due to shear deficiency in ground storey columns

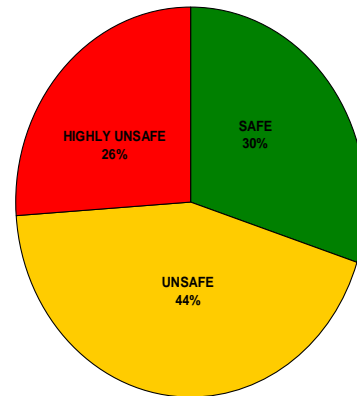
Buildings having P_{ot} less than $0.24f_{ck}$ have been considered safe whereas, between $0.24f_{ck}$ to $0.36f_{ck}$ have been considered deficient. If P_{ot} is more than $0.36f_{ck}$, buildings fall in highly deficient category. From survey, it has been found that only 30% of buildings are safe against overturning, 44% buildings fall in deficient category and 26% buildings in highly deficient category (Fig. 3.2).

Figure 3.2. Expected Building damage due to overturning

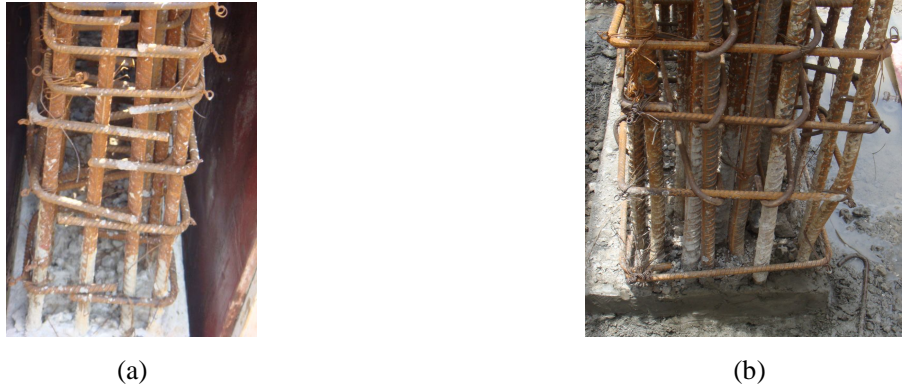
Inadequate detailing has been another important cause of failure of RC buildings, during past earthquakes. Common deficiencies, generally observed during survey are, inadequate anchorage at beam ends of exterior joints, inadequate shear and confining reinforcement in columns, faulty anchorage (90° hooks) of stirrups, inadequate shear reinforcement in shear walls, Inadequate detailing at slab-shear wall junction and inadequate confinement at splicing.

The compliance to detailing code in practice has been reviewed by observing the member dimensions in existing buildings and inspection of ongoing construction in new buildings. During the survey, improper spacing and anchorage (with 90° bend) of stirrups (Fig. 3.3) has been observed at many construction sites.

Figure 3.3. Faulty reinforcement detailing practice, (a) 90° hooks, (b) Improper and inadequate confining stirrups in columns
