Performance of Unreinforced Masonry Structures in the 2010/2011 Canterbury Earthquake Sequence

L.M. Moon & M.C. Griffith

SUMMARY:

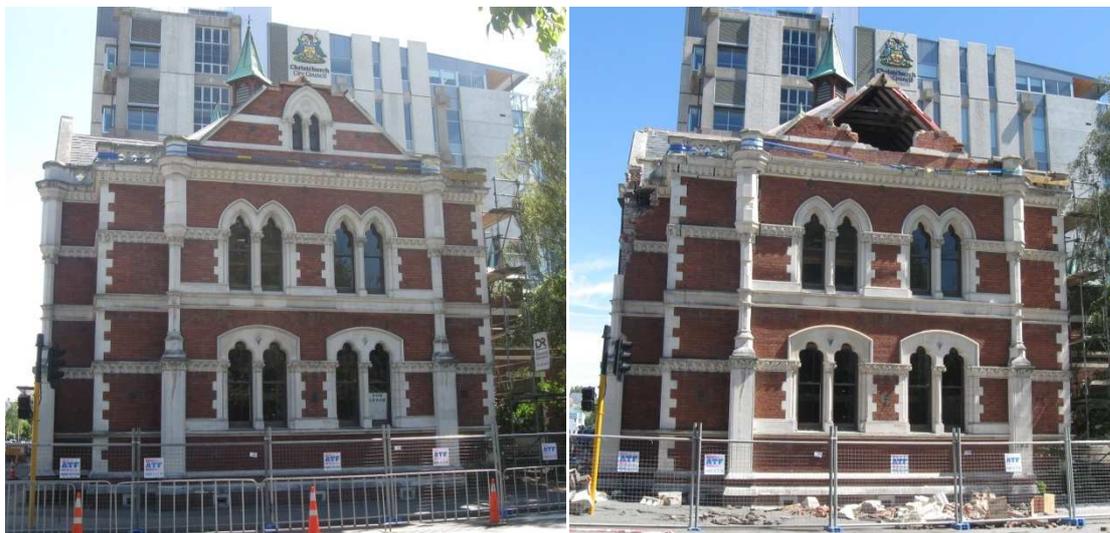
Figure 2.4 shows the additional damage sustained by one URM building due to the 22 February earthquake. The photo on the left was taken two days before the February 2011 earthquake, and the photo on the right was taken two days afterwards. The top of the gable end wall has collapsed, and some corner failure can be observed to the left of the building. The strap around the building and scaffolding to the right indicate that rehabilitation of the building was underway at the time of the February earthquake. Fortunately, the fence surrounding the building, present in both photos, meant that the public were protected from most of the falling masonry from this building. Barrier fences around many at risk buildings, combined with the loss of so many vulnerable parapets, chimneys and upper walls in September, probably helped minimise the lives lost due to falling masonry in the February aftershock (Ingham and Griffith, 2011c).

Figure 2.4. Christchurch URM building on 20 February 2011 (left) and 24 February 2011 (right)

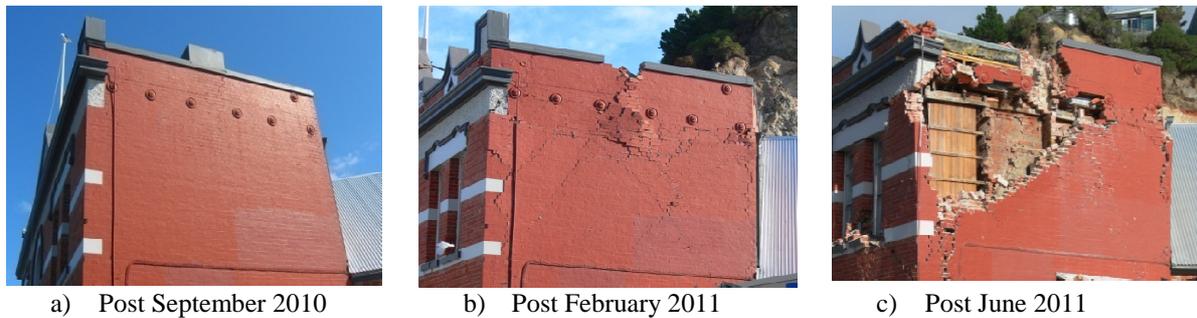
buildings it can be easy to overlook the effects of further large aftershocks; however, the aftershocks of 13 June, which occurred at around 1pm and 2:20pm caused widespread significant additional damage and severe liquefaction in some areas. Several previously damaged buildings suffered significant collapse, and a number of workers were treated for injury (Stuff.co.nz, 2011). The additional damage to URM buildings meant that many buildings previously planned to be saved and strengthened were damaged beyond repair. Figure 2.5 shows the progression of damage to one URM building due to the September 2010, February 2011 and June 2011 earthquakes. Minor cracks as a result of the September earthquake became significant cracks in February and resulted in partial wall collapse in June.

Figure 2.5. Progression of damage to a building during the September 2010, February 2011 and June 2011 earthquakes

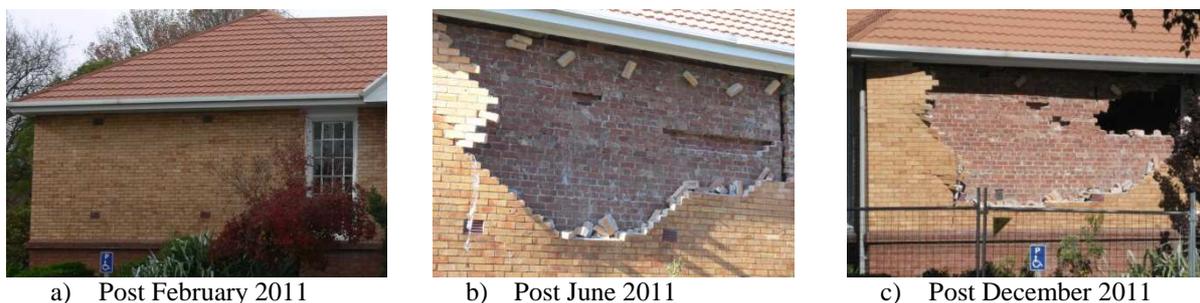
More than six months after the June earthquakes Christchurch again experienced two large aftershocks in one afternoon. At around 1:58pm on 23 December 2011 Christchurch was jolted by a M5.8 earthquake. This was followed about 80 minutes later by a M6.0 earthquake. Centred off the coast between 10 and 20 km east of the CBD the December 2011 earthquakes again caused significant liquefaction and further shaking damage. As with the June earthquakes, buildings which were thought to be repairable were damaged beyond repair and condemned to the demolition list. Figure 2.6 shows the progression of damage to a URM building after the February 2011, June 2011 and December 2011 earthquakes. The veneer leaf failed after as a result of the June 2011 earthquake while the internal structural wall only failed as a result of the December 2011 earthquakes. Although not visible in Figure 2.6(a), after the February 2011 earthquake wall ties were observed to be punching through the veneer layer, indicating differential movement between the two leaves.

Figure 2.6. Progression of damage to a building during the February 2011, June 2011 and December 2011 earthquakes
