# Case Studies of Geotechnical Damage by the 2011 off the Pacific Coast of Tohoku Earthquake and Tsunami in Japan

**H. Hazarika & H. Okada**

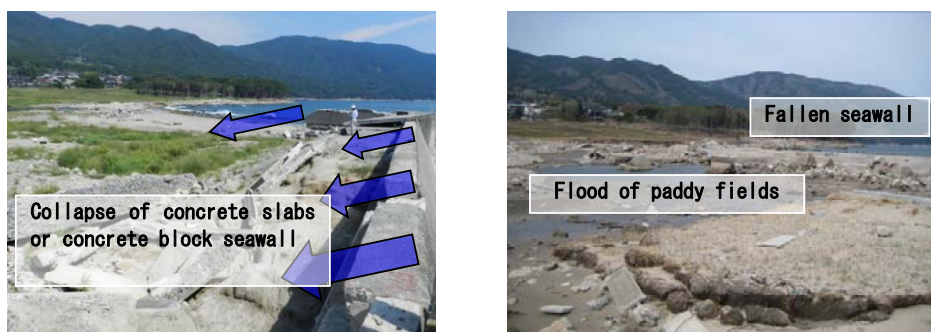
**Figure 1.** Damage situation in Yoshihama

(a) Collapse of seawall

(b) Collapsed seawall and flood in paddy fields

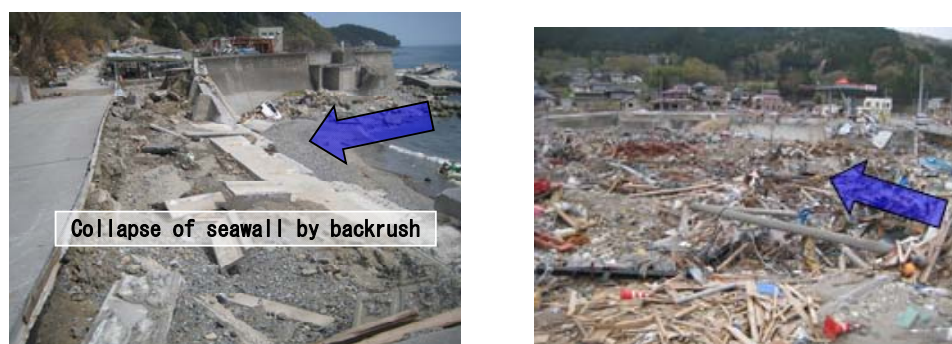
**Figure 2.** Tsunami damage in Okirai

On the other hand, the whole of Okirai area was inundated completely by the tsunami. The casualties were greater in this area with 66 deaths and 30 missing people. As shown in Fig. 2(a), the concrete sea wall along the coastal line completely collapsed. As a result, the tsunami run-up washed away most of

the wooden buildings in the area (Fig. 2b). The tsunami run-up was up to the third floor of the Okirai elementary school, which is located 200 m from the coastline. The tsunami run-up height in this location was found to be 16 m by the RTK-GPS survey conducted by the authors. According to previous records, the tsunami run-up height in Sugishita area of Okirai was 11.6 m during the Showa Sanriku tsunami in 1933, and was 7.8 m during the Meiji Sanriku tsunami in 1896 (Shuto, 2011). Based on our surveying data using the total station, the tsunami run-up height this time was estimated to be 16.79 m, which is much higher than past tsunamis that inundated this area.

(a) Collapse of seawall

(b) Collapse of houses in area protected by levee

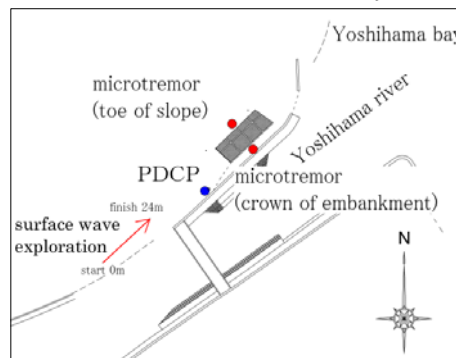
**Figure 5.** River dike damaged by the tsunami after the earthquake at Yoshihama area

Figure 5 shows the plane view of the river dike damaged by the tsunami after the earthquake at Yoshihama area. PDCP (one location), the surface wave exploration (over a distance of 24 m) and the micro tremor (two locations) were carried out on the levee body.

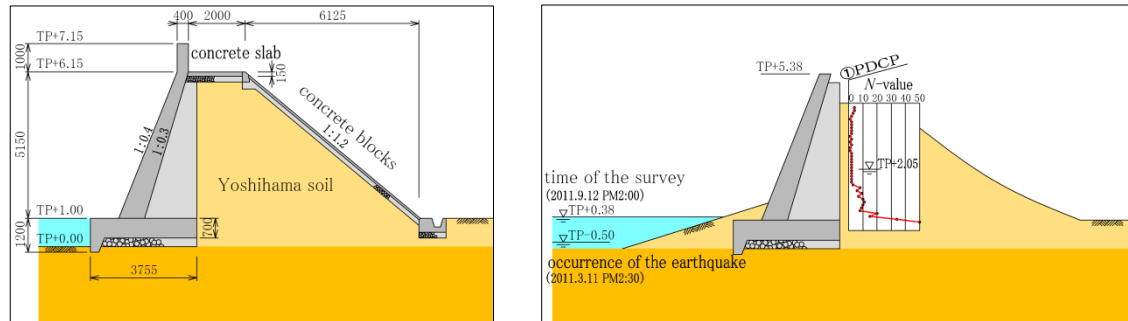
**Figure 6.** Estimated cross section of the sea wall before the earthquake

Figure 6(a) shows an estimated standard cross section of the embankment before the earthquake. The embankment is having the standard shape typically used in Japan with 5.15 m in height, 2.0 m in width at the crown, and 1:1.2 in gradient at the back. The structure of the sea wall consists of a concrete wall with counterfort on the river side, and a levee body with filled soil covered with concrete blocks on the back side of the slope. Figure 6(b) shows the N-value converted from Nd obtained from the PDCP test conducted on the soils of the levee body. The N-values of the fill soils ranged between 1 to 4, implying that the soil is very loose. However, the N-value increases along the bottom of the body, implying a dense state. From the PDCP test the ground water level was confirmed to be at 2 m below the ground surface. Therefore, it can be said that the fill soil is almost saturated.

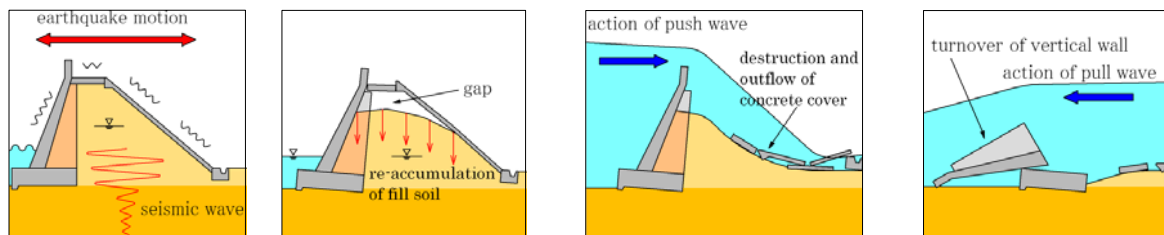
**Figure 11.** Mechanism of the collapse of the embankment

From the results of the site investigation on the coastal dike at Yoshihama area, it could be confirmed that the depth of dense layer in the embankment was shallow; the fill soil was not compacted enough and was in loose state when the earthquake and the tsunami struck. Also, the water level within the levee body was high. On the other hand from the laboratory investigation on the sampled soil, it was found that the pore water pressure rose within the embankment due to the strong earthquake motion with long continuation time and the fill soils liquefied. Due to huge volume change resulting from liquefaction, the levee body subsided and this has led to the collapse of the structure. Furthermore, the tsunami, which followed the earthquake, led to further reduction of the strength of the levee body in spite of the existing concrete blocks at the back.

Figures 11 (a) ~ (d) illustrate the mechanism of the collapse. The top layer of the fill soils subsided largely by the action of cyclic loading during the earthquake as shown in Fig 11(a). This has resulted in the generation of voids and differential settlement between the levee crown and the concrete blocks as shown in Fig 11(b). Furthermore, as shown in Fig. 11(c), the vertical wall tilted due to extra force of the tsunami wave, and the inundated water entered into the levee body resulting in the scouring of the sides and the toe of the levee. Finally, as shown in Fig. 11(d), the backrush of the tsunami further deteriorated the strength of the levee due to scouring and the force due to backrush led to the complete collapse of the wall.

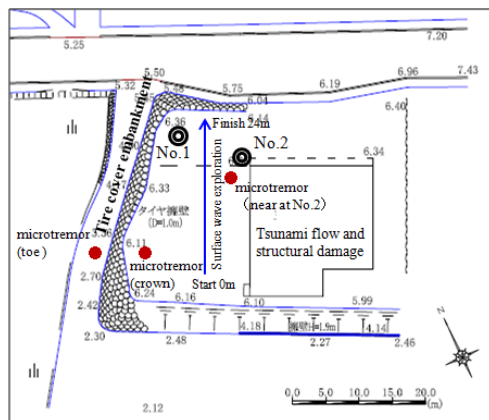
**Figure 12.** Tire retaining wall in Okirai

Figure 12 shows plane view of the tire retaining wall in Okirai. Fig.12 also shows the locations of the various field surveys (in-situ density, PDCP test, surface wave exploration, and micro tremor measurement) that were conducted. Soils samples were also collected from the three locations (No.1, No.2, soil within tire). Fig.13 shows distribution of S-wave velocity by surface wave exploration method conducted on the backfill soils. As shown in Fig.13, beyond the depth of 10 m, S-wave velocity is greater than 220m/s implying a hard stratum near the sloping side. Within the depth of less than 10 m, stratum with 150~200 m/s of S-wave velocity exists. Since the average height of the retaining wall was 3.2 m with a maximum height of about 4 m, it can be said that as a whole, the backfill soil was in the loose state. Fig.13 also shows converted N-value obtained from the PDCP test. Converted N-value and S-wave velocity in general are showing the similar trend. The converted N-values to the depth of 0~70 cm are high, so it can be said that near the surface the backfill soil has a very high density. The higher density near the surface may be the result of influence of cyclic load experienced by the backfill soils due to parked cars, since the yard was used as a parking lot. On the other hand, converted N-value within the depth of 1~1.5 m is about 5. Therefore, if we consider that the backfill consists only of sandy soil, it can be said that in general the backfill soil was in loose state.

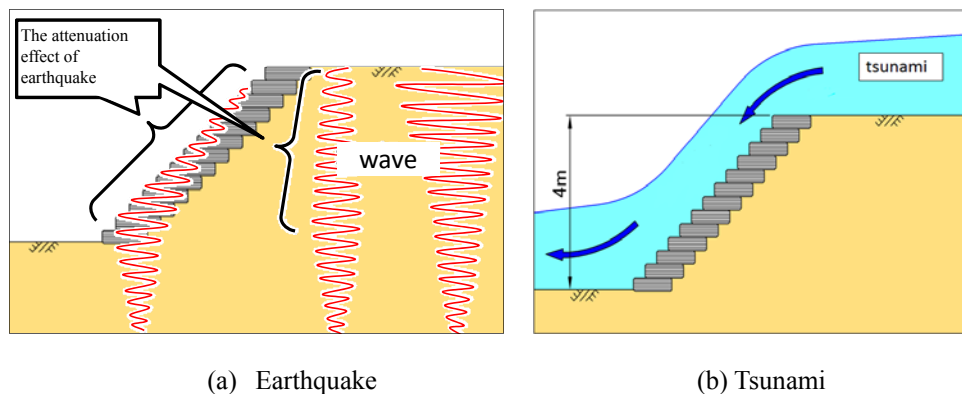
**Figure 15.** Behavior of the tire retaining wall at the time of earthquake and tsunami

Figure 15 shows the state of the tire retaining wall at the time of earthquake and tsunami. As shown in Fig. 15(a), the tire retaining wall has the confining effect (Fukutake & Horiuchi, 2007) which made the wall strong against earthquake, and this could prevent any sliding failure or surface failure of the backfill soils. On the other hand, permeable and flexible structures like the tire retaining wall can reduce the earth pressures and water pressures during earthquakes and tsunamis. In addition, the earthquake motion could be attenuated because of the seismic isolation characteristics of the tire and that prevented the failure of the backfill ground. On the other hand, as shown in Fig. 15(b), tsunami entering from the backfill side damaged the building situated on the backfill ground and also eroded the natural slope opposite to the road parallel to the building. However, the tire wall could prevent damage to the backfill as well as the sloping side of the backfill from erosion. The flexible structure also could prevent any scouring of the wall at the bottom, a phenomenon which was prevalent in almost any sea walls, sea dikes, breakwaters and quay walls in many parts of Tohoku area due to the tsunami this time. The fact that tires are strong against scouring is evident from the fact that even during the backrush, the tsunami could not do any damage to the retaining wall. The hoop tension due to confinement, isolation effect and the anti-scouring effect is due to the high strength attributable to the hoop stress in each individual tire, and the high flexibility of the tire retaining wall.
