Retrofitting of 8-Storey Bumi Minang Hotel Building (Numerical Simulation)

Fauzan, F. A. Ismail, Zaidir, A. Hakam, O. F. Nur
Andalas University, Indonesia

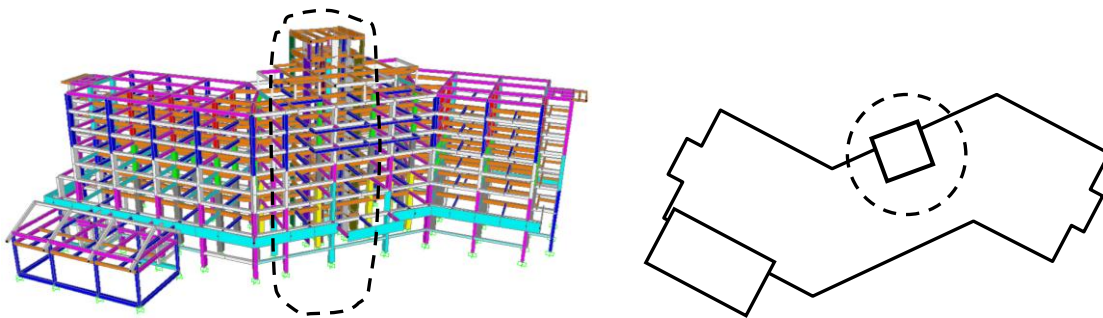
Figure 3. Damage core lift

The investigation on the building found no significant deterioration in the foundation. There were many main structural (columns, beams and slabs) damaged. Damage to structural elements were located on the floors 1 and 2. This damage resulted in a settlement in the floor plate in the middle of the building by more than 25 cm. A special case is for the elevator in the building (Figure 3), the concrete in this section has been broken. The damage resulted the floor 2 to 7 has dropped more than 40 cm. The level of structural damage in the middle part of the building is estimated to 90%. Overall it can be concluded that the Hotel Bumi Minang can be categorized as heavy damage.

Hotel Bumi Minang has suffered from damage on non-structural and structural elements. However, the damage on structural part was mainly in the center of the building. The structural damage is still possible to be retrofitted. Numerical simulations show that the elements of the building (especially column) has a smaller capacity than the working load. The addition of shear walls in the middle portion of the building can reduce the working forces. While the addition of more shear walls in the middle-upper and the left and right side of the building, provide a response even smaller dynamic forces. This study demonstrates the Bumi Minang Hotel still can be retrofitted to withstand the earthquake loads.

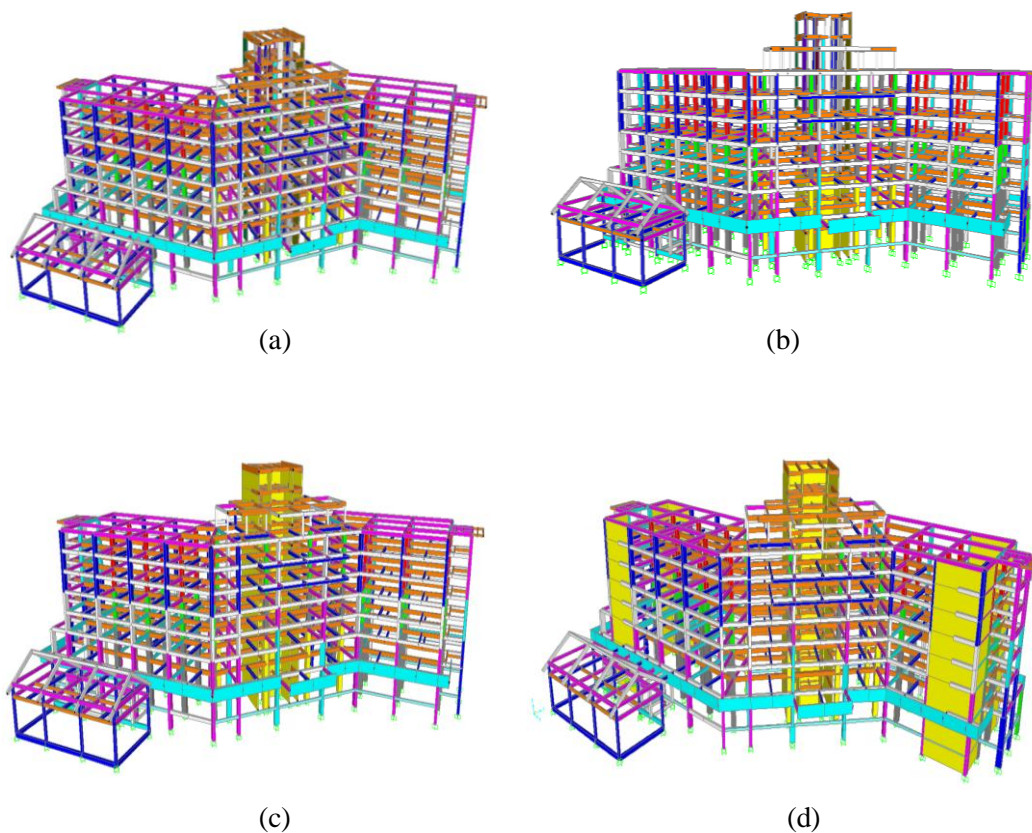
Figure 4. Structural models

Three-dimensional numerical simulations performed by modelling the building into five models. The first model is a building with the structural as same as the one in the field (Figure 4.a). The second model is with the addition of shear walls on the bottom of the lift area (Figure 4.b). The third model is with the addition of shear walls in all parts of the lift area (Figure 4.c) and four models with the addition of shear walls on the left and right wings (Figure 4.d).

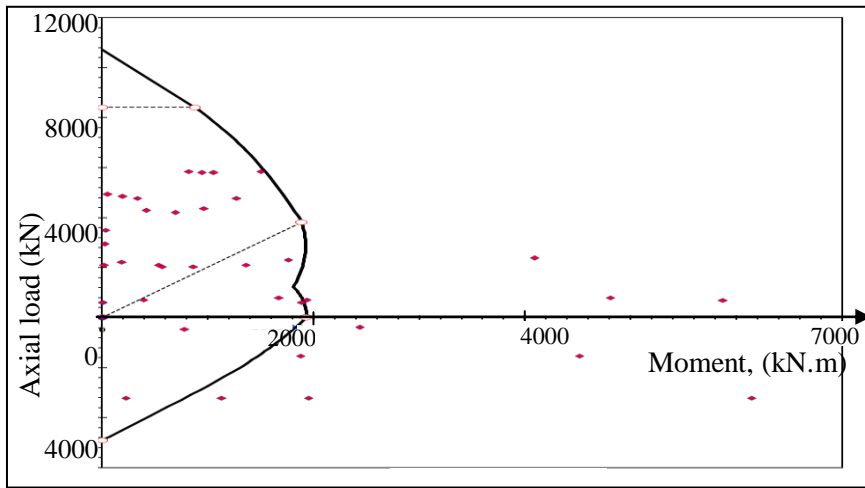
(a). 1st model

Figure 5 (a) to (d) show the figures of the curves of column capacity and spots of working load-moment. In those figures, the red spots are the value of the moment and axial loads in the columns elements. These values are resulted from the numerical simulations of the models. The straight curve in the figures represents the typical capacity of the bottom column. When the spots of the working load-moment are inside the capacity curves, it means the typical column of the model is strong enough to carry the external loads, and vice versa. Numerical simulation results show that the building suffered from over load on the first model (original type). The capacity of the column element was not sufficient to withstand the forces (both axial forces, moments as well as shear forces) due to earthquake loads. In the 2nd model is still showing the higher working moment-load than the column capacity. The structure of the models 3 and 4, show the maximum working forces are less than the capacity in which mean the structure can retain the applied external loads.
