Repair and Retrofit of a 17th Century Library Structure in Istanbul

Sesigur, H. & Cili, F.

Istanbul Technical University, Turkey

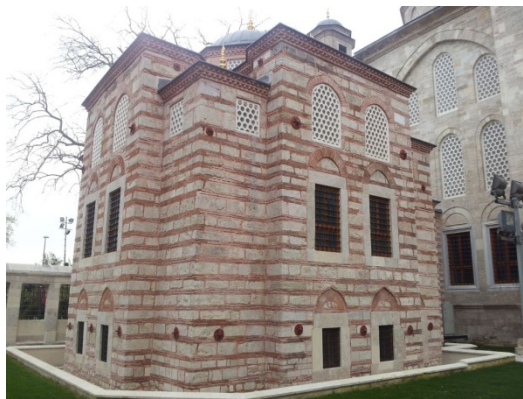
Figure 1.1. View of the Library Building from the North-East Façade

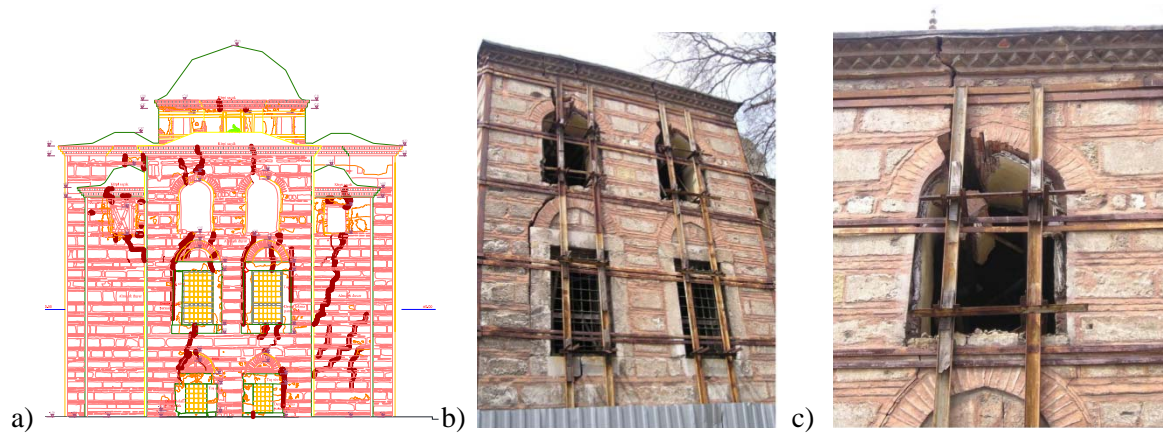
Within the scope of the restoration of the Library Building, detailed structural and architectural site investigations were performed. During these investigations following structural issues was encountered: At the ground floor, the cracks having up to 2cm wide were observed on the cross vaults, while at the roof level, up to 4cm wide were observed on the vaults. The observed crack patterns are shown in Fig. 2.2. Major structural problems of the Library Building originate from the tensile stresses (i.e. the masonry material in the system has low tensile strength) which occurred at different points of the building and are mostly concentrated at the vaults, domes and walls, which might be produced by ground settlements and earthquake forces.

Both on the internal and external surfaces of the side walls of the cistern intense pollution and vegetation were observed. There was also a surface degradation of the outer surfaces of the side walls due to loss of some of the stones. In some parts of the side walls holes of different sizes were formed probably to use the cistern unauthorized. In the region of the northeast side walls a noticeable distortion of the cross vaults forming the roof upholstery was observed. The irregular infill over the cross vaults with heights ranging from 0.80 to 2.80 m is clearly a sign of excessive roof loads (Figure 2.3). Although there was not a significant deterioration of the columns, the wooden tension members connecting the columns to each other and to the side walls were completely missing.

Figure 2.2. Damage patterns are seen at the a,b) South-East Façade c) Detail of a window

The crack patterns are shown that the façade walls have lack of out of plain restraints. In order to prevent the out of plain failure of façade walls it is proposed to conduct high strength steel tie rods for two different levels of the structure, Fig. 2.7.

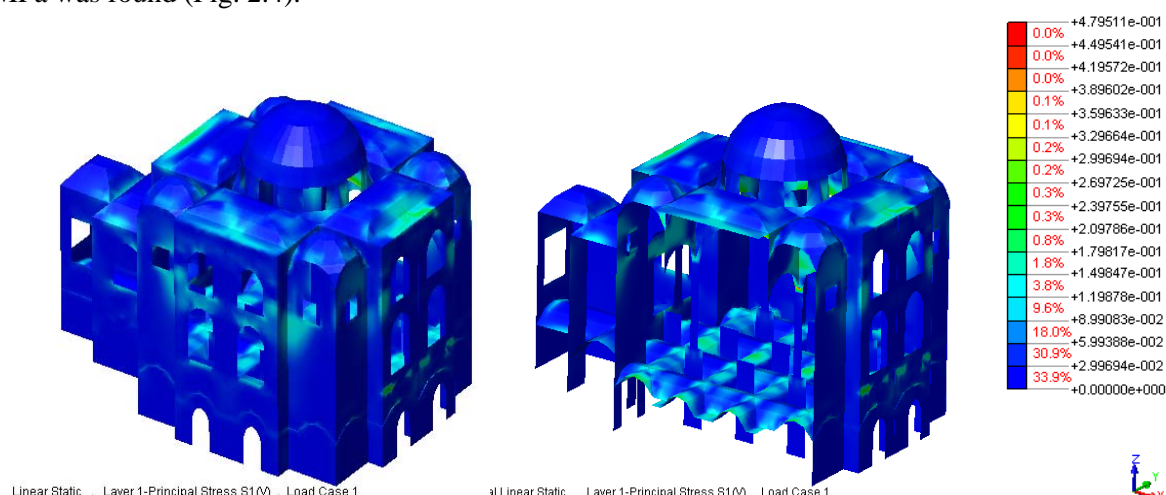
The self weight preventive analysis indicates that the compressive stress at the base of the façade wall is approximately equal to $\sim 0.30 \text{ MPa}$, while at the base of the buttresses, an averaged value of $\sim 0.40 \text{ MPa}$ was found (Fig. 2.4).

Figure 2.4. Principle stresses due to gravity loads

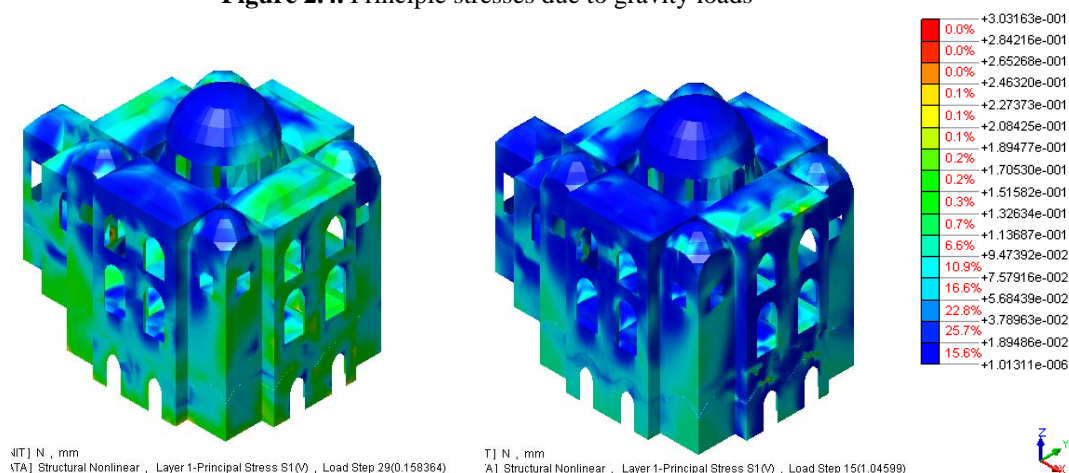
Figure 2.5. Principle stresses due to incremental lateral loads

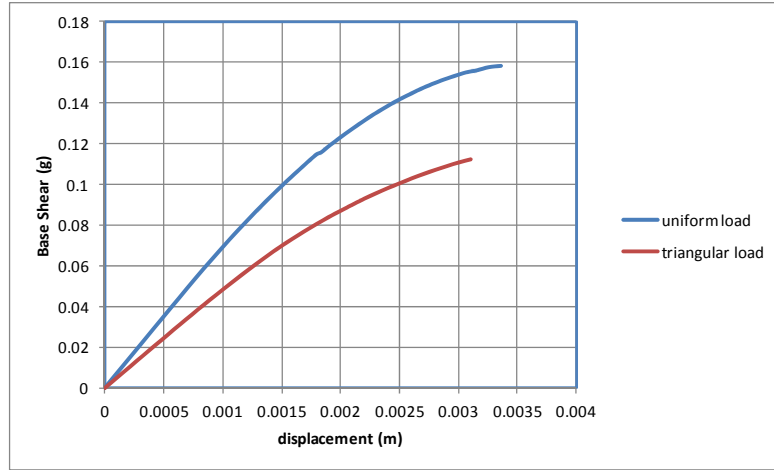
In order to obtain the capacity of the structure, nonlinear static pushover analysis method is used. For the beginning of the load increment, uniform and triangular load distributions are considered. Due to the damage distribution is widely seen on the south-east façade, pushover analysis is done for y direction of the structure. The relation between the base shear and the displacements for the control point (restraint level of the dome) before strengthening process is presented in Fig. 2.6.

Figure 2.6. Capacity curves of the structure before the strengthening

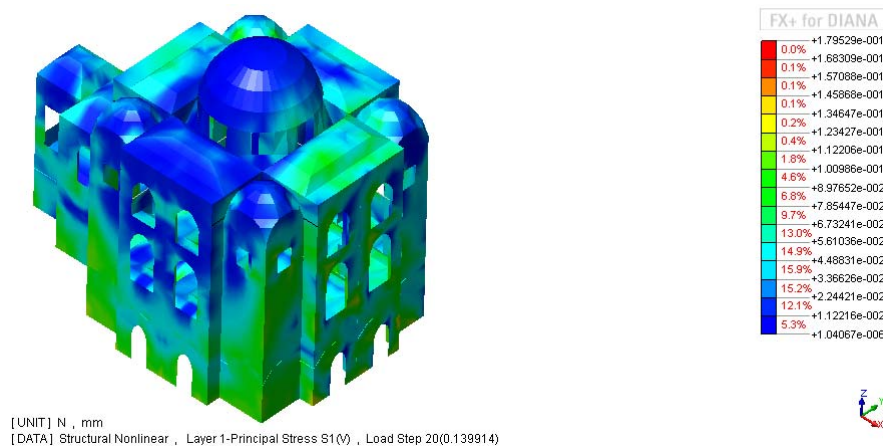
Figure 2.8. Principle stresses due to incremental lateral loads after strengthening

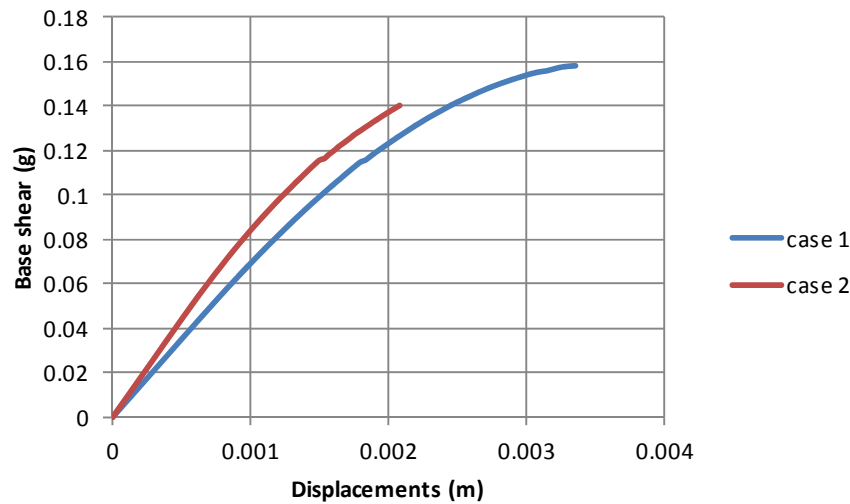
Figure 2.9. Capacity curves of the structure before (case 1) and after (case 2) the strengthening

In this study the 16th century single domed library structure has been numerically investigated under gravity and seismic loads before and after strengthening. In order to select proper strengthening system, a nonlinear static pushover analysis is performed. During the site investigations crack patterns on the south-east façade is observed and due to preventing the walls out of plain failure it is decided to propose steel tie rods which connects the façade walls each other. The numerical results show that the structure becomes more rigid due to the strengthening system.
