NEES/E-Defense Tests: Seismic Performance of Ceiling / Sprinkler Piping Nonstructural Systems in Base Isolated and Fixed Base Building

SUMMARY:

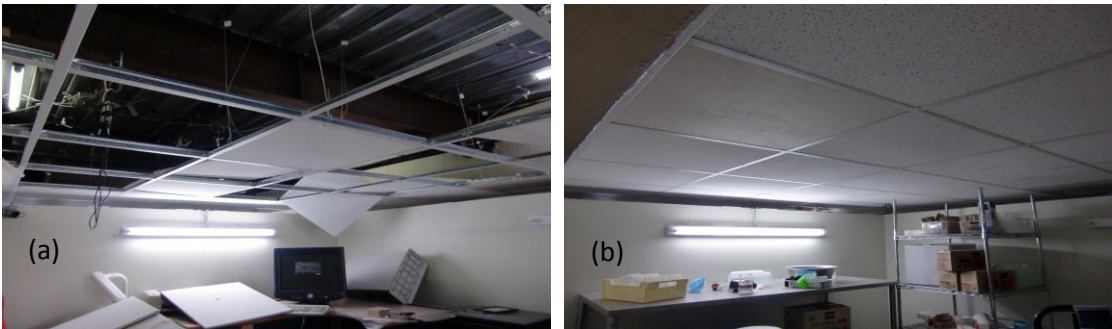
During the experiments, a maximum of three panels (1%) from the unbraced (4th floor) ceiling were displaced or fell to the floor in while up to 40% of the panels in the braced (5th floor) ceiling were displaced and/or fell. Most of the damage was located under the North-East and South-East decks. The condition of the braced and unbraced ceiling after 3D-Northridge-Rinaldi (TPB system) is compared in Fig. 9. Over the course of the test program, some of the cross tee sections failed but the main runners always remained intact.

Figure 9. Condition of (a) braced ceiling (5th floor) and (b) unbraced ceiling (4th floor) after 3D-Northridge-Rinaldi (TPB system)

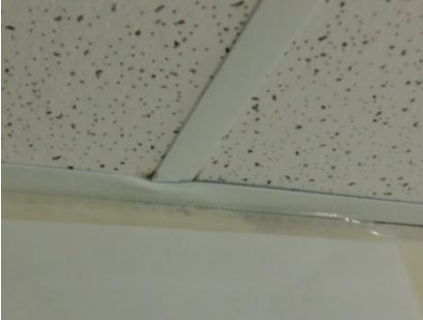
Fig. 13 shows minor damage observed at the unattached joints between grid members and wall molding. The mechanism is interpreted as follows: when the grid member moved away from the wall, the grid member lost contact with the wall molding (Fig. 14(a)). Since the middle slot is large relative to the screw dimensions, the grid member may settle slightly (Fig. 14(b)). As the settled grid member moved back toward the wall, it hit the wall molding to cause the observed damage (Fig. 14(c)). Note that ASTM E580/E580M-11ae1 (ASTM 2011) permits the use of either 22-mm (7/8-in.) or 50-mm (2-in.) wall molding to support seismic clips, and therefore, by installing the grid members with 19mm (3/4-in.) clearance from the wall, only 3.2mm (1/8-in.) seat length will be available from the edge of wall angle.

Figure 13. Ceiling perimeter attachment failure after 3D-Northridge-Rinaldi (TPB system)

Based on the data from the experiment, fragility curves were developed to represent the statistical likelihood of occurrence of the ceiling perimeter damage shown in Fig. 13. These fragility curves are

Fig. 15 shows that at PFA of 1(g) the probability of unseating was more than 80% in all cases. Unseating could perhaps be avoided by increasing the seat length of the 22 mm (7/8 in) wall molding.

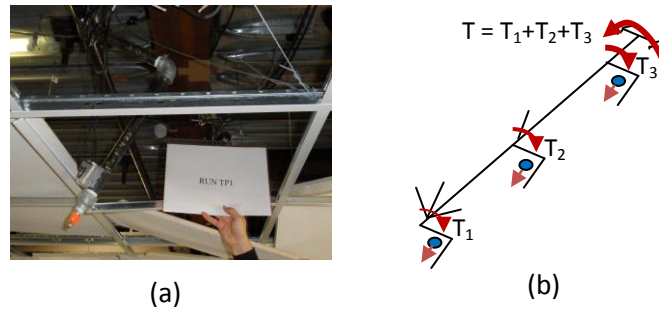
A vulnerability of armover drops compared to straight drops was observed in these experiments. During 3D-Northridge-Rinaldi (TPB system), the entire 5th floor Branch Line 1 with three armover drop pipes twisted around its connection point to the main run (Fig. 16(a)). Due to vertical acceleration, a vertical inertia force is generated proportional to the mass of the armover drop. The twisting moment around the branch line is the summation of the torque generated at each drop (Fig. 16(b)). The current code (NFPA 2011) permits the connections along this branch line to be designed without torsional resistance since the cumulative horizontal length of the unsupported armover less than 610 mm (24 in). However, the torsional resistance of the threaded joints was not sufficient to resist the cumulative torsional demand generated in the large vertical excitation, and permanent twisting of the branch line was observed.

Figure 16. (a) Armover permanent rotation after 3D-Northridge-Rinaldi (TPB system), and (b) torsional demand on armover branch line

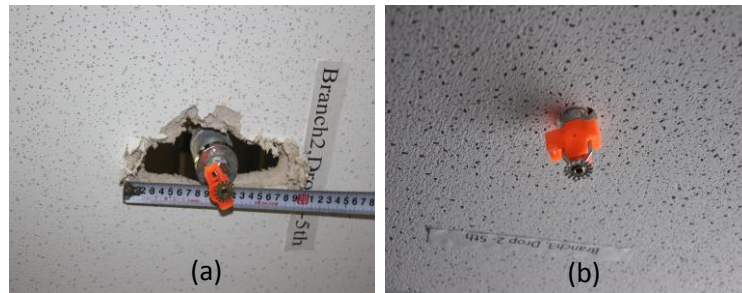
Wherever rigid drop pipes were used, the sprinkler head damaged the ceiling panels regardless of whether the oversized gap configuration, which conforms to code requirements (ASTM, 2011), or the no gap configuration were used. Pounding of the sprinkler heads against the ceiling panels produced damage to the ceiling panels even in motions with moderate horizontal floor accelerations. As an extreme example, a 200 mm (8 in) long piece was knocked out of the ceiling panel during (2D - Tohoku- Iwanuma/base fixed) (Fig. 17(a)), which is much larger than the 50 mm (2 in) gap required by code. On the other hand, no damage was observed around the flexible hose fittings that were mounted at the end of Branch Line 3 (Fig. 17(b)).

Figure 17. Comparison of observed damage near (a) conventional sprinkler head, and (b) flexible hose sprinkler head after 2D-Tohoku-Iwanuma (base fixed)

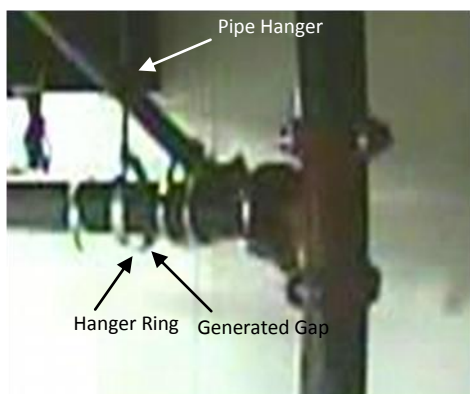
Another response mode that was clearly observed during testing was formation of a gap between the pipe and the hanger ring of the pipe hanger. The vibration and subsequent pounding of the pipe against the hanger ring led to failure of the hanger ring connection (Fig. 18). This behavior is probable in large vertical excitation, where the pipe hanger threaded rod has not been detailed to extend down to the pipe. Fig. 19 depicts this failure that was observed at two hangers near the riser pipe on both floors.

Figure 18. Captured frame from recorded video that shows the generated gap Between Pipe and hanger ring during 3D-Northridge-Rinaldi (TPB System)

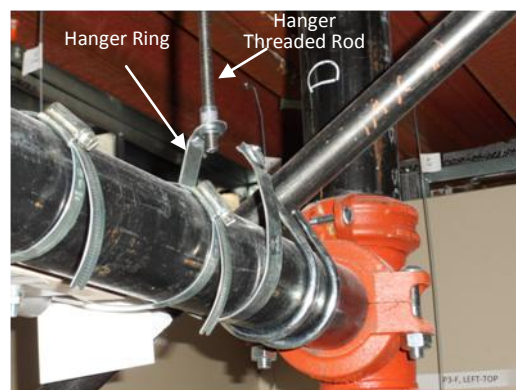
Figure 19. Pipe hanger ring failure after 3D-Northridge-Rinaldi (TPB System)
