Seismic Retrofitting Journey of Industrial Buildings

This paper describes the collaborative project team set up by P&G and the journey of this team to implement seismic retrofitting on industrial buildings in Northern India. The journey starts at the point where seismic deficiencies were uncovered in existing facilities. P&G established and implemented a plan to create the project team to resolve the matter.

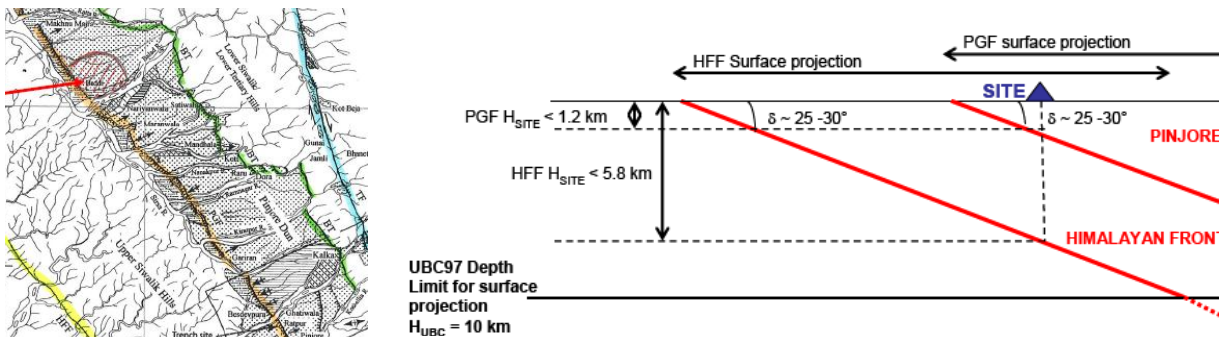
However the desk study quickly revealed that Baddi is in a very high seismic region as shown in Figure 5. Closer examination of the project location revealed that the site is located in a fault zone and surrounded by several active faults, at least one of which is highly active (slip rate > 5 mm/yr) and capable of generating large-magnitude ($M_w > 7.0$) earthquakes (Source Type A according to UBC 1997) as shown in Figure 6.

IS 1893 (Part1): 2002 does not include a provision for near-source factors which are clearly relevant in this instance.

Figure 6. Map and schematic representation of known active faults in relation to the project sites.

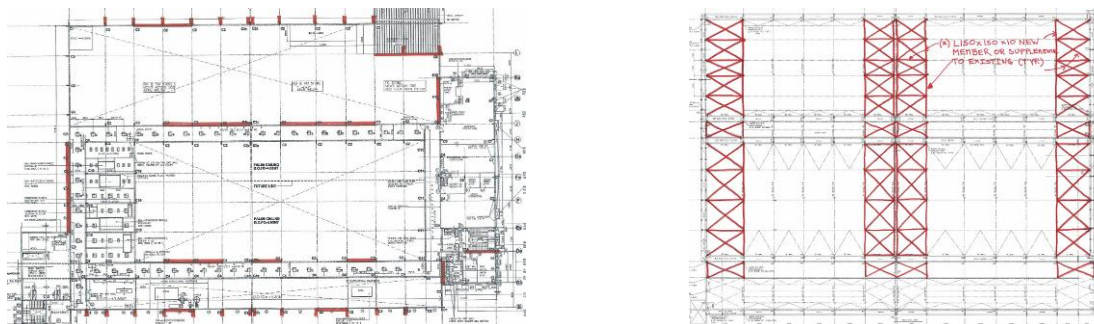
- Seismic movement joints had not been built
- Seismic detailing had not been built, with the steel fixers and common civil engineering construction practitioners in the region not being familiar with the concept of 135 degree hooks and closely spaced links etc...
- The diaphragm was not complete
- The existing RC columns and beams were deficient in flexure and shear with very limited deformation capacity.
- Steel to concrete connections were inadequate.
- Internal walls did not connect to the roof diaphragm.
- Large amounts of unreinforced masonry infill potentially posed a large risk.

Given that the new buildings were now being judged against P&G's global standard it was decided not to explore if the original building had been in compliance with IS 1893. It was clear that significant works would be required such as the addition of reinforced concrete shear walls (and their foundations) and strengthening of the roof diaphragm as shown in Figure 7.

Figure 7. Concept sketches of the likely extent of the required retrofitting works.

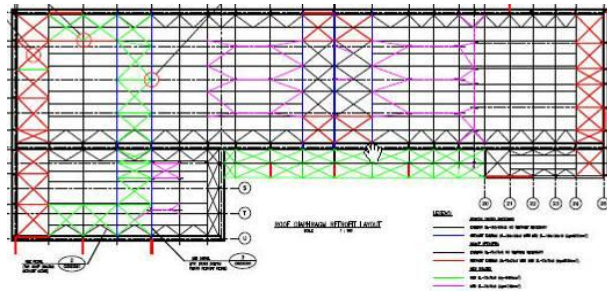
Figure 13. Shear walls and roof diaphragm work.

Where additional diaphragm bracing was required, it was provided in service corridors or externally to the main building in order to minimise impact on the function of the factory. Where possible, the reinforced

concrete shear walls were designed to be external to the main buildings to further reduce the impact on production.

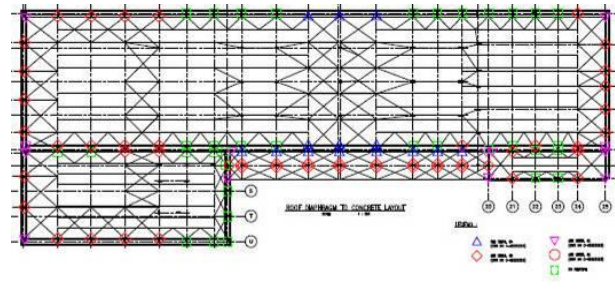
Figure 14. Connection for repair or strengthening.

A number of existing steel and concrete members needed bespoke strengthening due to local deficiencies.

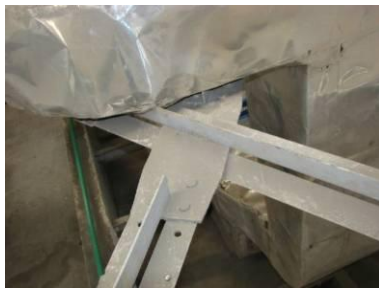
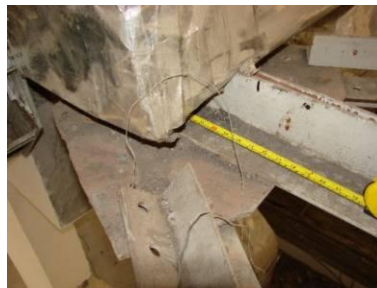
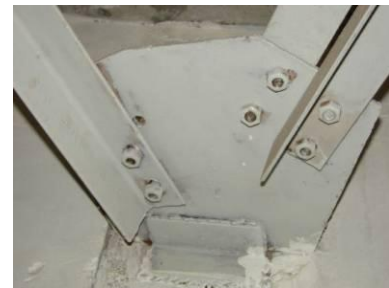
After completion of the retrofit design, a visual survey of the steel was carried out, due to quality concerns of the existing steel work, in order to improve the projects knowledge prior to engaging with contractors. It is simpler to budget and plan for known problems rather than incurring unexpected time and cost increases. Typical findings from the steel work visual survey are shown in Figure 15. The survey findings were communicated to bidders during the tender process to ensure the bidders were fully aware of the required work which consisted of repairing as well as retrofitting.

Figure 15. Identification of typical steel work deficiencies.

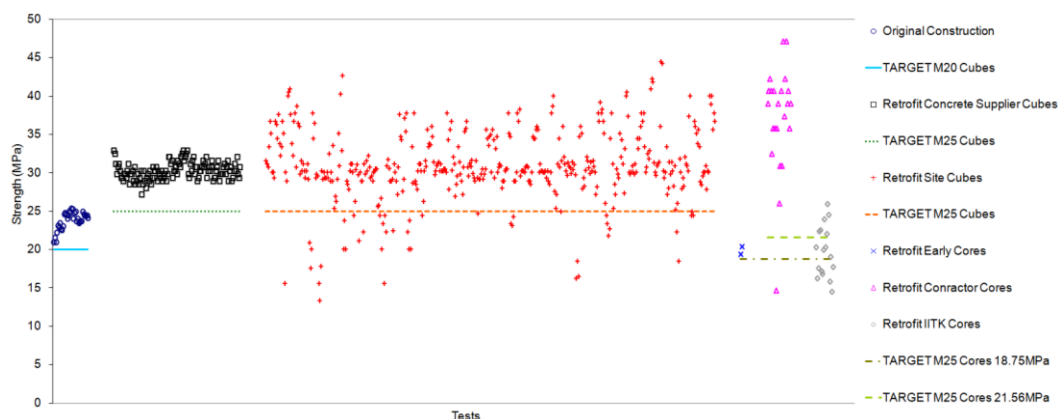
Much of the labour on site was from a rural background with limited formal training in construction. Achieving a reasonable level of construction quality was always a challenge. At one point the quality of the concrete became questionable and early core results indicated that the specified retrofit cube strength of 25MPa had not been achieved. Figure 16 shows the variability of concrete strength results. Final independent testing of cores by IITK confirmed that the achieved concrete quality was at best marginally adequate. To avoid breaking out concrete each shear wall was reassessed in terms of what the controlling concrete strength would be in order for concrete to be the strength controlling factor. This allowed us to conclude that there was adequate spare capacity in the retrofit design of the new shear walls to be able to still have adequate strength even with reduced concrete strengths.

Figure 16. Highly variable concrete strength results during the project time line.
