# Observations on Performance of Structures during 18 September 2011 Sikkim (India) Earthquake

**H.B. Kaushik & K. Dasgupta**

*Dept. of Civil Engineering, Indian Institute of Technology Guwahati, Guwahati 781039, India*

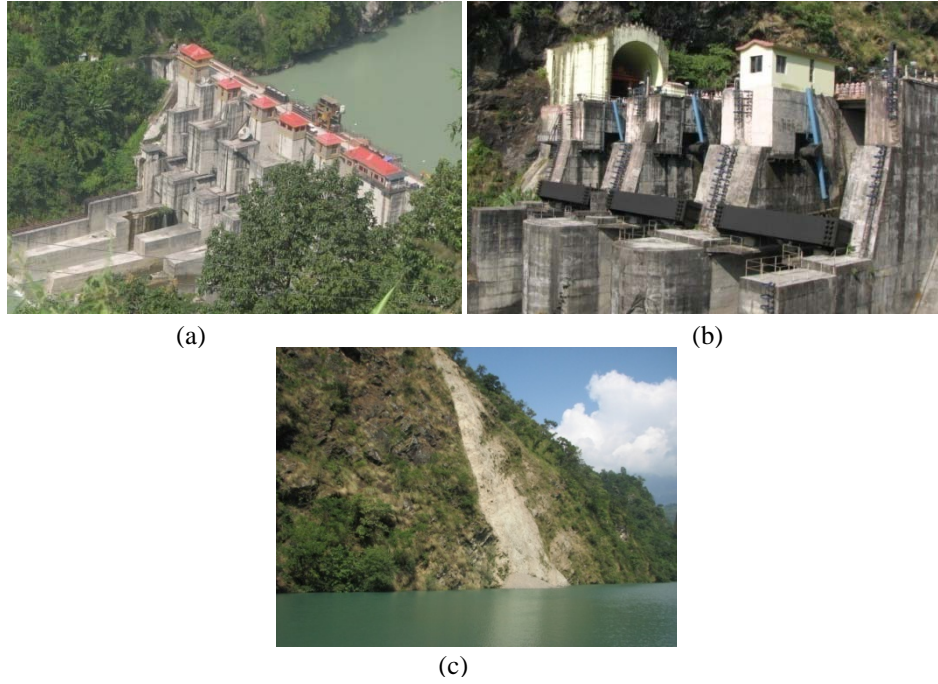
Sikkim is rich in hydropower potential in spite of its small area and is drained by many perennial rivers. Several hydroelectric power plants are currently in operation in Sikkim over these rivers and many more are being planned. National Hydroelectric Power Corporation (NHPC) has already constructed concrete gravity dams over Teesta River (513 Mega Watt) near Dikchu and over Rangit River (60 Mega Watt) near Rangit Nagar (Fig. 2a, 2b). Authors visited both the dam site and power station site and inspected several structures constructed on these sites including the dams. No damage due to earthquake shaking or landslide was observed in the body of any of these dams. The power stations also performed extremely well; the only visible damage was minor cracking in masonry infill walls at various locations in the power stations. Severe landslides and ground deformations were observed near both the dam sites that resulted in accumulation of excessive debris and silt in the reservoir and on the downstream of the dam (Fig. 2c). The 2011 Sikkim earthquake will be known for the severe damage caused to properties and lifelines by hundreds of landslides triggered due to the shaking and subsequent rainfall in the region (Fig. 3a, 3b). Subsidence was observed at Ranipool near Gangtok that resulted in settlement of a part of National Highway by about 180 mm (Fig. 3c).

**Figure 2.** Performance of dams during 2011 Sikkim earthquake: (a) Project Teesta-V, (b) Project Rangit, and (c) accumulation of excessive debris and silt in reservoirs due to landslides.

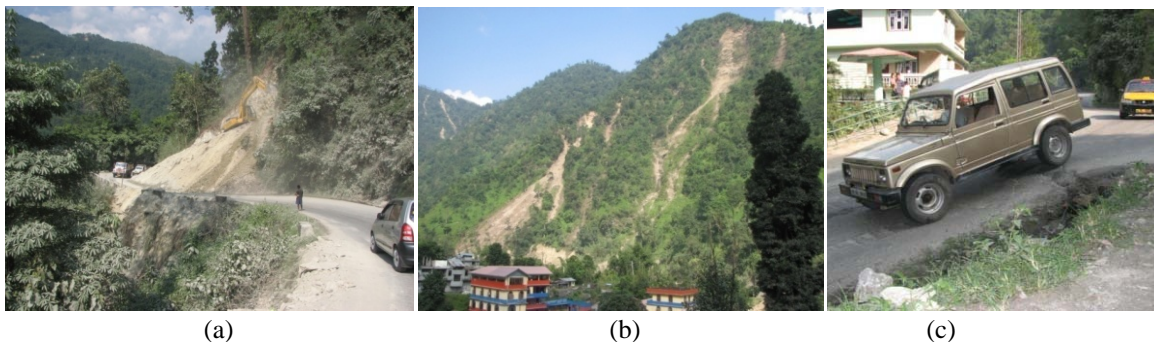
**Figure 3.** Severe landslides and ground movement after 2011 earthquake shaking (a) near Rangpo, (b) near Nimtar, and (c) subsidence resulted in settlement of a part of National Highway 31A at Ranipool near Gangtok.

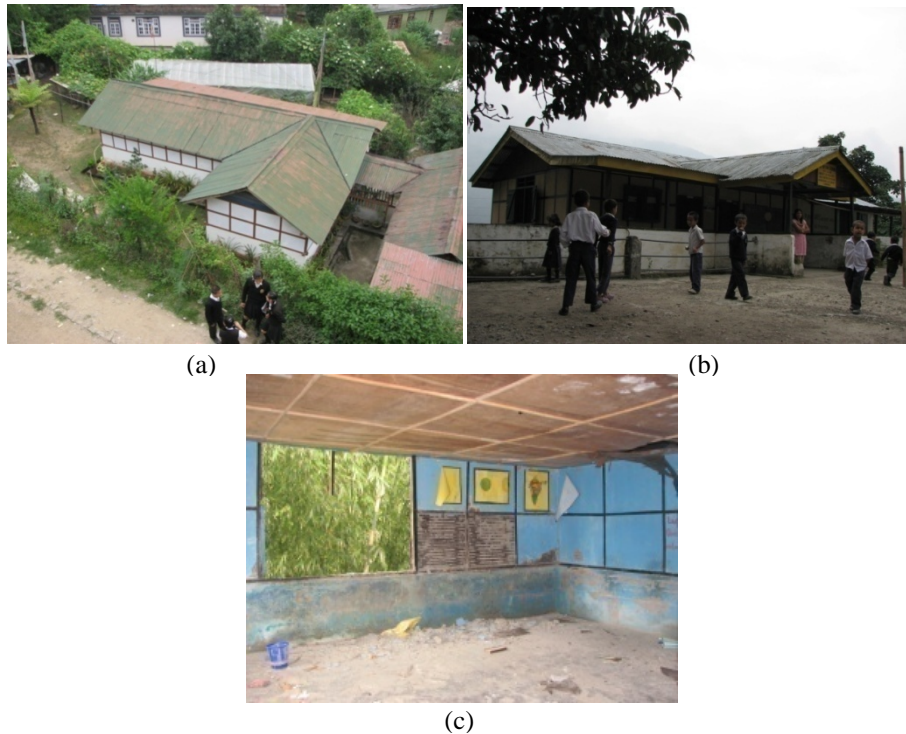
Primarily two types of vernacular housing systems, which are mostly non-engineered, are constructed in Sikkim: wooden houses and masonry houses. Most traditional houses in Sikkim constructed privately are typical single story bamboo houses known commonly as the *Ikra* houses (Fig. 4a, 4b). *Ikra* type wooden housing is commonly constructed in Sikkim due to its natural advantages related to light weight, local availability of materials, etc. Performance of traditional *Ikra* houses was extremely good in both the earthquake shakings of 2006 and 2011. The only damage observed in *Ikra* constructions due to earthquake shaking alone (not due to landslides) was to additional class rooms constructed on third story of new building of Government Secondary School at Sichey in East Sikkim as shown in Fig. 4c. The walls of *Ikra* rooms over the terrace of this building suffered out-of-plane collapse. This suggests that *Ikra* type houses may not be suitable for construction on higher stories due to possible amplification of ground motion along the height of the building. Several other wooden vernacular housing systems in other parts of India have also performed extremely well during several past earthquakes (Kaushik and Jain 2007). This observation presents a case for encouragement to construction of vernacular housing systems, especially in seismically active regions.

**Figure 4.** Performance of *Ikra* constructions during past earthquakes (a) Ranka Senior Secondary School - primary sections (b) Thamidara Junior High School – new two storied building, and (c) Government Secondary School, Sichey: damage to *Ikra* walls on top floor of additional school building.

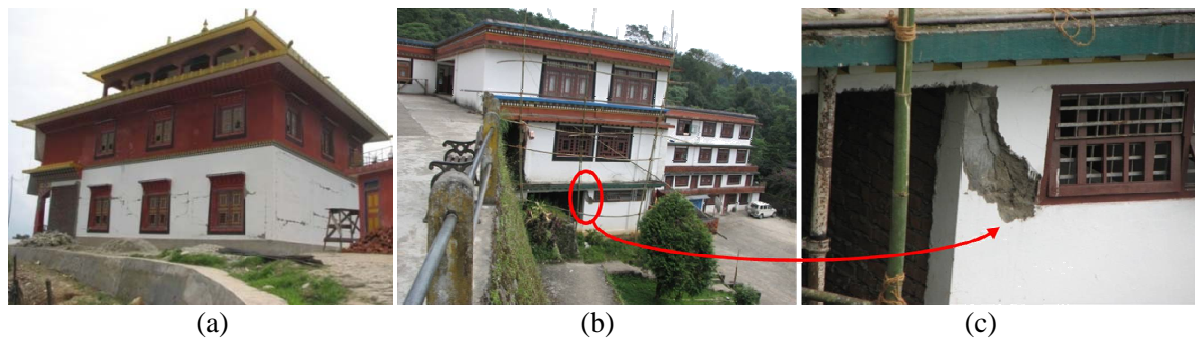
The main pagoda building of Enchey monastery is a masonry structure that suffered damage during 1980, 1988 and 2006 earthquakes (Kaushik et al. 2006). During the 18 September 2011 earthquake, no significant damage was observed in the first storey of the building, and in the upper storey, cracks below the window sill, local spalling and crushing of masonry pier above window openings and dislodging of masonry blocks below roof were observed. Among the monasteries located around Gangtok, most severe damage was observed in Rey Mindu monastery, located on a diversion from Rumtek-Lingdum road (Fig. 5a). The original masonry structure of the monastery building, which underwent significant damage over the course of time, was constructed more than 100 years ago. Subsequently, in 2005 the masonry structure was replaced by RC buildings with masonry infill walls. Though the building performed quite well in 2006 shaking, both the exterior and interior brick masonry walls underwent severe cracking with several interior walls undergoing demolition and fresh construction after 2011 shaking. The largest monastery complex near Gangtok, the Ranka-Lingdum monastery, suffered minor damage in the form of cracking in masonry walls during both the earthquakes. After 2011 earthquake one RC column in the first storey of new building of the monastery suffered severe damage (Fig. 5b and 5c). Most of these monasteries reportedly suffered minor damage during the 2006 shaking too, and subsequently minor repair works, mostly cosmetic, were carried out.

**Figure 5.** Damage in Monasteries in Sikkim during 2011 earthquake (a) severe cracks in exterior brick masonry walls of Rey Mindu monastery (b), and (c) damaged RC column in first storey of a new building in Ranka-Lingdum monastery and reconstruction of an adjacent masonry wall.

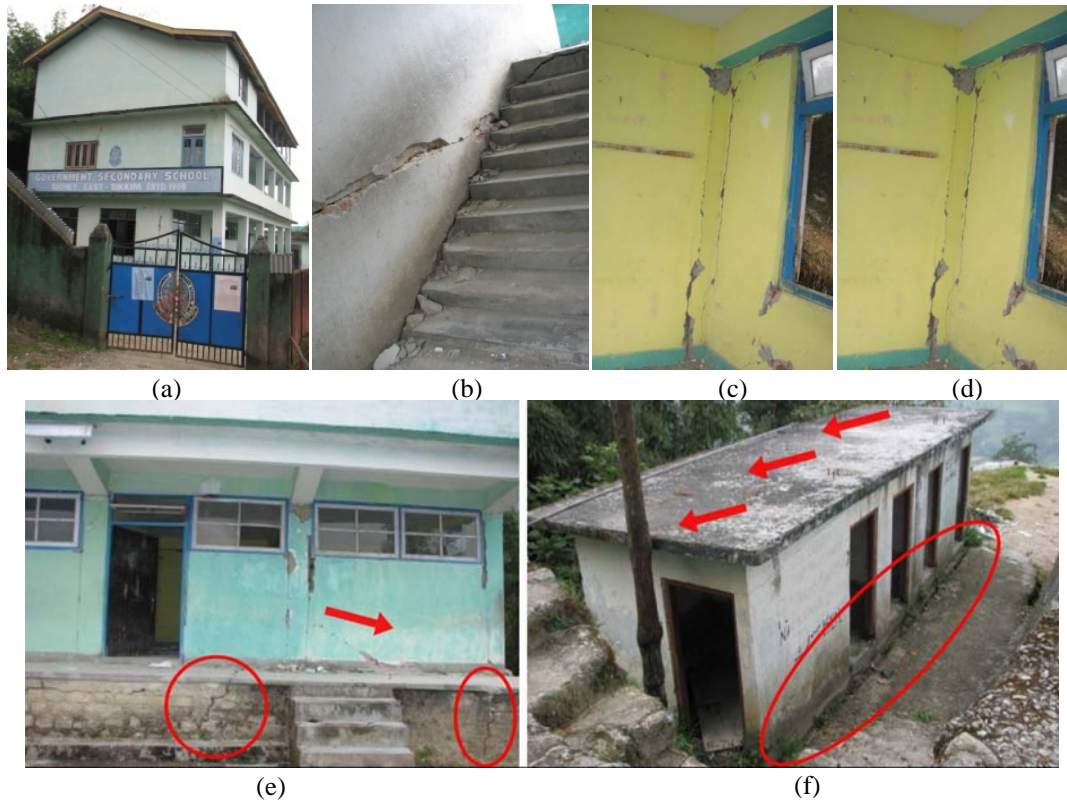
Large number of school buildings have been reported to have damaged during the 2011 earthquake shaking. In several cases, buildings were damaged to such an extent that they were abandoned by the administration and classes were held at temporary locations. The old building of Government Secondary School at Sichey is a three storey RC building with brick masonry infill walls and it was constructed in 1969. It suffered significant damage during the 2006 event (Kaushik et al. 2006). Consequently, repair work and marginal change in the vertical configuration of the building (introduction of window opening in one of the damaged infill wall panels) was carried out (Fig. 6a). The renovated old building suffered extensive damage during the 2011 earthquake and the entire school building had to be subsequently abandoned. There were cracks in the infill panel along the column-wall junction and at lintel levels. Extensive cracks were observed in interior walls and in the first storey corridor due to current earthquake shaking. The new building suffered extensive cracking in floors due to ground movement, cracking along the flights of staircase (Fig. 6b) and separation of brick masonry infill panel along the edges of beam and columns (Fig. 6c). RC columns of both building suffered significant damage, especially those located near the door openings and in the corridor (Fig. 6d). Ground deformation at the base of the new school building was also observed resulting in formation of cracks in corridor (Fig. 6e). The same ground deformations also caused movement of the toilet block leading to horizontal separation crack along the pavement (Fig. 6f). Clearly, the retrofitting schemes used to strengthen these buildings after 2006 event appeared to be completely ineffective.

**Figure 6.** Government Secondary School, Sichey: (a) overview of renovated old school building, (b) damages in staircase, (c) separation of masonry blocks along beam-column interfaces, (d) damage to RC columns, (e) cracks in corridor of new school building, and (f) separation crack in pavement beside toilet block.

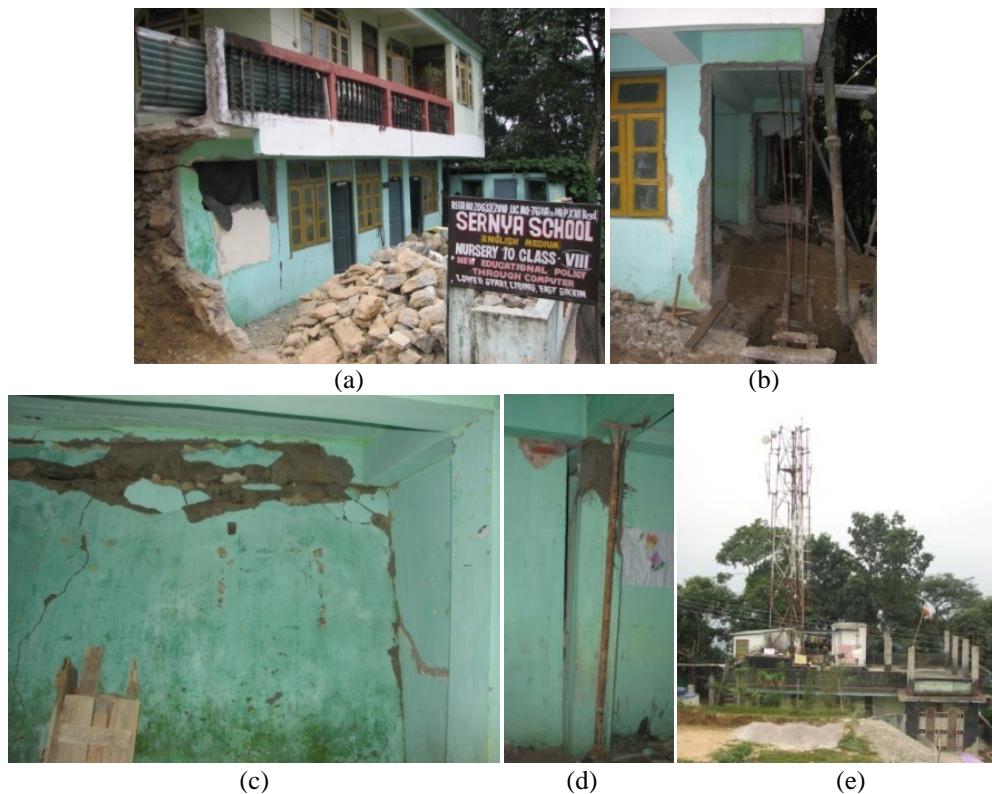
Sernya School at Lower Syari in Gangtok is housed in the first storey of a two storey RC frame building (Fig. 7a). Due to absence of tie beams at the bottom of first storey columns, a portion of first storey collapsed during the 2011 event (Fig. 7b). Damage was also aggravated by ground movement along the adjacent slope. Severe cracking and out-of-plane movement of masonry infill walls was also observed in the building (Fig. 7c, 7d). Subsequently most class rooms of the school were abandoned and temporary repair works were also being undertaken on the damaged columns by the house owner who happened to be a retired government civil engineer (Fig. 7d). One RC column in the first storey was found to be significantly damaged due to vibration of a mobile communication tower fixed at the top of the building as shown in Fig. 7e.

**Figure 7.** Damage in Sernya School building: (a) partial collapse of portion of first storey, (b) collapse of walls due to ground movement, (c) out-of-plane movement of masonry infill, (d) repair work in first storey, and (e) vibration of mobile communication tower on top of the building damaged the supporting RC column.

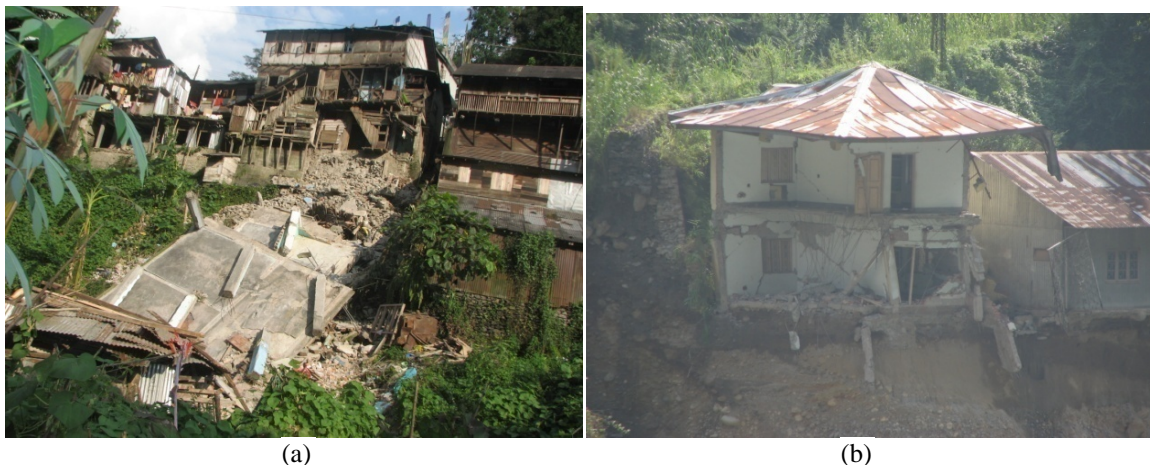
It was observed during 2006 earthquake shaking that government buildings generally performed quite well, and small repair or retrofitting work essential for few buildings was quickly carried out after the shaking. On the other hand, during 2011 shaking several government buildings responded extremely poorly and had to be abandoned. In 2006 shaking, though few buildings suffered severe damage, no building suffered complete collapse. While during 2011 shaking and its aftershocks several buildings collapsed completely and large number of buildings suffered severe damage showing high seismic vulnerability of structures in Sikkim even though several smaller past earthquakes provided sufficient warnings about the poor construction practice in the region. A four storey RC building at Dikchu bazaar constructed about 10 years back on rear side of an old wooden house collapsed completely after two days of the main shock (Fig. 8a). The building was constructed on slope over a RC retaining wall and the slope started failing after the main shock. This resulted in severe tilting of the building along the slope prompting the occupants to vacate the building before it collapsed completely during an aftershock two days later. Poor construction practice, inadequate reinforcement detailing, and inadequate measures to arrest slope failure appeared to be the primary reasons for the collapse. Another two storey RC building constructed on slope and located near the Dikchu dam site suffered partial collapse during the main shock. This building was not being used for residential purposes, and therefore, losses were minimal (Fig. 8b).

**Figure 8.** (a) Collapsed four storey RC building at Dikchu bazaar; (b) a part of two storey RC building near Dikchu dam site collapsed during 2011 shaking.

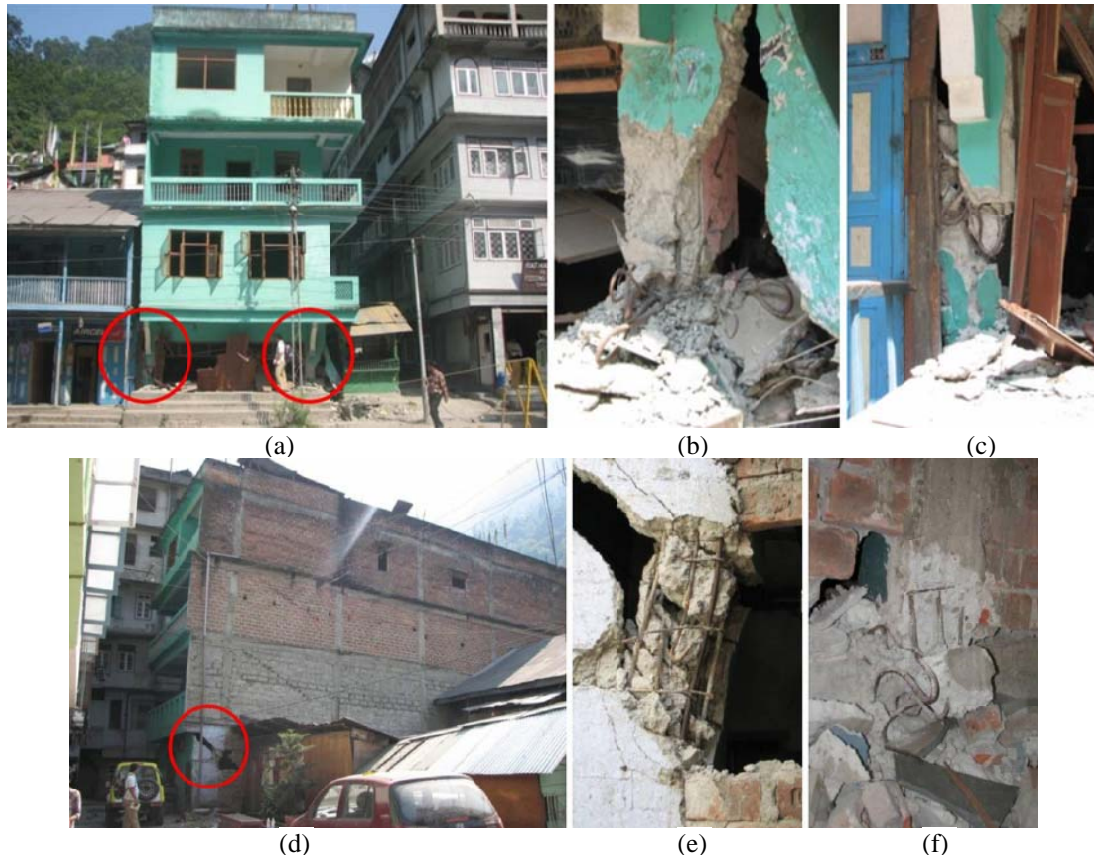
A four storey RC building at Singtam market collapsed partially during 2011 earthquake shaking due to failure of several RC columns in the first storey (Fig. 9a, 9b, 9c). The first storey of the building was primarily used for operating commercial shops, and only second storey was occupied by the owner at the time of the earthquake shaking. Plain reinforcing bars with inadequate shear reinforcement were used in most columns of the building, and these bars in several first storey columns buckled during the shaking taking the storey down. Two front RC columns and one internal column in the first storey buckled due to severe shaking resulting in tilting of the whole building along its length towards front side (Fig. 9d). This also resulted in shear failure of one column of the rear side in the first storey (Fig. 9d, 9e). Only one internal RC column of the building suffered complete failure (Fig. 9f); this may have possibly saved the building from complete collapse. Interestingly, only minor damage was observed in the upper stories of the building. A six storey RC building, constructed about 15 years back, and an adjacent nine storey RC building constructed about 20 years back at Baluwakhani in Gangtok tilted severely during the main earthquake shaking (Fig. 10a). The shorter building suffered complete collapse during an aftershock on 23 September 2011. This resulted in further tilting and subsequent pan-cake type collapse of three intermediate stories of the bigger adjacent building (Fig. 10b). Both the buildings were constructed on hill slopes, and failure of foundation of the shorter building along the slope triggered the collapse of both the buildings.

**Figure 9.** Partial collapse of a four storey RC building at Singtam market during 2011 shaking: (a) Overview of the building with failure of front RC columns, (b), (c) closer views of complete failure of front RC columns, (d) tilting of the building along its length, (e) failure of RC columns on the rear of the building, and (f) failure of an internal RC column showing use of plain reinforcing bars and inadequate provision of shear reinforcement.

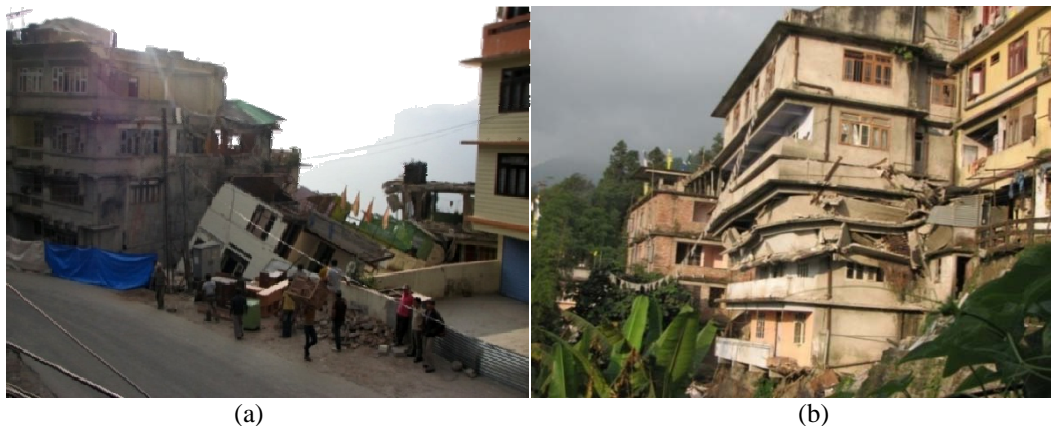
**Figure 10.** Collapse of two RC buildings at Baluwakhani in Gangtok: (a) the six storey building collapsed completely due to foundation failure, and (b) adjacent nine storey building suffered pan-cake type collapse in intermediate three stories.

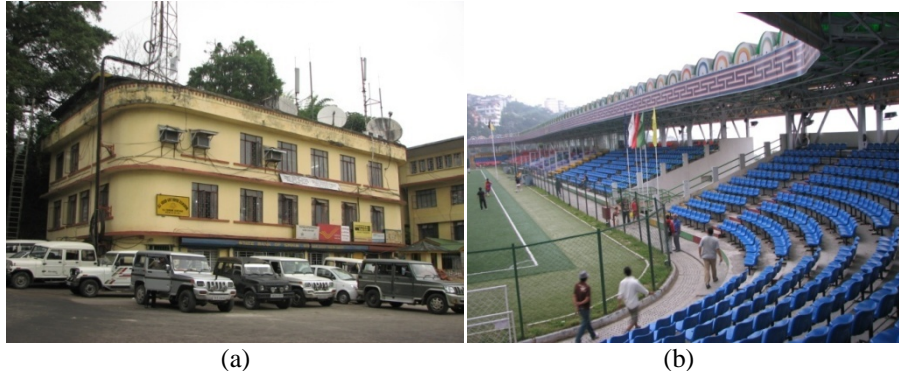
Though performance of a large number of RC buildings in Sikkim was below par, several RC buildings performed exceptionally well during the earthquake shaking. A three storey RC building in front of the Tashiling Secretariat building hosts many Government offices (Fig. 11a). It performed exceptionally well during the earthquake shaking, though the performance of the Secretariat building constructed right across the road was quite poor. One of the major sports stadiums in Gangtok, Paljor Stadium, was constructed in 2005, and performance of the RC and steel supporting structure of the main stadium and the ancillary buildings was very good during the earthquake shaking (Fig. 11b).

**Figure 11.** Good performance of buildings in Sikkim: (a) A three storey RC building in front of Tashiling Secretariat building, (b) RC and steel supporting structure of Paljor stadium and its ancillary buildings in Gangtok.

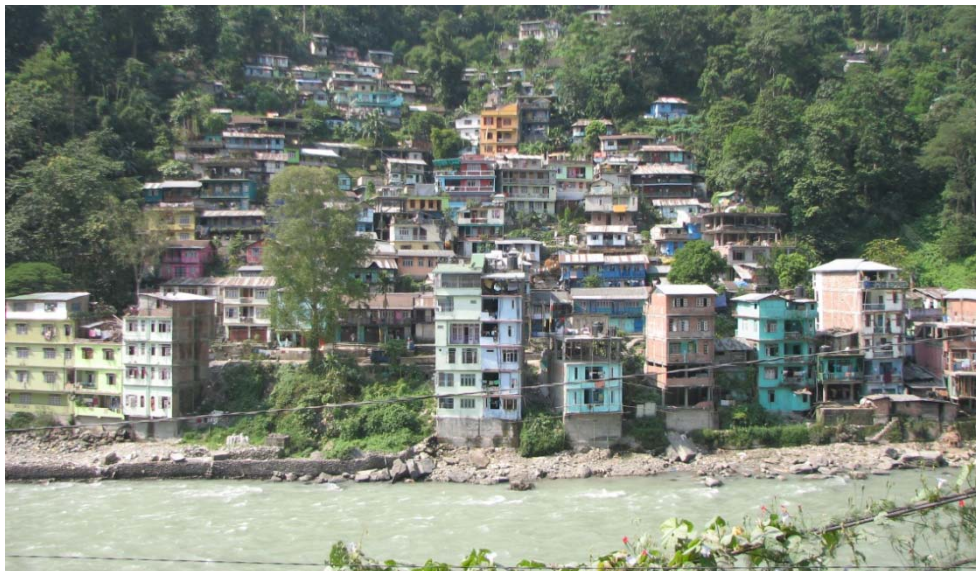
Sikkim is located in one of the most seismically active regions in India, and therefore, earthquakes occur frequently in this region. Further, Sikkim has a difficult hilly terrain and harsh weather conditions and construction activities in this region should be handled by competent engineers and skilled labours. Construction activities in such regions also require proper planning and strict adherence to the codes of practice and building bylaws. However, in most cases construction in Sikkim and adjoining areas has been carried out in a haphazard way without proper planning, without utilizing services of engineers, without using the codes of practice and building bylaws (Fig. 12). Moreover, construction material available in the region is not of very good quality. This has resulted in extremely poor and seismically vulnerable construction practice in the region. One example of such construction practice is construction of large number of closely constructed six to eight storey RC buildings on slopes of river banks (Fig. 12). As discussed in the above sections, several such buildings collapsed during the earthquake shaking.

**Figure 12.** Haphazard construction practice in Sikkim
