Analysis of Damages and Behavior of the Masonry Buildings Due to February 27th 2010 Chilean Earthquake.

P. E. Alcaíno, C. Castro & N. K. Valdebenito

School of Civil Engineering, Pontificia Universidad Católica de Valparaíso, Valparaíso, Chile. E-mail: pablo.alcaíno@ucv.cl

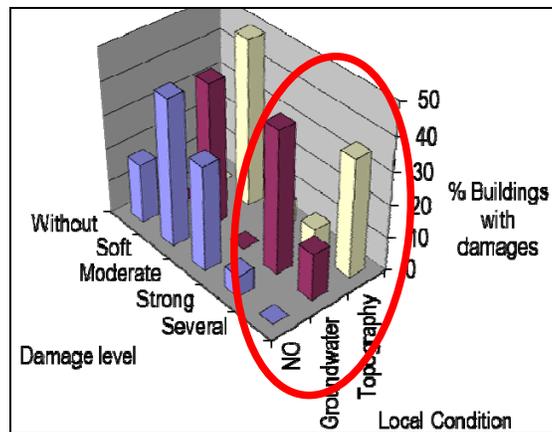
Figure 5. Assessment of influence local geotechnical special conditions in the damage level of buildings.

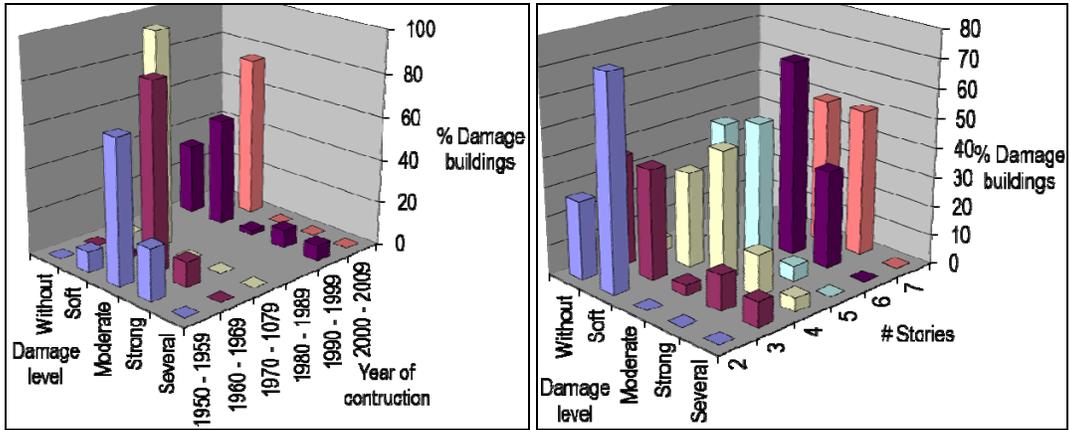
Figure 6. Assessment of influence of no unique conditions in the damage level of buildings.

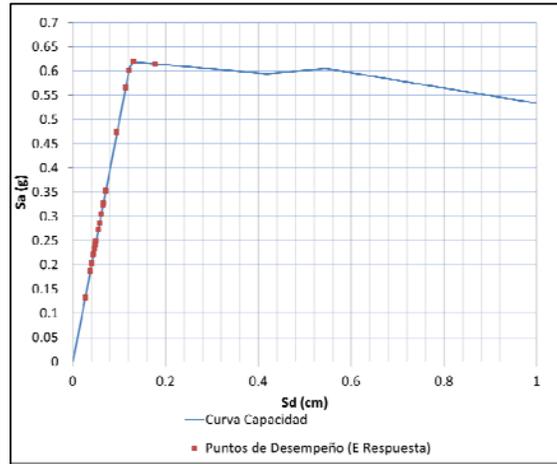
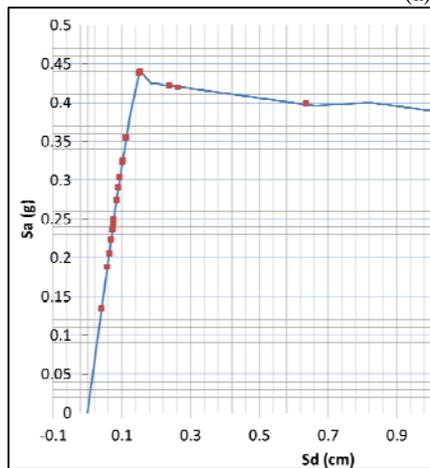
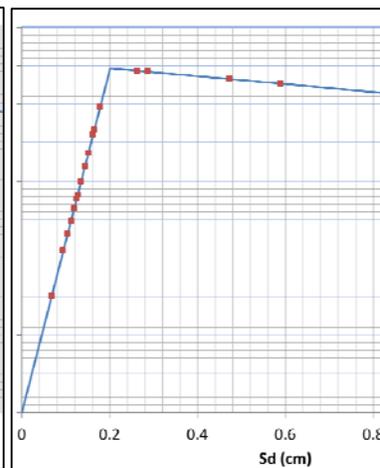
After, when the design was checked and the push over completed, was possible to verify that the behaviour of the buildings under study is very linear with a brittle failure, as shown in Figure 7. It also indicates the performance point for each demand spectrum. You can observe that many performance points are close to or in the failure.

Figure 7. Performance points: (a) B1, x-axis, (b) B3, axis y, (c) C1, axis y

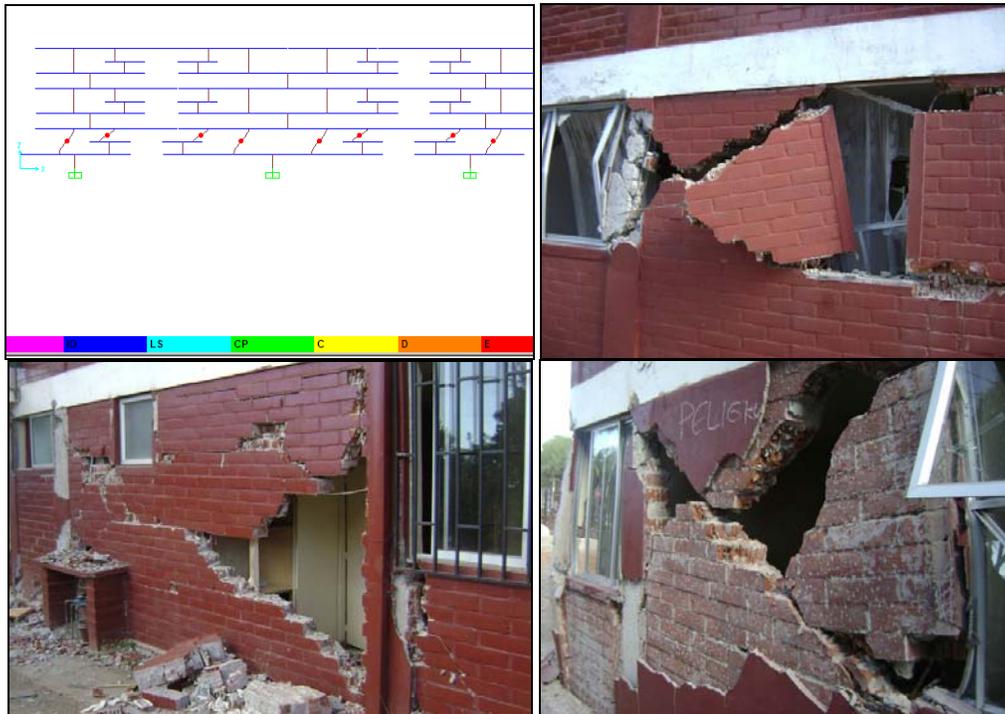
conclusions of Alcaino and Valdebenito (2011), the level of damages predicted by the model was compared with the observed damages. The Figure 8 shows the comparison between the modelled performance point for the building type B1 and its real observed damages. Similarly, the Figures 9 and 10 show the comparison for buildings B3 and C1.

Figure 8. Comparison between the damages predict with the model and the observed damages in building B1.

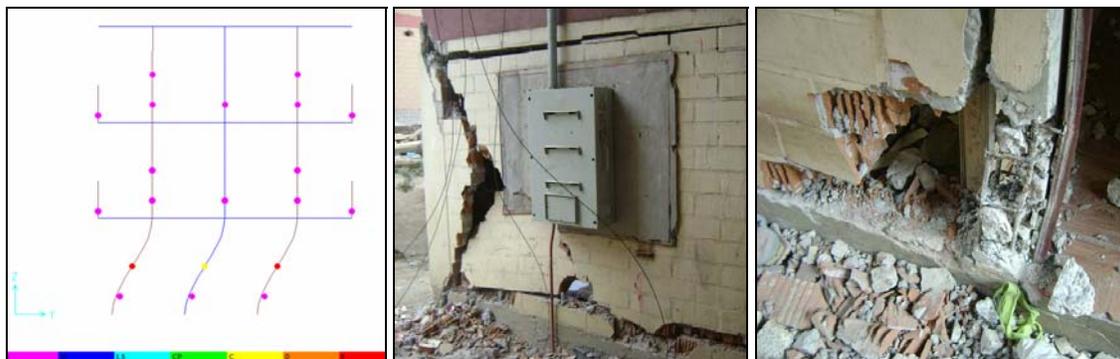
Figure 9. Comparison between the damages predict with the model and the observed damages in building B3.

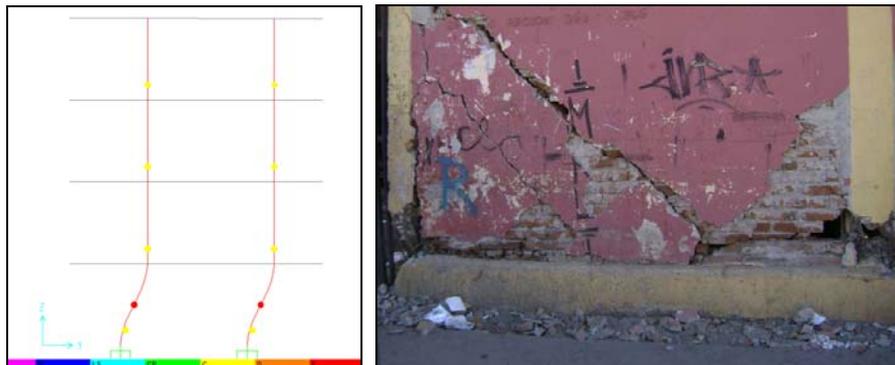
Figure 10. Comparison between the damages predict with the model and the observed damages in building C1.
