DAMAGE DUE TO TSUNAMI AND TSUNAMI RESISTANCE PERFORMANCE OF WOOD HOUSES DURING THE GREAT TOHOKU EARTHQUAKE

SUMMARY:

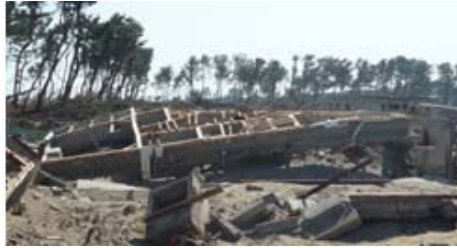
In the area with over 5 m flood water depth, most of the wood houses in the inundated area were washed away by the tsunami. How the houses were washed away; as for the case which the whole house including foundations was washed away (Photo 2.1), the case which only foundations were left (Photo 2.2), the case which sills and foundations were left (Photo 2.3), the case which sills, foundations and floor boards were left (Photo 2.4), and so on, were observed. There were several cases that the hold down fastener was failed, as shown in Photo 2.5. The foundations or wall of bath room made by concrete block often remained in, as shown in Photo 2.

Photo 2.1. Foundations washed away.

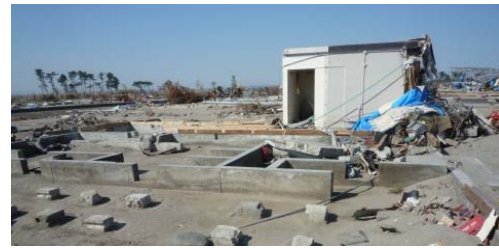
Photo 2.2. Only foundation remained.

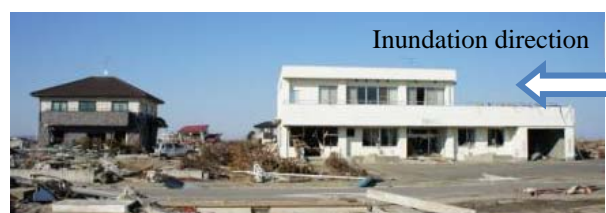
Most of wood houses near the shore in the area of Arahama, Arahama-shin, and Yuriage were washed away. However, not all the houses were washed away. For example, many houses which were located far from the shore remained (Photo 2.6). The houses in the downstream of RC building remained, as shown in Photo 2.7. A group of houses that remained downstream of large RC apartment building as shown in Photo 2.8. The buildings that survived were a mix of older and newly constructed wooden houses. In addition, the factory building protected wood houses for an even further distance. This is expected to be due to the relatively new construction of these houses that had better structural specifications, as shown in Photo 2.9.

Photo 2.7. Wood house to remain in the downstream of RC building in Arahama, Sendai city.

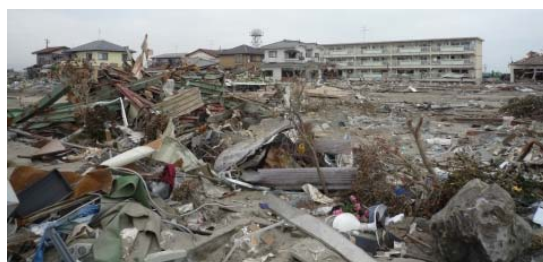
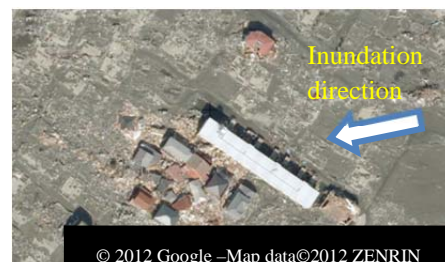
Photo 2.8. Group of wood houses that escaped damage downstream of large RC structure

(a) Conspectus on the ground

(b) Aerial photograph

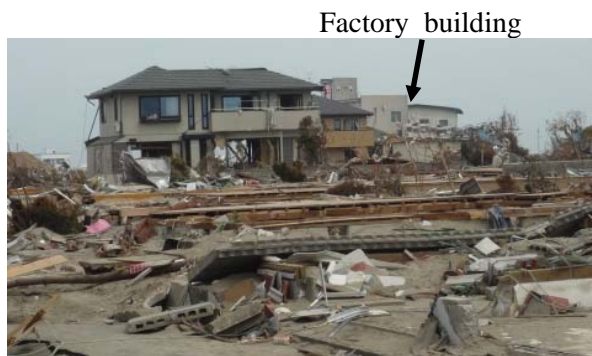
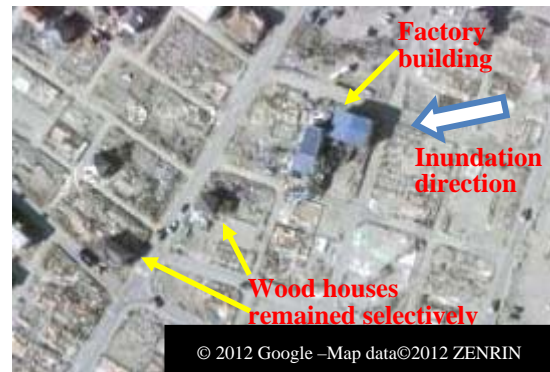
Photo 2.9. Wood houses remained in the downstream far from the survived factory building.

(a) Conspectus on the ground

(b) Aerial photograph

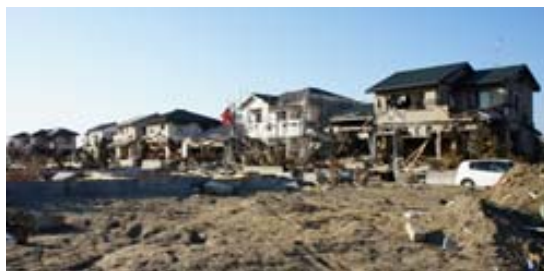
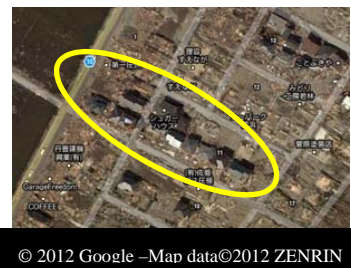
Photo 2.10. Wood houses to remain in the shape of a line in Arahama-shin, Wakabayashi ward, Sendai city.

A line of wood houses remained were confirmed in Arahama-shin, Wakabayashi ward, Sendai city, as shown in Photo 8. The front survived house of the line was non-wooden. The flood water depth in this area was estimated at the level about 4-5 m. On the other hand, wood house which didn't have survived buildings in the inundation direction avoid being washed away, but suffered heavy damage, as shown in Photo 2.11. Several such houses were confirmed in each surveyed area and were built by the better specification, for example, with many metal fasteners.

(c) Conspectus on the ground

(d) Aerial photograph

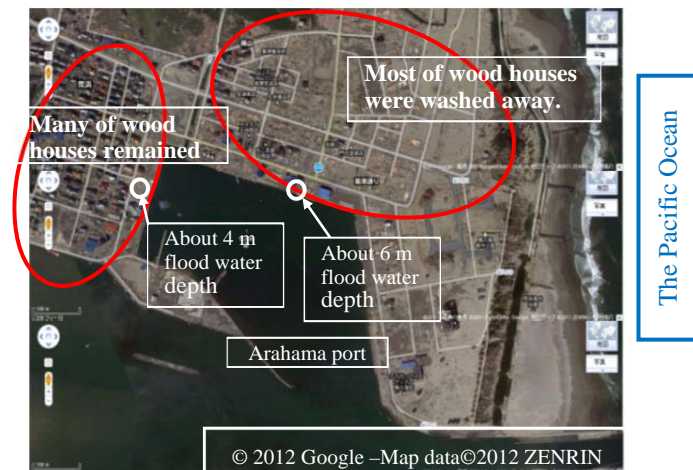
For example, Arahama district in Watari town is surrounded with sea shore and faces the Pacific Ocean in the east, and there is a port in the south side, as shown in Figure 2.2. In the area between Pacific Ocean and Arahama port, most of wood houses were washed away. In the north area of the Arahama port, the flood water depth was estimated to be about 6 m. Many of wood houses were washed away. On the other hand, in the west area of the Arahama port, the flood water depth was estimated to be about 4 m. Many of wood houses remained.

Figure 2.2. Aerial photograph and the flood water depth estimated in Arahama, Watari town.

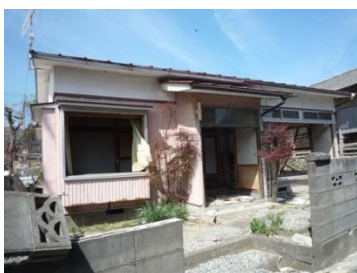
Photo 2.17. Survived house which might have comparatively slight structural specifications.

At the location where we went up the slope land from the shore, a light steel-frame house remained under the about 5 m flood water depth which was estimated by the water trace on the wall of the house. In the next of this house, the 1-story old wood house (Photo 2.17) whose structural specification was not so good, but the anchor bolts were installed remained. In addition, a warehouse with mud walls (Photo 2.18) was remained and an old wood house without anchors (Photo 2.19) turned and moved horizontally. Because the wood house under about 5 m flood water depth were almost washed away in plain areas, it might be possible for the slope land to make the tsunami wave force a little lower.

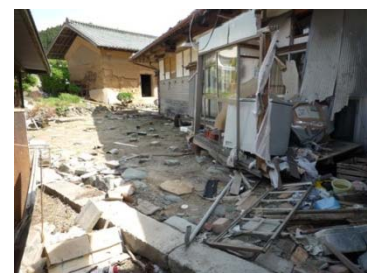
Photo 2.19. Survived old house which rotated and moved horizontally
