Analysis of the “Casa dello Studente” collapse during the L’Aquila 6th April 2009 earthquake

M.G. Mulas, D. Coronelli, L. Martinelli, R. Paolucci, F. Perotti

The partial collapse of a seven-story RC building with two underground levels, occurring during the April 6 2009 earthquake of L’Aquila (Italy), is analyzed with a comprehensive multidisciplinary approach taking into account all the possible significant factors. Attention is paid to the building history – from 1965 to 2009 – crossing transfers of ownership, refurbishment works and different code regulations; to the quality of the in situ cast material; to the ground motion actually experienced on the site. The comparative analysis between the original design and the picture of the collapse as visible immediately after the earthquake has allowed the explanation of the chain of events leading to the collapse itself. Additional data on material properties and ground motion, together with numerical modelling and analysis, led to the determination of the collapse causes.

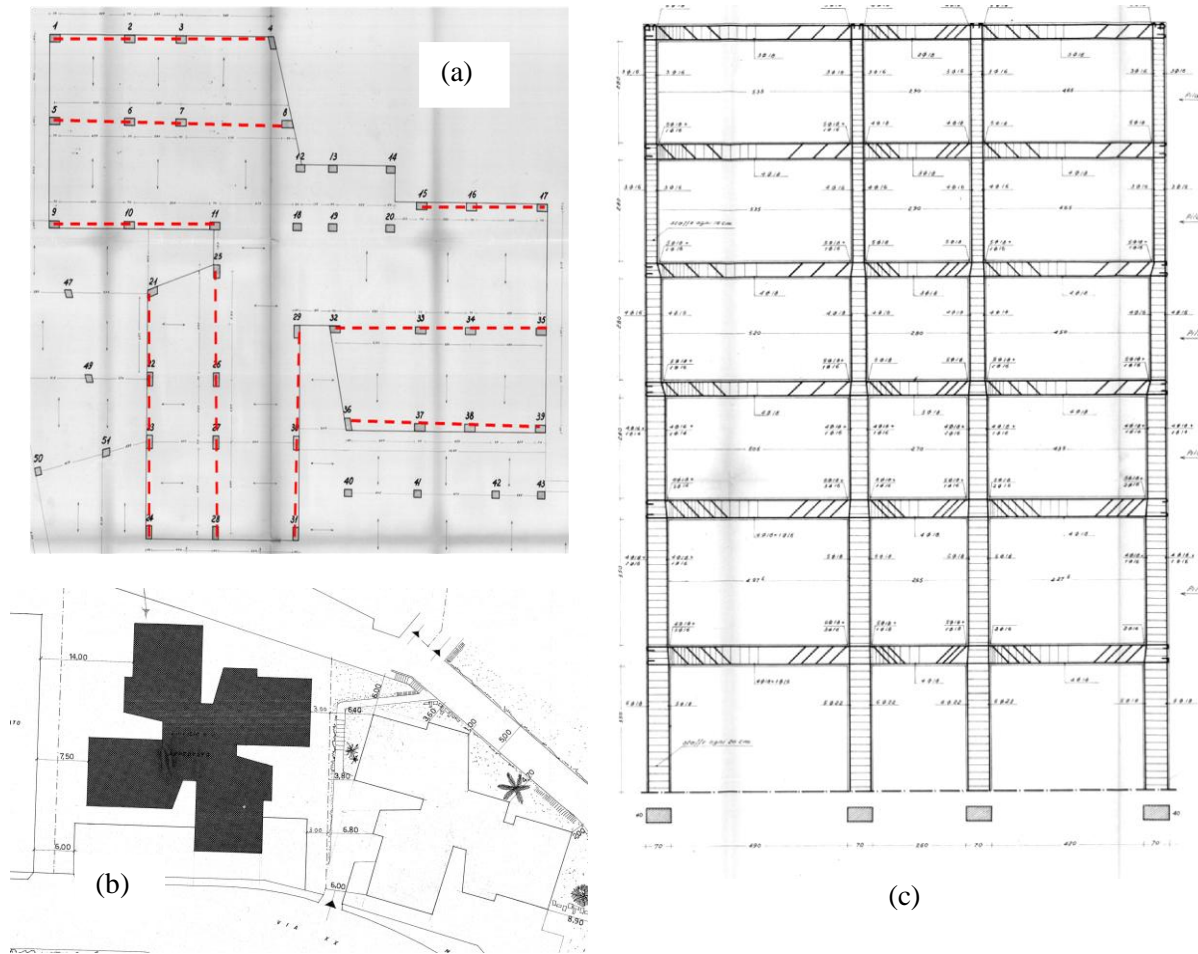
The above criteria were used for designing the main lateral load resisting system, i.e. the longitudinal frames located in each wing of the building (red dotted lines in Figure 2a). Loads acting on each frame (Figure 2c) were apparently derived according to tributary areas and to criteria that were typical, at that time, for designing vertical load carrying systems. Given the building plan configuration, the procedure led to substantial underestimation of seismic forces in the NS direction (vertical direction in the plan view 2a), encompassing only three longitudinal frames; note, in this respect, that the adjacent building (on the left in Figure 2b), designed according to the same procedure but characterized by a four-wing plan, i.e. by the same number of frames in the two directions, performed satisfactorily during the April 6th 2009 earthquake.

The underestimation of the design seismic forces resulted, in turn, in a significant lack of resistance to lateral forces in the NS direction; focusing on the columns at the ground story, where the collapse sequence was triggered (see Section 7), it can be estimated, by simple limit-state analysis, that overall limit resistance was between half and one third of the value required to resist seismic action, assuming a behaviour factor in the range 1.5-3. In analyzing the structural configuration and performance it can be also observed that the stiffness and resistance of the floor assemblage has proven to be sufficient to perform adequate membrane action but the detailing of the transverse frames located, in each wing, on the facades of the short sides, was not suitable for absorbing in-plane horizontal forces. In addition, the RC frame supporting the staircase mostly contributes to strength and stiffness in the EW direction.

Figure 2 – (a) Structural plan of the building with column numbering and plane frames; (b) comparison with plan configuration of the adjacent building; (c) main structural frame (typical).

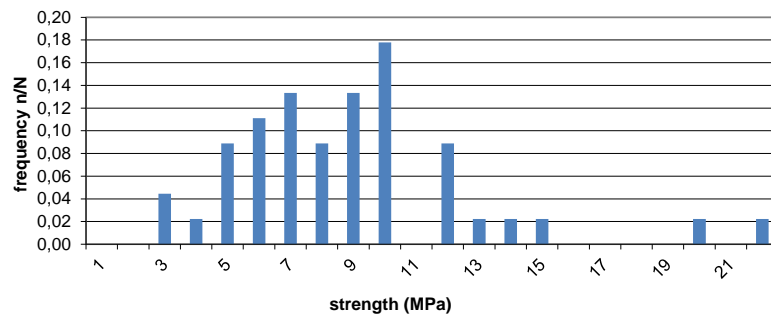
strength (COV=0.29) typical of low-strength concrete, and the irregular distribution of strength values indicated by the histogram (Figure 4.1). The variation of strength with density was coherent with theoretical models (Neville, 1972) and the low density and strength were correctly related. The variation of strength with ultrasonic velocity measurements agrees with results in the literature on low strength concrete; low velocity values agree with the low strength. The strength values obtained with the SONREB method, calibrated on the basis of the core results, are in agreement with the destructive tests. The mean values of strength at each story of the building agree with the sample mean, and no trend can be recognized from the top to the bottom indicating that the cores were not affected by earthquake induced damage. The mean strength and standard deviation of the cores taken from members of the collapsed part of the building agree with the results of the sample.

Fig. 3 – Histogram of core cylinder strength

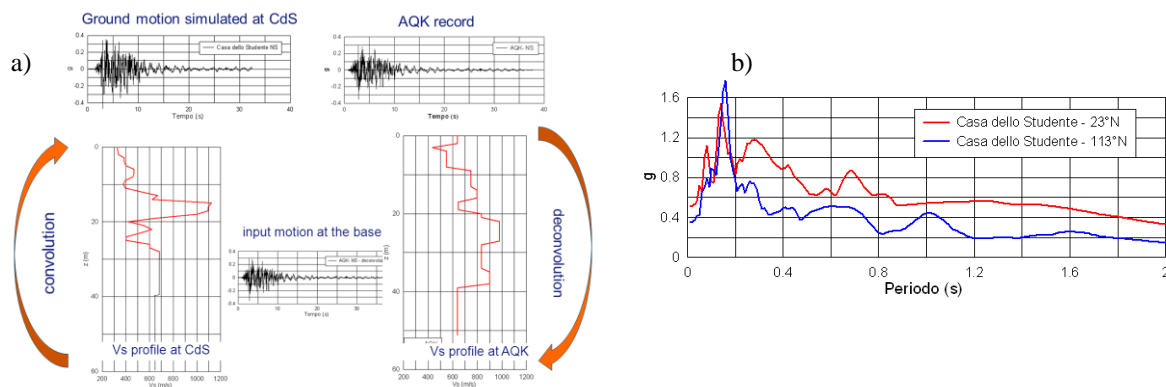
Figure 5. (a) Sketch of the procedure to obtain ground motion at the CdS site based on the AQR record; (b) simulated elastic response spectra, rotated along the principal directions of the building.

The resulting elastic response spectra for a 5% damping ratio, in Figure 5b, show the prevailing amplitude of the 23° N component, as a consequence of the directionality of earthquake ground motion in the L'Aquila records along the fault normal direction (e.g. Paolucci and Smerzini, 2010).

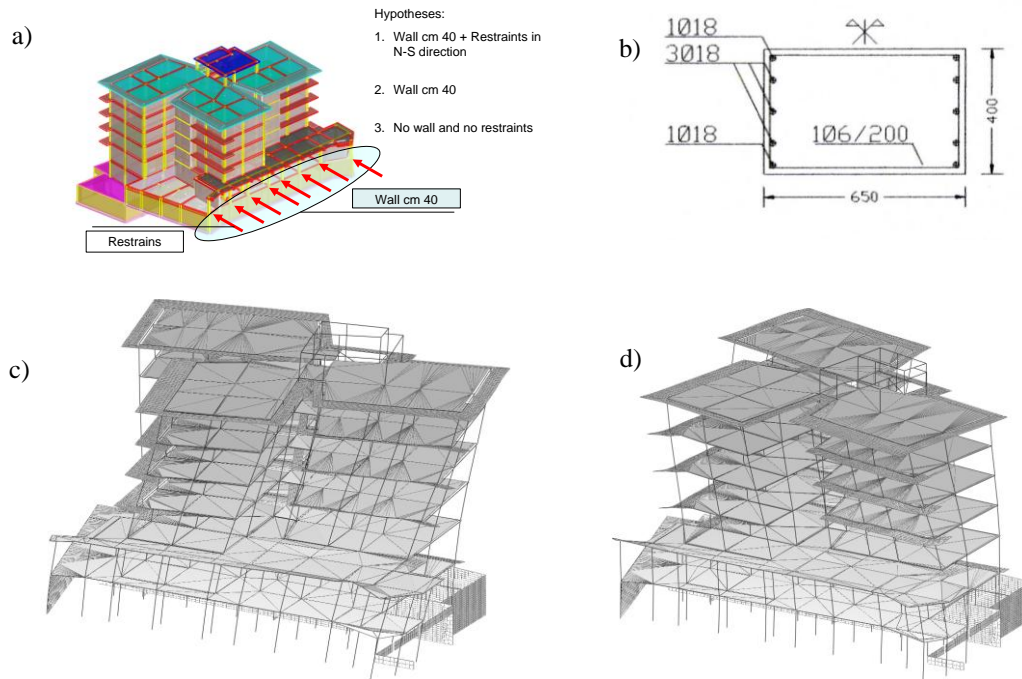
Figure 6. a) Geometric model of the building; b) typical column detailing at ground floor; c), d) modal shapes for 1st and 2nd mode, respectively.

Figure 6 c),d) shows the first two mode shapes of the structure in the configuration at the date of the seismic event, in the most flexible configuration, the one without the constraints at the level of XX Settembre street, without the basement wall towards XX Settembre street and including a 70% reduction in stiffness of beams and columns. Boundary conditions at the basement, as well as reduction of members stiffness, induce little modification on the first mode shapes. The period of the first and the second mode falls in the ranges 0.83-1.63s and 0.81-1.45s, respectively. For the most rigid structure the values are only slightly different while for the most flexible they differ to a larger extent but anyway fall in regions of the response spectrum that have almost equal spectral ordinates. Involving both a rotational component with respect to a vertical axis, the first two modal shape can be combined in the response giving rise mainly to a translation in the North-South direction, the same of the North wing main frames.

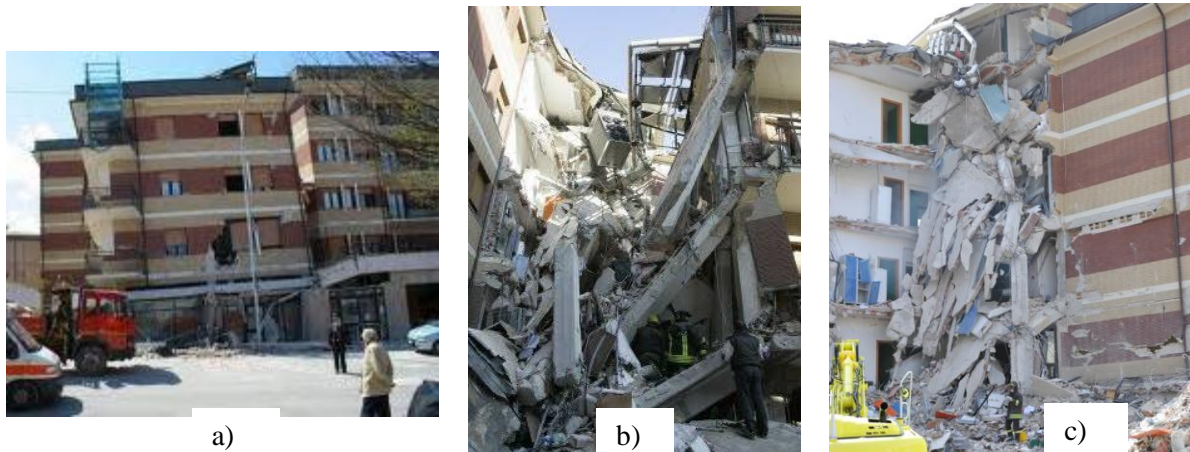
At today's date, the South and West wings are still standing and can be accessed without major problems, due to the absence of relevant damage, both structural and non structural. The North wing, that suffered a partial collapse (Figure 7a,b), was completely demolished by April 9, to allow for fire-fighters to rescue, in safety conditions, the bodies trapped in the collapsed region (Figure 7c). Immediately after the earthquake, the situation of the building – as witnessed by many pictures – was the following:

1. The ground story – at the level of the road – had a partial soft-story mechanism concerning all

- the columns of the North Wing frames (Fig. 7a).
2. The soft-story mechanism was associated to a displacement in the direction of the frames of the collapsed wing.
 3. The three columns of the North Wing at the interface with the other Wings (# 21, 25 and 29 in Figure 8a) collapsed totally from the ground story to the building top (Figure 7b).
 4. No significant damage was found in the structures of the two underground floors.

Figure 7 – North Wing Collapse : a) North view; b) connection zone; c) demolition before removal of col. 29.

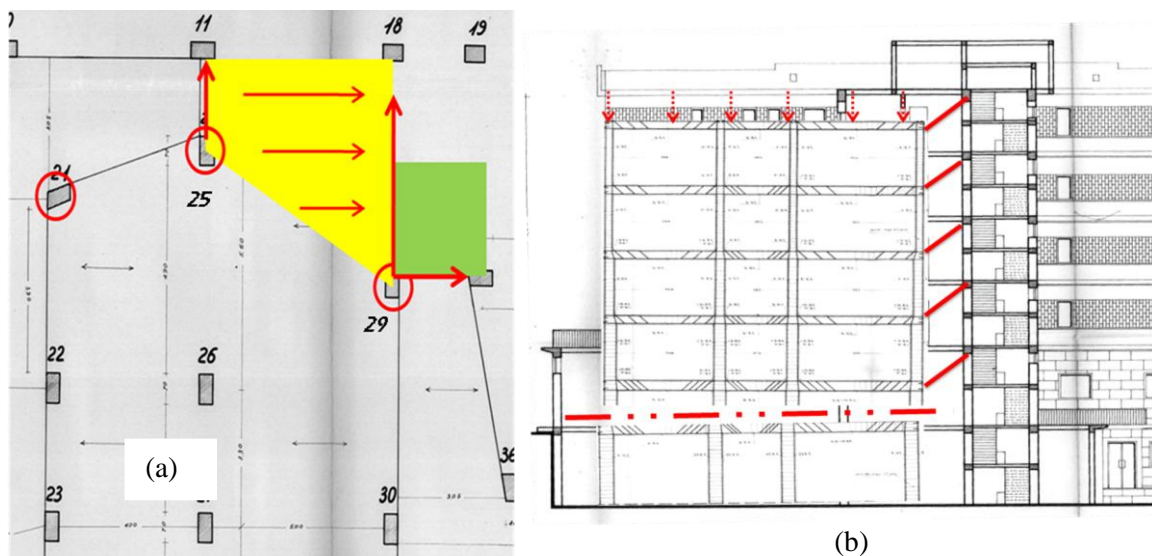
From the description above, it can be stated that actually two separate collapse mechanisms took place in the building. A first one, that can be defined as “the collapse initiating event” was the failure of all the columns at the ground story in the North Wing, due to an excessive ductility demand on the plastic hinge at top and bottom of each column. With the soft-story mechanism restricted to the North Wing, the connection zone between this and the other wings is subjected to a dramatic vertical relative displacement: the chord of the beams at the border of North Wing is shown with red solid lines in Figure 9b. The original design of the connection zone is affected by unfavorable characteristics, as the misalignment of columns and a reentering corner (Figure 8a). In addition the beam 18-29 supports the nonstructural wall REI 60 that increases stiffness and strength of a limited part of the beam itself. The beam failed in shear at the cross-section corresponding to the end of the wall between the green and the grey zone (Figure 8a); the region between the wall and the elevator (see Figure 1b) is still standing in the building. The floors at levels 1-4 in the yellow zone in Figure 8a underwent a strong distortion, that in turn caused tension forces on the floor itself and on columns 25 and 21. These forces, acting out of the frames plane, induced instability of columns and the final catastrophic failure along the building height, a second event caused by the joint presence of the soft story mechanism, the lack of regularity in plan and the collapse in shear of the beam 18-29. The presence of strong tension forces is witnessed by: (a) the cracking pattern of a few structural elements recovered after the partial failure of the North Wing and its demolition; (b) tension cracks, perpendicular to the red arrows in the yellow zone in Figure 8a, still visible in the ceilings.

Figure 8 – Collapse mechanism: (a) plan of the collapsed region at a typical floor; (b) view in N-S direction.
