SOIL MECHANICS AND FOUNDATION ENGINEERING
ASPECTS OF THE ALASKAN EARTHQUAKE
OF MARCH 27, 1964

by Ronald F. Scott¹

SUMMARY

This report begins by briefly summarizing the geology and soil profiles of the Anchorage area. The most important effects of the earthquake with respect to soil engineering are then qualitatively described and illustrated and a brief discussion of the stability of slopes in the region of interest is presented.

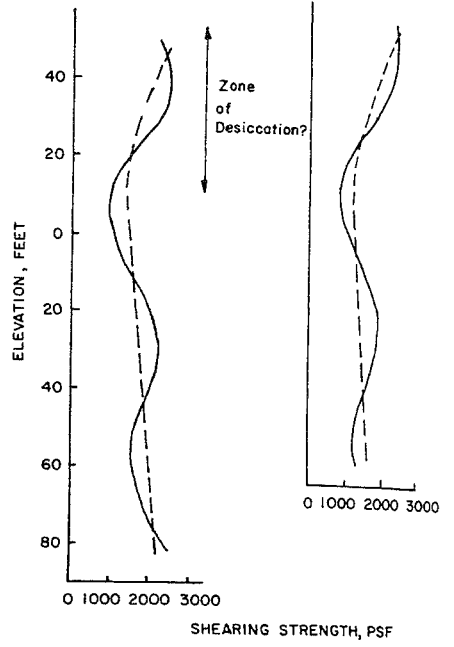
FIG. 4

to the earthquake ground motions. Alternatively, it will be observed that the normally consolidated-desiccated soil profile exemplified by Fig. 4 shows a minimum shearing strength at some depth (approximately mean water level in that case). The earthquake may also have caused a reduction of the shearing strength of the clay at that depth due to increased pore pressures as shearing deformation progressed. The sensitivity of the clay, or lowered strength on remolding, arises from the same phenomenon.

- Fig. 4 Representative Shearing Strength Profiles, Anchorage, (From Ref. 5). The solid lines were drawn by the original investigators through the scattered data points. The fluctuations in shearing strength probably arise from changes in the silt or sand content of the clay. The dashed lines are the author's estimates of the strength increase with depth in the clay.

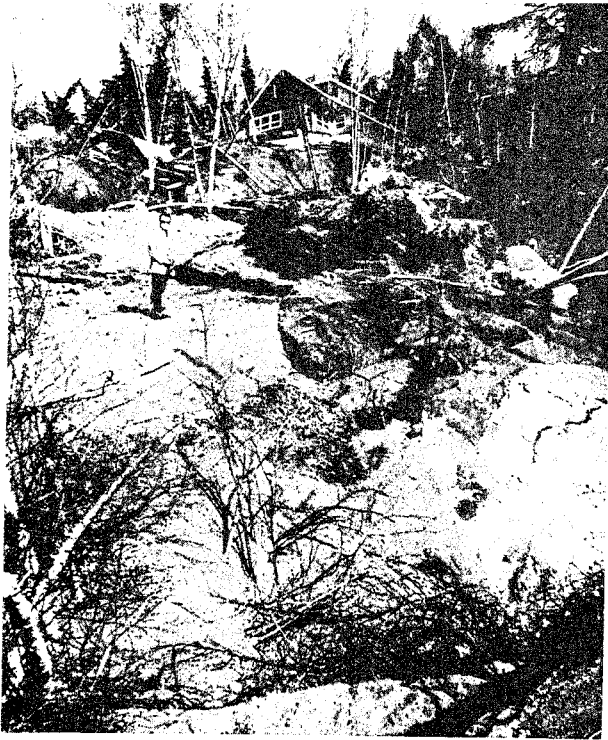
FIG. 6

At Turnagain Heights the very large landslide, part of which is shown in the aerial photograph of Fig. 5 and from the ground in Fig. 6, appears to have been of the laterally spreading type which has been known to occur (8) as a result of high pore pressures in a relatively pervious layer or layers underlying the sliding mass. In this case the excessive pore pressures may have been generated by the shearing of such layers due

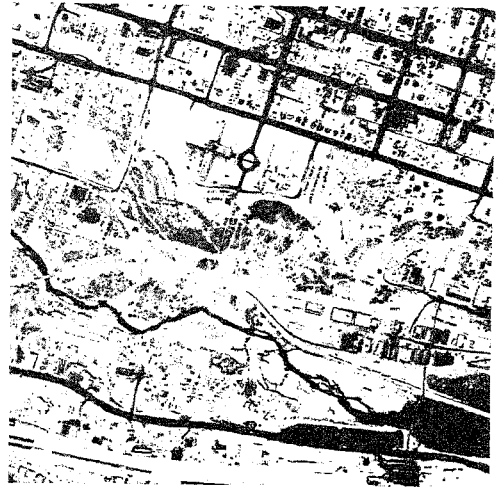
FIG. 8

The Government Hill and 1st Avenue slides, the latter of which is shown in the aerial photograph, Fig. 8, both appear to be examples of simple rotational slides. Such slides typically occur over longer times than flow slides, up to several hours, but at Anchorage the movements and earthquake were probably contemporaneous. More noticeably than at other locations, other older rotational slides are observable in Fig. 8 adjacent to the most recent one at 1st Avenue. Examination of local records might indicate whether or not the more recent of the previous slides occurred as a consequence of an earthquake,

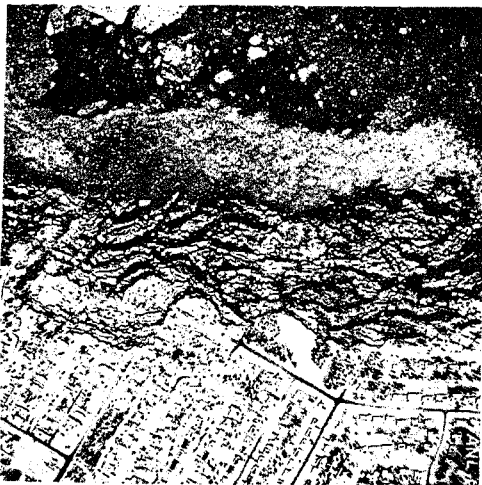
FIG. 5

Typically, such spreading failures occur very rapidly, in minutes, so that it is not possible to say whether the Turnagain slide, having been initiated by the earthquake, stopped with the cessation of the vigorous general ground motion or continued after it. It does not seem likely that the landslide terminated before the earthquake. For equal ground motions it would appear that the bluffs at Turnagain were less stable than at other locations as a result of weaker soils or higher static pore pressures. Assuming a minimum cohesive shearing strength, c , for the Bootlegger Cove clay of about 1000 psf and a unit weight, γ , of about 125 pcf (5), the bluffs at Turnagain certainly had a height which exceeded the minimum value for stability ($4c/\gamma = 32$ ft) for the case of excessive pore pressure in an underlying layer (8).

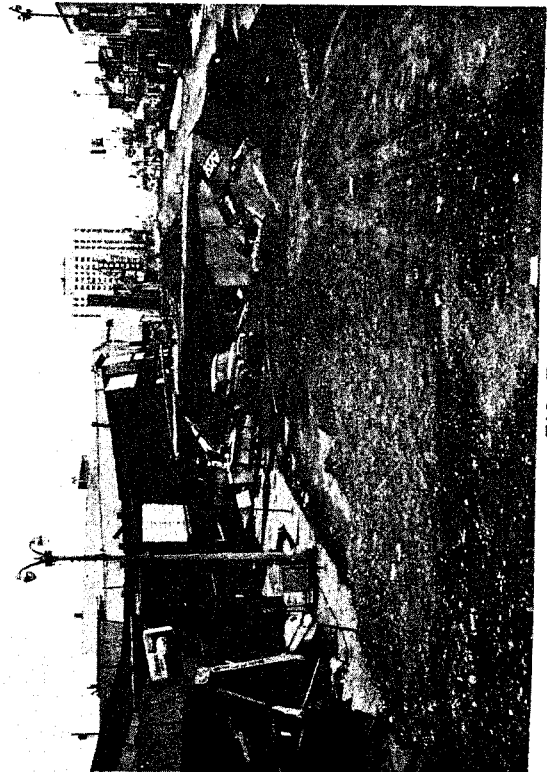
FIG. 7

The L Street and 4th Avenue slides underwent lateral soil movements much smaller than those at the Turnagain slide. In each case a very large mass of soil, including a part of the bluff and relatively flat slopes at the toe, moved laterally without much rotation for a distance of perhaps 10 to 12 feet. The soil behind the new cliff formed at the head of the slide was left unsupported thereby and failed causing a section (graben) behind the slide to fall down into the space provided by the lateral movement. This behavior in some areas has repeated itself to a diminishing extent behind the primary slide block, causing successive groups of cracks and grabens. The graben of the 4th Avenue slide and its effects are shown in Fig. 7.

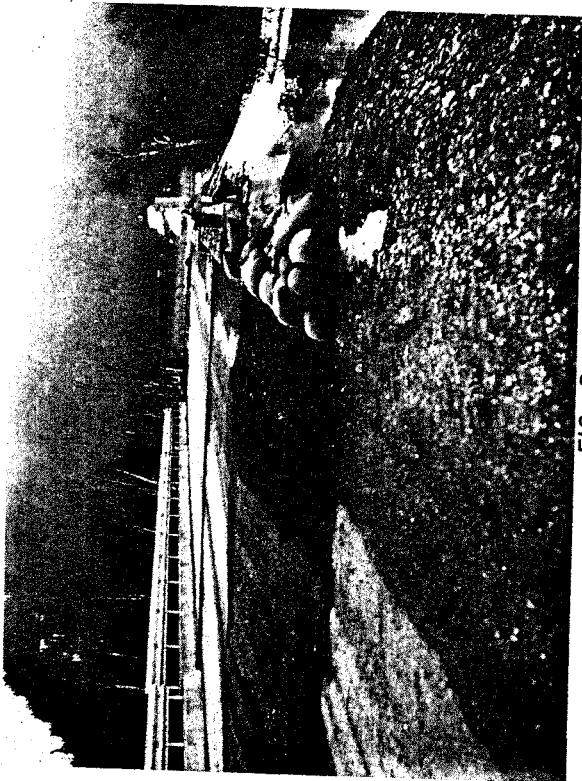
FIG. 9

The condition of the road and bridges to Portage gets progressively worse as Portage is approached. Up to perhaps 10 miles from Anchorage, damage is confined to some slumping of approach fills and settling away from abutments, while the bridges are relatively intact, as shown in Fig. 9. Further on, as a result of the slumping of the road shoulders, large cracks appear in the highway and underlying base course, which is, of course, frozen to a depth of several feet. Such a crack is shown in Fig. 10. By this stage, most of the road bridges, which are made of reinforced concrete supported for the most part on wooden piles, had collapsed into the streams which they crossed, Fig. 11. In some cases, the ground movements vibrated the bridge off the piles so that the deck fell upon, and was impaled by, the piles. From visual inspection, the tops of the piles were not at levels obviously different from those to which they had originally been driven. The bridges on the railway, running for the most part alongside the road, were either trestle structures or steel on wooden piles, and had not been damaged to the same extent as the highway bridges.

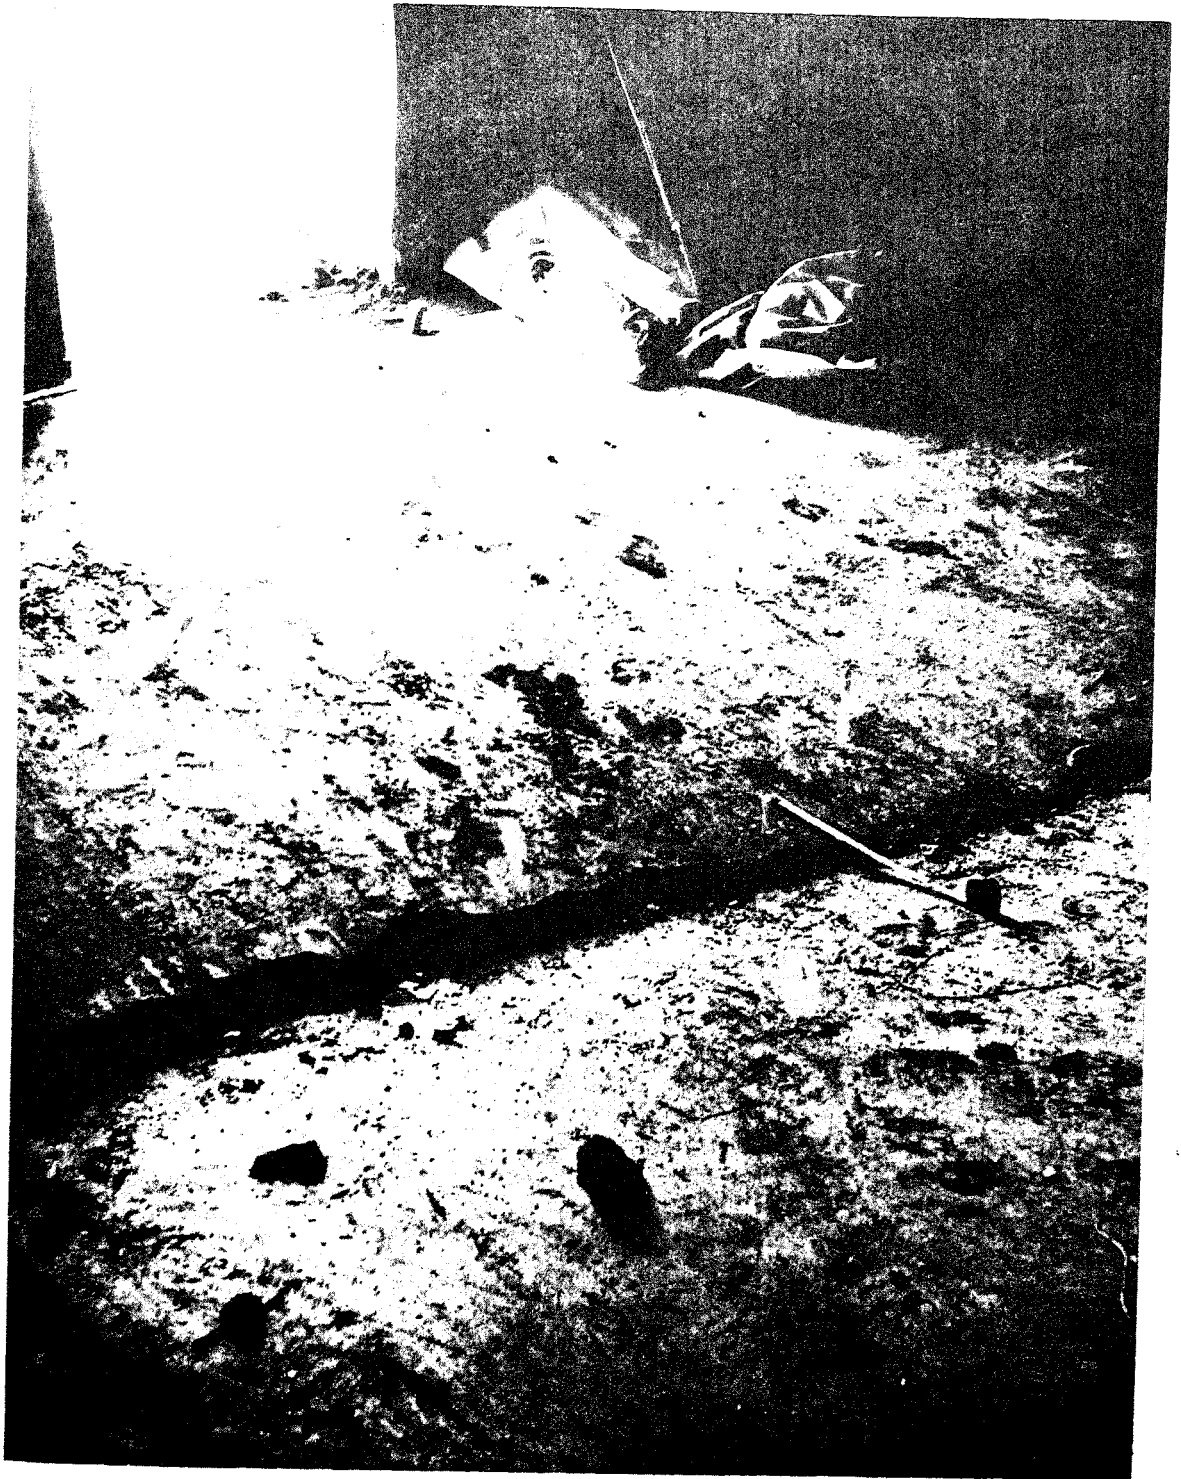
FIG. 13

A cross section through the wharf at Whittier is shown in Fig. 12, and Fig. 13 shows typical damage to the floor slab of the warehouse behind the wharf. It appears that the fill on which the warehouse floor slab rested underwent some compaction during the earthquake and settled away from the floor, which broke for lack of support. It is also possible that the ground shaking induced oscillations of the wharf structure and sheet-pile wall to and from the fill, assisting in its compaction and imposing lateral stresses on the unsupported floor slab, which, deflecting downwards, buckled as shown in Fig. 13. Movements of the latter kind would seem to be unlikely if the tie-rods and earth anchors to which they were attached were adequately placed and were sound before the earthquake. Since the tie-rods apparently passed unprotected through the fill below the warehouse, it is possible that they had been damaged before the earthquake and did not contribute full support during it.
