# EARTHQUAKE EXPERIENCE IN NORTH AMERICA, 1950-1959

Karl V. Steinbrugge\*

Vincent R. Bush\*

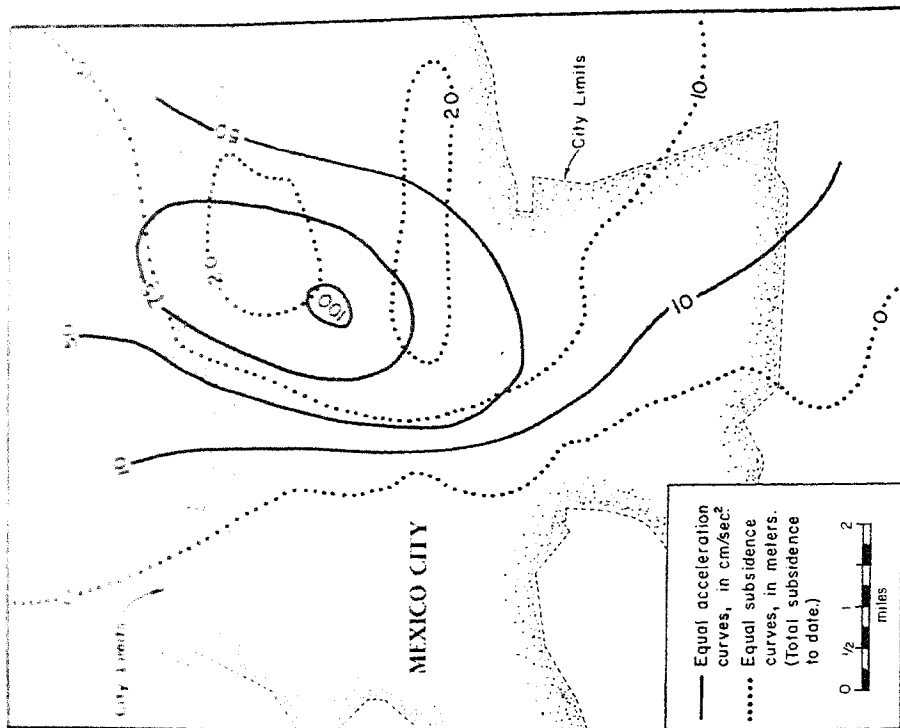
1. Effect of ground. The best recent example was the 1957 Mexico earthquake at Mexico City (#13); see also Figure 2.
2. Variations of the earthquake's focal depth. While good examples with respect to damage are lacking, it is reasonable to expect intensity variations as a function of focal depth. The depth of focus probably influences the energy release per unit surface area.

Figure 2. Relation between subsidence and acceleration in the July 28, 1957, shock. Subsidence is indicative of geologic conditions. After J. Merino y Coronado.

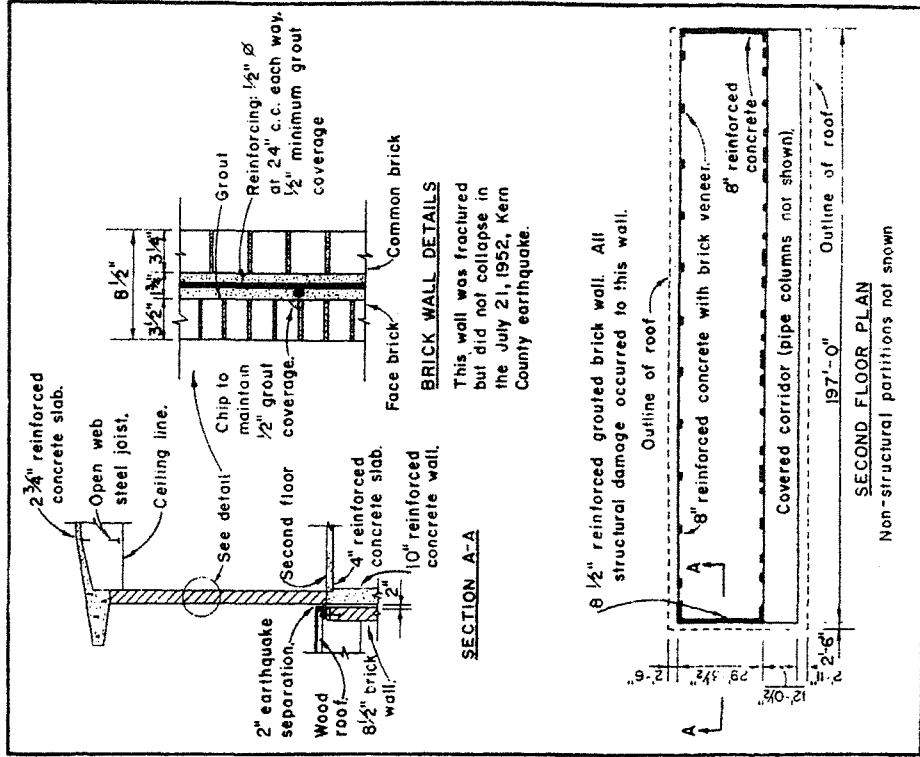
Figure 4. Administration Building, Arvin High School

One instance of effective use of reinforced grouted brick masonry was the Arvin High School in the 1952 Kern County earthquakes (#4, pp. 367-375). The design and construction of the group of structures were done under the jurisdiction of the Field Act, a California law which has proven effective in making public schools highly earthquake resistive. Over-all damage was less than 1%, although the nearby mercantile district in the City of Arvin had losses up to 100%. Damage was noted at roof to wall connections in several buildings, but the fracturing of the reinforced grouted brick masonry wall in the two story Administration Building shown in Figure 4 is of greatest interest. Cores from this wall taken prior to replacement indicated adequate compressive strength; however, observation during demolition indicated unsatisfactory bond between the mortar and brick. Also, it appeared that metal lath had been placed in some of the bed joints contrary to specifications.

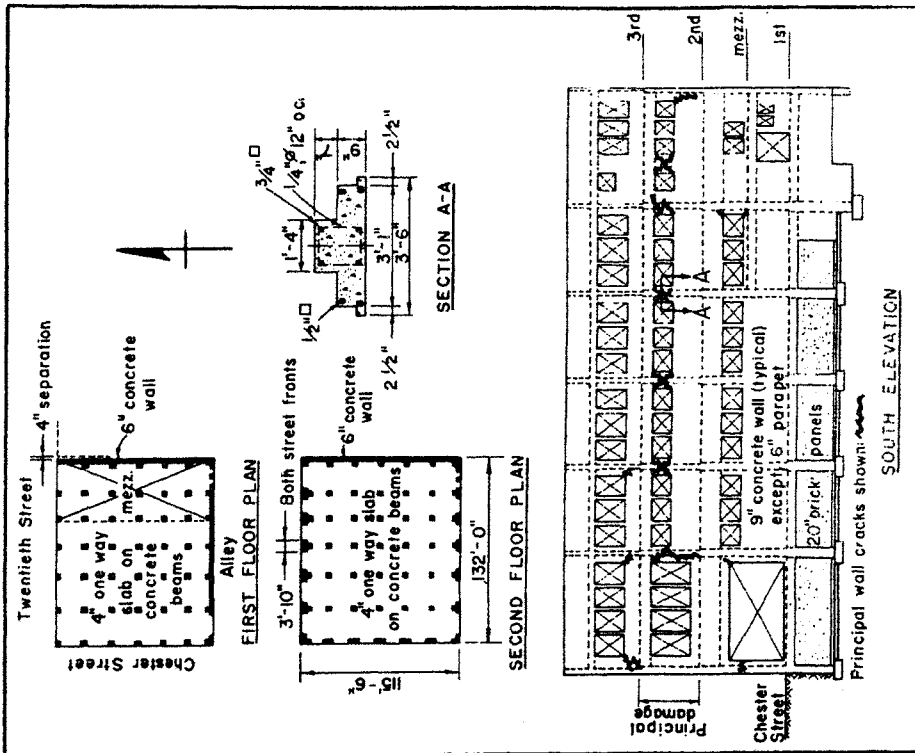
Figure 3. Brock's Department Store, Bakersfield.

Brock's Department Store in the 1952 Bakersfield shock: This three story plus basement reinforced concrete structure was the only one of its type to have suffered serious damage in the past decade. The design deficiencies and damage to the shear walls may be noted in Figure 3. The "L-shaped" shear wall layout also added serious torsional stresses (#4, pp. 337-343). A number of other rigid structures such as the Hotel Padre in Bakersfield performed well.
