## ENGINEERING ASPECTS OF THE EARTHQUAKES

### IN THE MAIPO VALLEY, CHILE, IN 1958

Rodrigo Flores (1); Santiago Arias (2); Victor Jenschke (3); Luis A. Rosenberg (4).

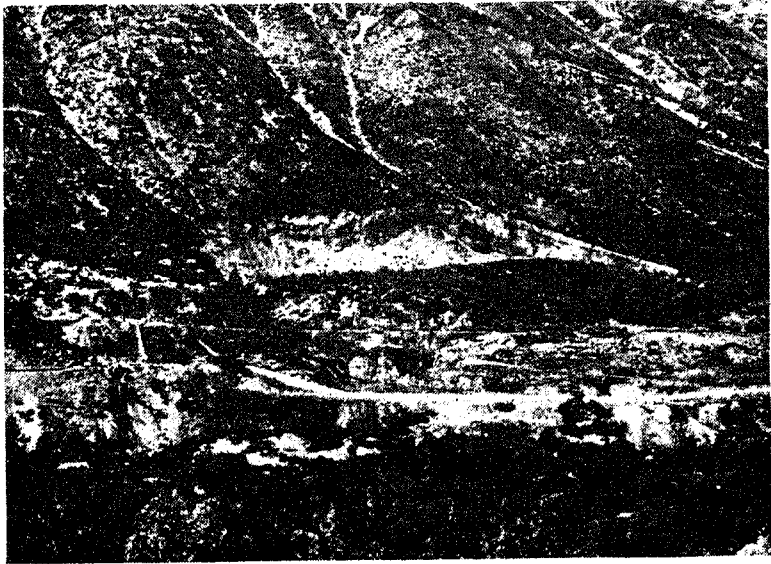
In the Maipo Valley, about 2 Km. downstream from the intake which supplies water to the Queltehue Hydroelectric plant, another large slide having a volume of over 4,000,000 cubic meters took place. The slide dimensions were approximately 500 x 400 meters and its maximum vertical displacement was about 80 meters. (Fig. 3). The slide occurred in debris material grading into alluvial terraces at the place called El Manzanito. Displacement at the surface of rupture reached about 100 m. A telephone line located lower down suffered an approximate displacement of 40 m., and the canal which services the Queltehue Hydroelectric plant and crossed the toe of the slide was displaced about 3 m. to the West and raised 4 m. above its original elevation. Both the channel and the road to the canal intake were destroyed for a length of over 500 m. A small steel bridge spanning the canal was similarly ruined and displaced 3 m. up and 3 m. horizontally from its original position.

Fig. 4,- Heavy landslide at El Manzanito. A large part of the fracture surface can be observed. Lower down appears the steel siphon that was built to replace the canal.

Engineering studies for the repair of this section consulted various possibilities. The final solution consisted in a welded steel syphon 3.25 m.  $\phi$  x 10 mm. thick x 430 m. long and weighing about 400 tons. (Fig. 4).

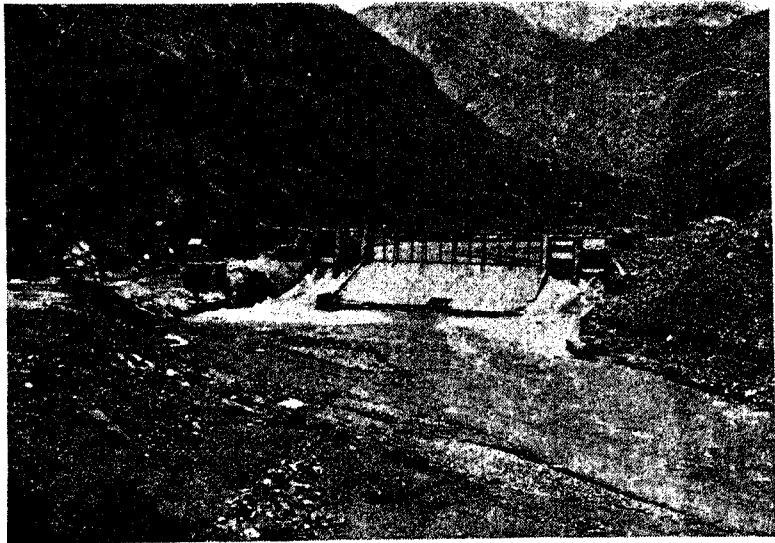
Maipo Canal Intake. (Fig. 5, 6). The intake comprises essentially a dam of gravity type which conveys water from the Maipo river to the canal that services the Quelchues plant, and several bays provided with gates for the control of the flow. Lateral compression by the earthquakes reduced in about 30 cm. the width of whole structure, causing numerous cracks at an angle of 45° in the masonry elements, and horizontal cracks in the piers which support the gates. These horizontal cracks usually coincide with construction joints. The steel beams and girders of the superstructure failed in buckling. Most of this damage appears to be caused by differential motion between the dam founded on sedimentary soil and the piers founded on rock and solidarizing, therefore with the rocky eastern slope. While appearances might indicate an eastward slide of the sedimentary layers on which the dam is founded, geological evidence shows that the eastern rocky bank of the river broke away from the mountain and advanced towards the river bed compressing the intake in such a way that its primitive width was reduced by approximately 50 cm. This was proved by huge crevices appearing some scores of meters above the works level. The western bank of the river did not experience any damage.

Fig. 5.- Maipo canal intake. Panoramic view. The fracture in the East central pier is seen.

The repair of the structure consisted mainly in filling cracks, eliminating leaking joints, and grouting. A reinforced concrete gate pier (90 cu. mts.) was rebuilt. Fig. 7. The lower portion of these piers which had experienced abrasion by stones, gravel and sand was lined with 12 mm. thick steel plates and the spillway apron was lined with a layer of graded rock.

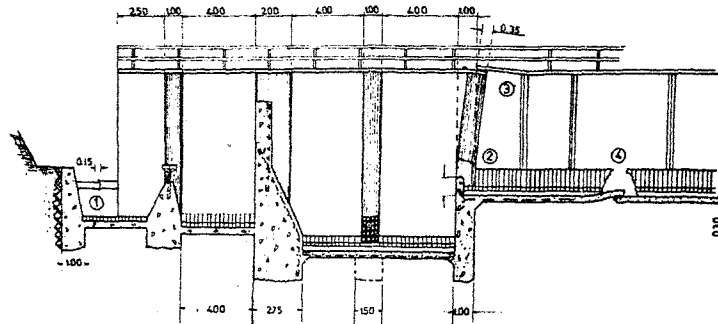
Fig. 6.- Cross section at the intake works on Maipo river.

- 1.- Fracture and overlapping of small reinforced concrete slab above the canal.
- 2.- Fracture of reinforced concrete pier.
- 3.- Fracture and overlapping of the upper R.C. slab.
- 4.- Fracture and overlapping of the R.C. spillway apron.

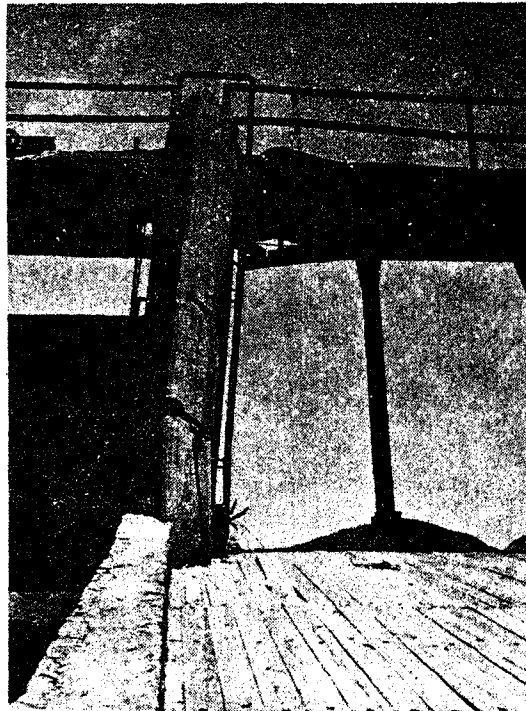
Fig. 7.- Fracture of the pier and buckling of the bridge steel girders.

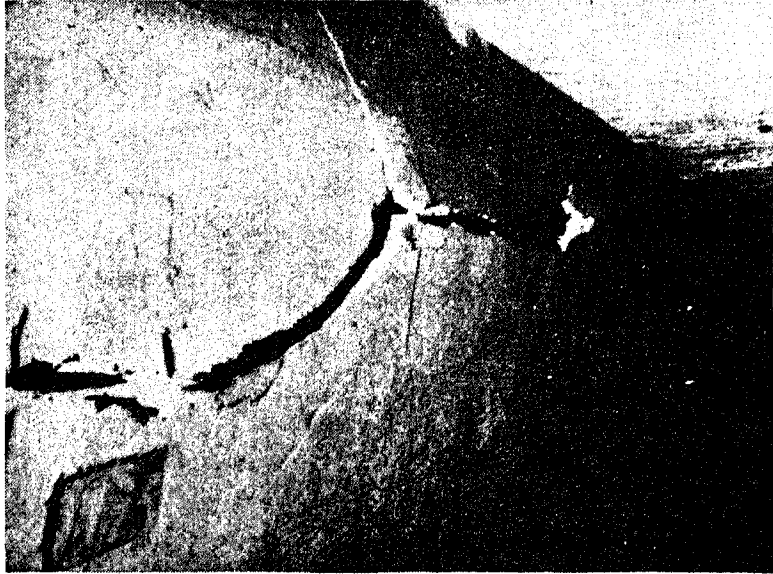
N° 1 Tunnel. This 300 mts. long tunnel traverses the Porphyritic formation through what appears to be a fault zone. The poor quality of the ground dictated the use of a lining in the form of an arched concrete floor, with vertical walls of concrete blocks supporting a roof structure formed by reinforced concrete T beams. Most of the damage consisted of failure of the concrete blocks under squeezing and consequent flexural cracks in the walls. (Fig. 8). The roof structure resisted well the vertical stresses which caused the T beams to develop their ultimate strength, with flowing in the reinforcing bars in many places. The work of repair was complicated by the fact that the change in sections downstream required lowering the tunnel to a depth that in some parts amounted to 1,4 m.

Fig. 8.- N° 1 Tunnel. The concrete blocks of the tunnel eastern wall have failed under rock pressure.

Operations were planned according the following stages: a) Total lagging of the tunnel for safety purposes, with frames spaced every 0,6 m., 1,2 m. to 2,4 m., depending upon conditions in the tunnel; b) Alternate excavation of sections between frames to new floor elevation; c) Placement of steel frames in excavated sections; d) Concrete pouring in floors and walls to the elevation of the original floor; e) Withdrawal of timbering and placing of underpinning supported on frames already placed; f) Excavation of second portions; g) Placement of remaining steel frames; h) Concrete pouring between original hillside wall, beams and steel frames.

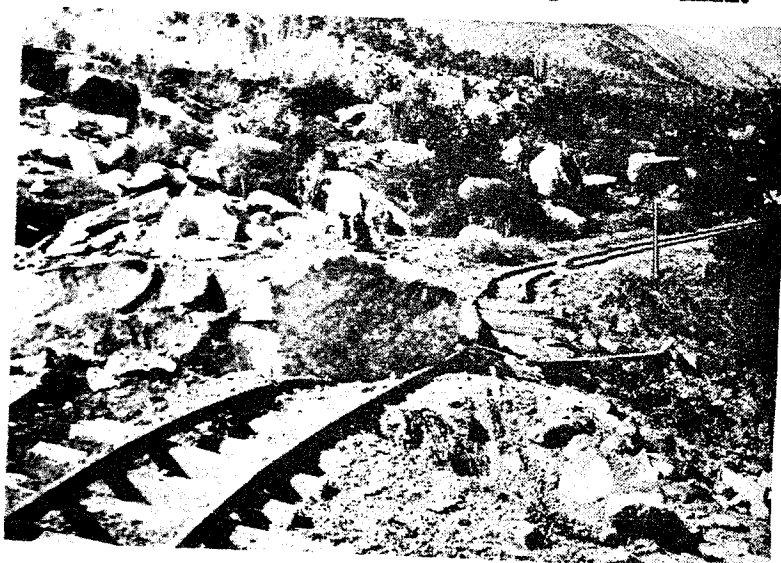
Railroad Tracks. The narrow gauge track between Puente Alto and Volcan was cut in several spots. This railroad normally services diverse points along the valley hauling both passengers and freight. The most serious damage was registered near Romeral due to a big avalanche, where even the rails were sheared off. (Fig. 11). Damage along the line was promptly repaired.

Fig.11.- Railroad track destroyed by falling rocks.

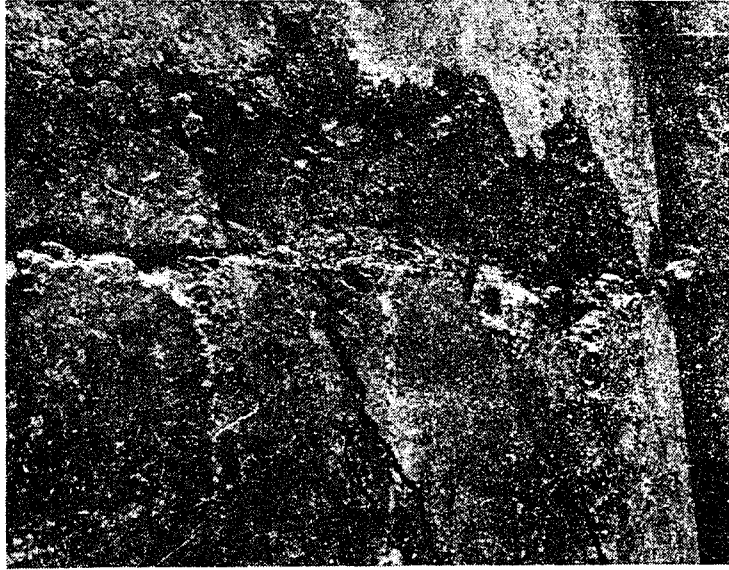
Belonging also to the Compañía Industrial El Volcan there is a smaller silo about 8 m. high used in the industrial process. This silo has diverse cracks, mainly one located at 0,40 mts. elevation and another at about 1,50 mts. elevation. It is interesting to note in the latter longitudinal steel rods that have undergone a considerable plastic elongation and suggest an important flexural work in the fracture zone. Undoubtedly the crack corresponds to a construction joint. (Fig. 12).

Fig. 12.- Volcan Silo. Detail of horizontal crack.

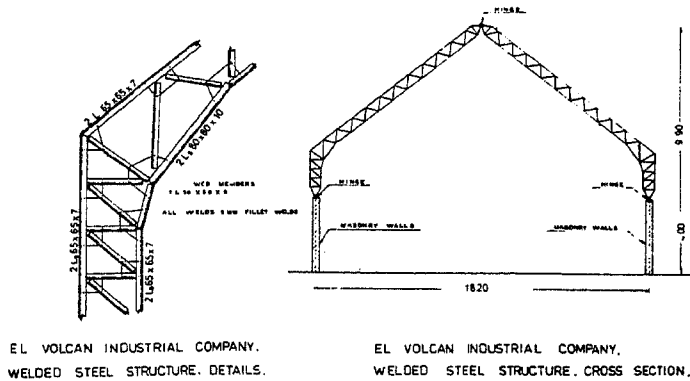
Fig.13.- Welded steel structure. Cross section and details.

At first sight the failure of this kind of structure in an earthquake is surprising, considering that wind loads are many times higher than the design load of  $10\% g$  required by codes. It must be noted, however, that due to the orientation of the structure relatively to the valley (longitudinal axis of structure parallel to the valley), the entrapped wind could act only in a longitudinal direction. The structure failed through rupture of the rigid joint defined by the vertical and the slope. (Fig. 14). The collapse was determined by the faulty design of the joint which did not contemplate continuity in the bars of the bottom chord in the change of direction. Moreover, the absence of bracing in the bottom chord left the structure with a very low safety factor even for design loads. In addition, welding was of poor quality, showing insufficient penetration, porosity and discontinuities. It should be noted that this structure was not designed by a structural engineer.

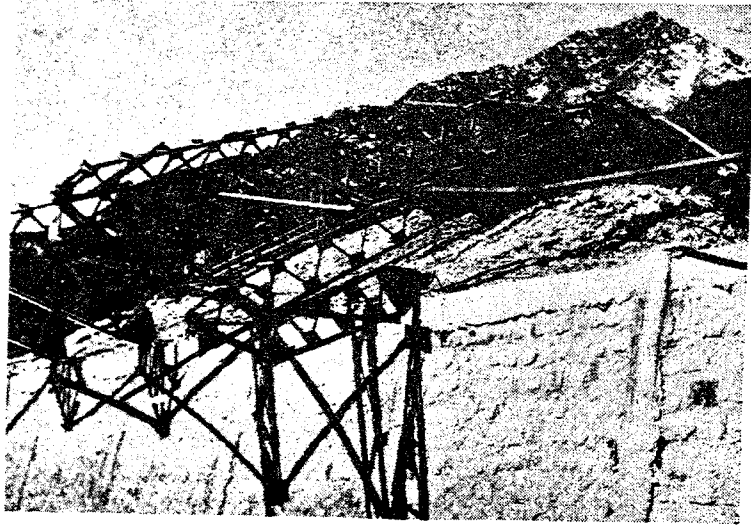
Fig.14.- Steel structure at El Volcan. The galvanized sheet cover has been withdrawn.

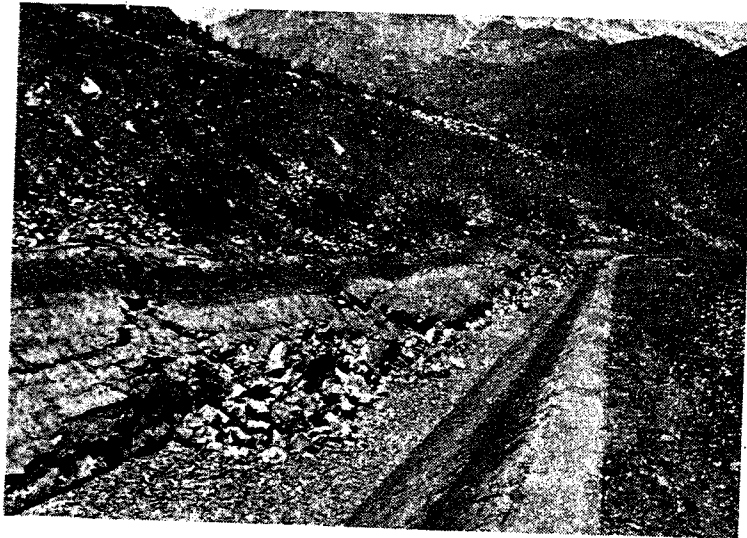
Some damage as shown in the Fig. 15 and 16 may be considered typical of the vibrational effect of the ground. The severe effects that the seismic wave can produce when it reaches a vertical or a sloping surface are well known. When the vibration action reaches a sloping face it has been

In damages like the present the poor quality of wall linings is felt. In other cases like in open canals, the absence of jointing between the bottom and the walls is also apparent.

Fig.15.- Maipo canal. Open canal section. Walls lined with stone masonry.

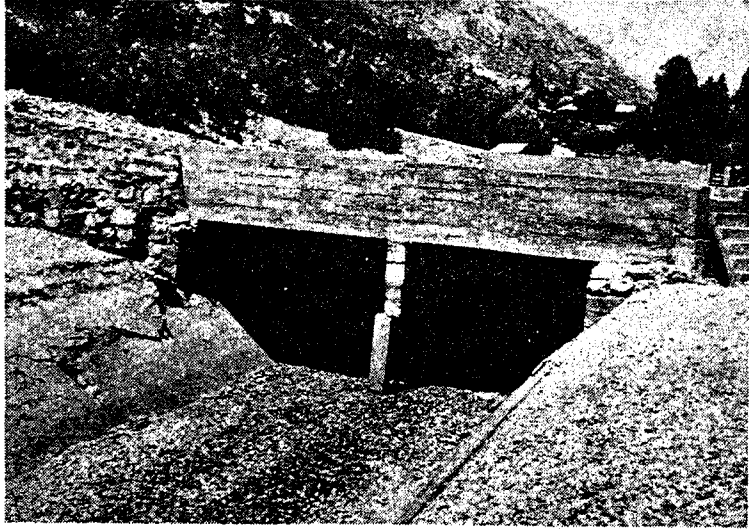
Fig.16.- Maipo canal. Passage over the canal. Shear of the column due to the sudden horizontal movement is seen.

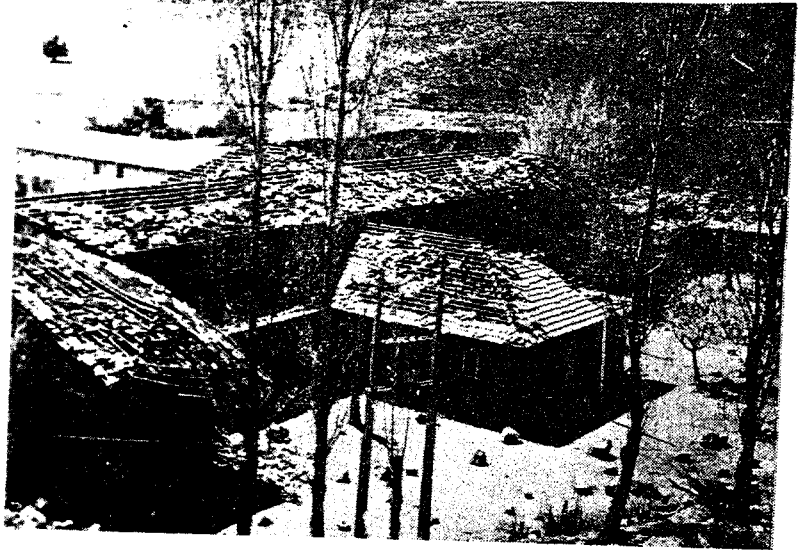
Fig.18.- Melosas Summer School Camp. Collapsed staircases.

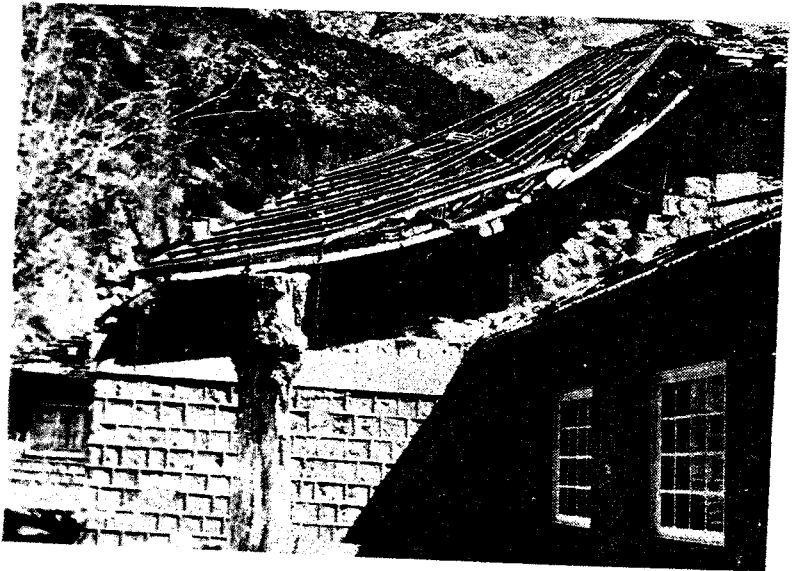
Fig.19.- Melosas Summer School Camp. Collapsed staircases. It shows the concrete slab complete in spite of its large deformation.

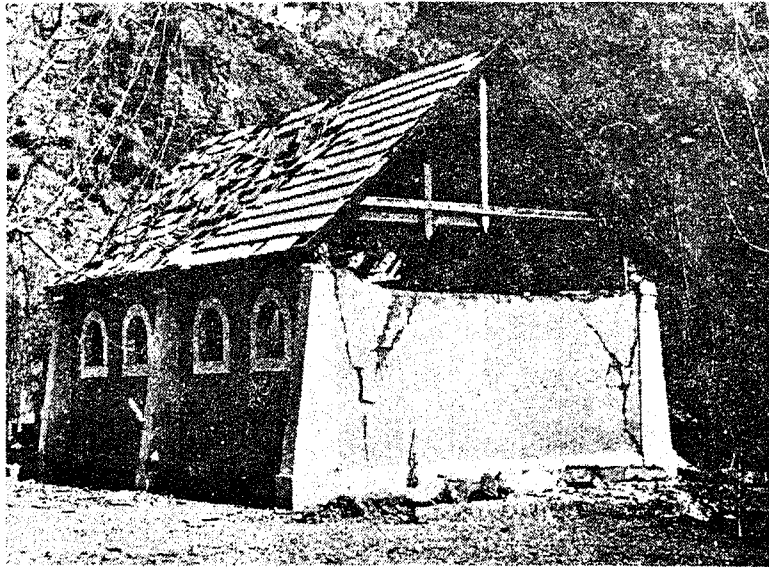
- Ba.- Buildings with walls not restrained transversally at the top. The Queltehues Church presents an example of this type (Fig. 20). In all observed cases the walls had collapsed.

Fig.20.- Queltehues Church. Shows collapsed end wall and cracks caused by movement normal to the wall.

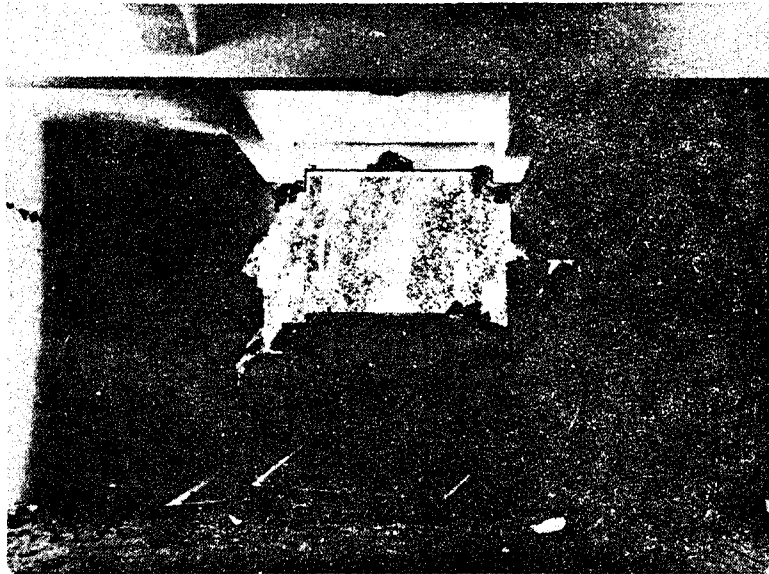
- Bc.- Construction with walls restrained transversally at the top by means of a slab. Longitudinal walls work in shear. There exist only two examples of this system of construction but unfortunately neither of them corresponds to normal conditions. One of these examples is found in the central two storey body of the Melosas Summer School Camp building. Like the upper portion of the staircases, the second floor of this building is partly constructed upon a one storey structure. As a result of the staircases collapse at the second floor level these walls had to absorb all the horizontal forces transmitted by the roof slab, resulting in shear failure (Fig. 21).

Fig.21.- Melosas Summer School Camp. Second floor wall destroyed by shear stresses.
