A BRIEF HISTORY OF DAMAGING EARTHQUAKES
IN WELLINGTON CITY AND DEVELOPMENTS IN
MULTI-STORY BUILDING CONSTRUCTION IN NEW ZEALAND

by J.A.R. Johnston*

This paper describes Wellington City, the most populous centre in New Zealand's strongly active seismic zone, its earthquake experience especially during the Wairarapa earthquakes of 1942, its buildings and the extent and nature of the building damage resulting from those earthquakes.

The principal features of a number of multistoried earthquake resistant buildings designed by officers of the Ministry of Works are described, current trends in building construction reviewed and unresolved structural problems outlined.

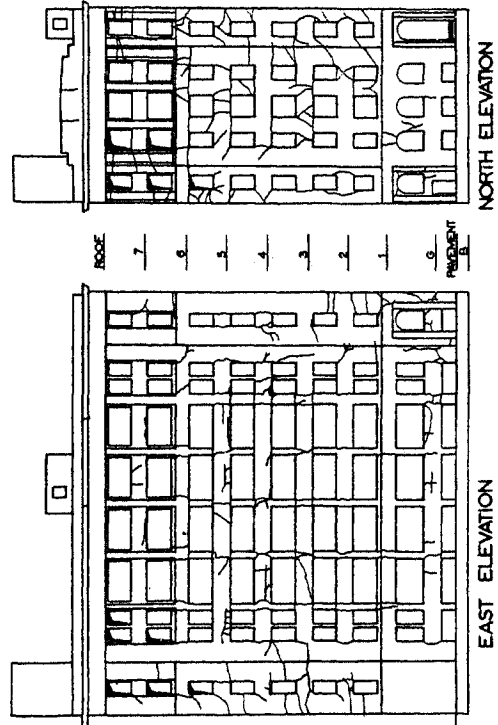
fig.3.a TYPICAL DAMAGED TYPE I. BUILDING

Most of the older concrete buildings had been noticeably strained by shrinkage and temperature movements prior to the earthquake and had low percentages of wall panel reinforcement. Old cracks in these buildings were widened and extended and new cracks formed while masonry partitions, fragile finishes and contents sometimes suffered. Figure 3 represents a typical building of this type. Two or three buildings with little bracing lost most of their glass. Almost invariably damage was most evident to the narrow elevations regardless of orientation. Broad buildings were seldom damaged on either elevation so that there is little to suggest that increased stiffness and shorter periods induced greater accelerations. Damage was also evident at the junctions of wings in most U shaped and L shaped buildings.
