FOUNDATION FAILURES DURING THE COATZACOALCOS (MEXICO)
EARTHQUAKE OF 26 AUGUST 1959

Roger Diaz de Cossio[†]

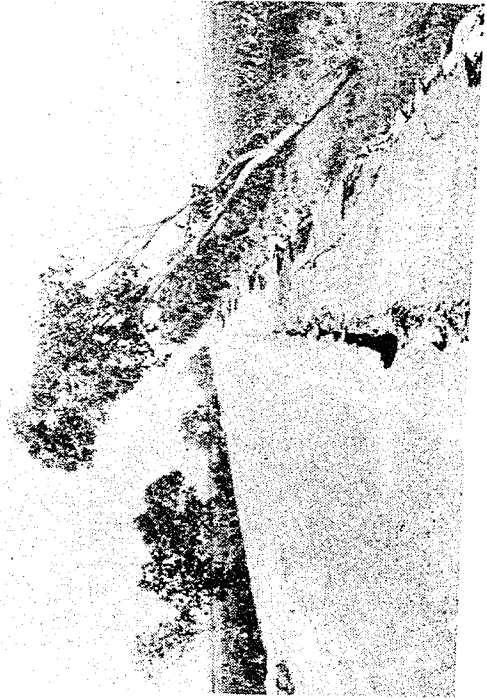
FIG. 12. HIGHWAY BETWEEN MINATTLAN AND COATZACOALCOS

Figure 12 shows a portion of the Minatitlán-Coatzacoalcos Highway, 15 Km from Coatzacoalcos. This highway is built on marshy ground. The shock waves traveling through the marsh had their maximum effect on this very stiff strip, as compared to the adjacent ground. The settlement of the crown, and the lateral displacement of the shoulders of the

road can be seen in the figure. Large longitudinal cracks formed along the highway. Fig. 13 shows another portion of it just outside Coatzacoalcos. The bridge in the background is one of the entrance bridges into town. Heavy cracking can be observed in the highway, as well as settlement of the highway relative to the bridge. The bridge is founded on piles that rest on a consolidated layer of soil, about 20 m deep, and did not suffer any structural damage. It should be noted that the railings on the bridge were originally inclined.

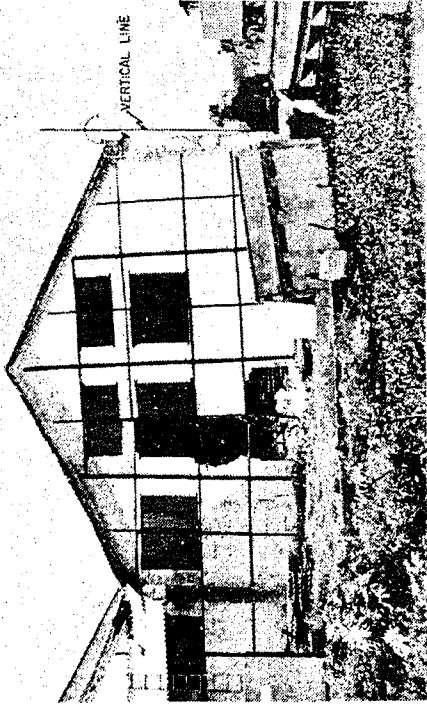
Fig. 14. WAREHOUSE NO. 2. FREE PORT ZONE IN COATZACOALCOS

Figures 14 and 15 are from the free port zone of Coatzacoalcos. All the warehouses, piers, and docks suffered severe damages. Fig. 14 is a photograph of Warehouse No. 2. The Coatzacoalcos River is on the right. The vertical settlement and large horizontal movement of the warehouse can be clearly noted. Fig. 15 shows a sectioned dock with a railroad track. The rails were displaced about one meter with respect to each other. The very large movements of structures in this zone can only be explained by large movements of the subsoil.

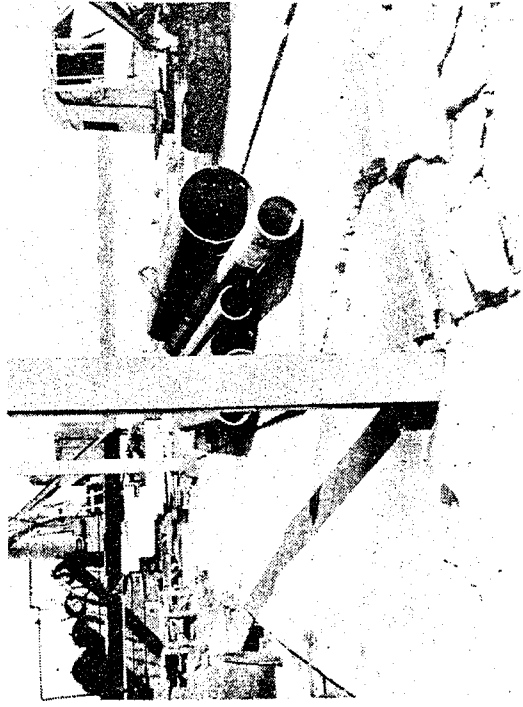
Fig. 16. SHIPYARD INSTALLATIONS OF THE MINISTRY OF THE NAVY IN COATZACOALCOS

Figures 16 and 17 show two aspects of the shipyards of the Ministry of the Navy installations at Coatzacoalcos. The large settlements of the columns can be clearly seen in the photographs. Fig. 17 shows that the column settled about 0.8 m with respect to the floor slab. Also from the Ministry of the Navy installations are the two photographs of a repair shop that settled about 1 meter (Figs. 18 and 19). The Coatzacoalcos River is in the background of Fig. 18. The top portion of the repair shop is shown in Fig. 19. Cracking in the bricks and beams is obviously due to a sudden settlement, and not to horizontal acceleration.
