KAPKOTE EARTHQUAKE OF
DEC. 28, 1958

Earthquake Engineering School,
University of Roorkee*

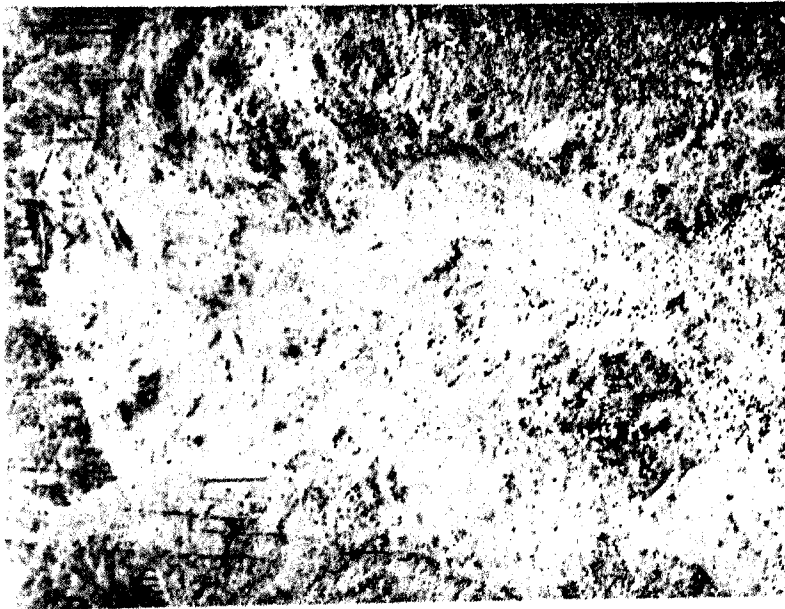
Photo. 1 Landslide

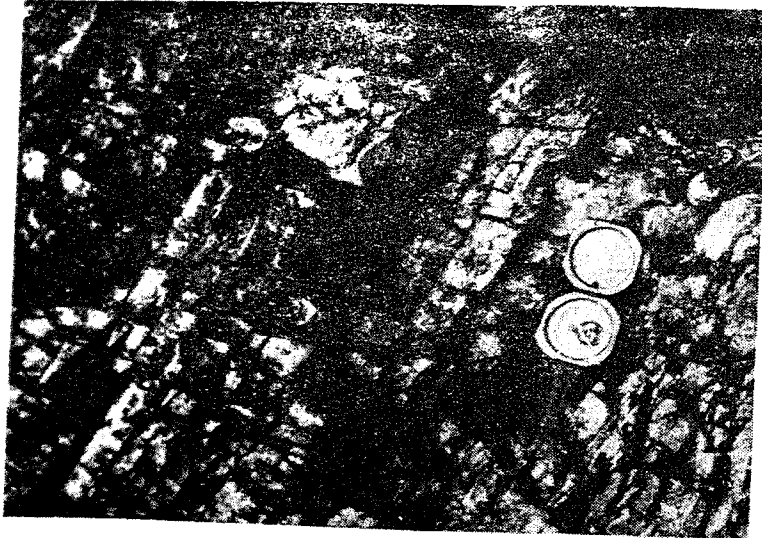
Photo. 3 Highly Jointed Rock

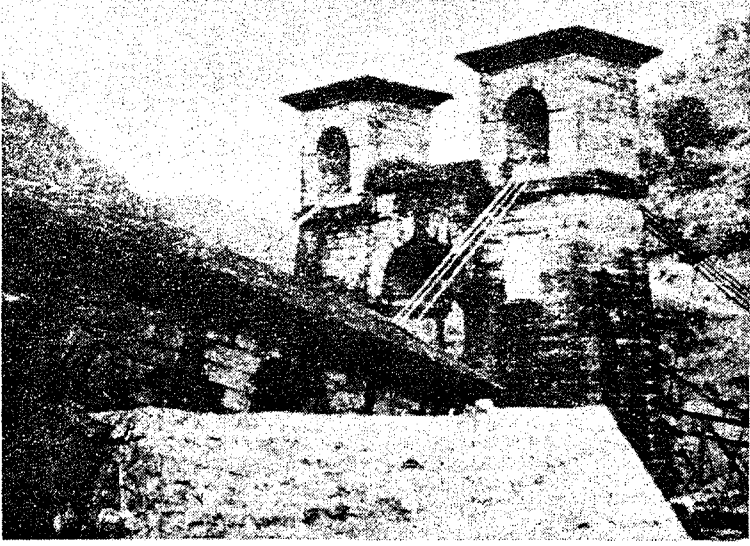
Photo. 5 Damaged Bridge

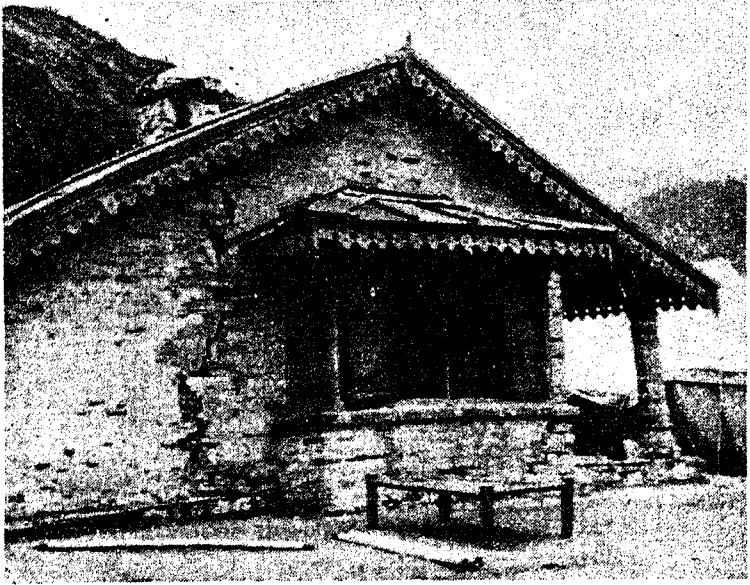
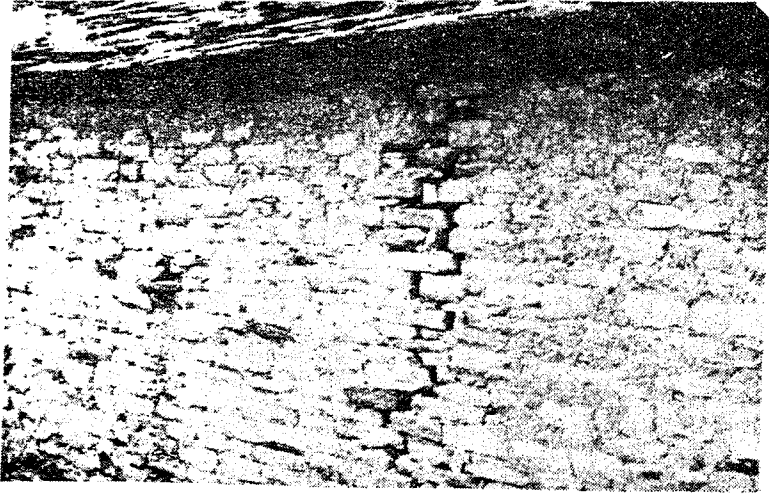
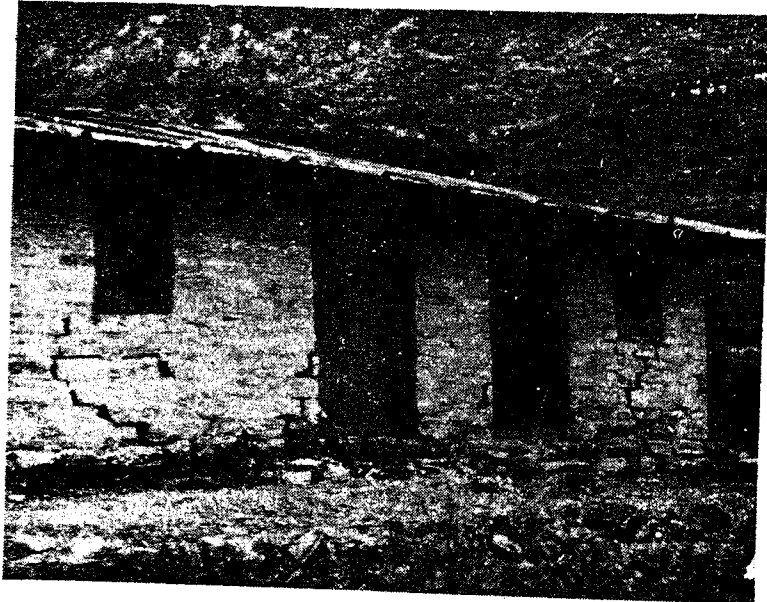
- (i) In areas like Loharkhet and Hatsila, the shock aggravated the unstable conditions of the hill side caused by scouring action of the stream and even better constructed buildings were damaged. The subsidence combined with earthquake forces caused the buildings to be split vertically (Photo 6, 7 & 8).

Photo. 6 Damage due to Sinking

Photo. 7 Damage due to Sinking

Photo. 8 Damage due to Sinking

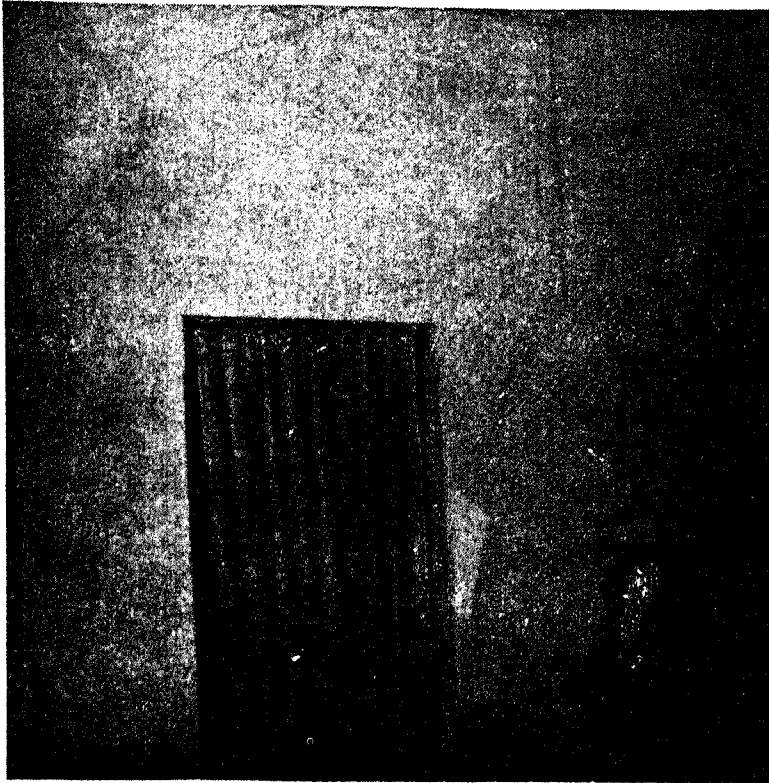
- (ii) In Kapkote, where the foundation is stable, the damage is only due to the earthquake. Buildings which were constructed on systematic courses of masonry in lime or cement mortar developed minor cracks (Photo 9). Walls constructed of irregular courses and in mud mortar collapsed completely (Photo 10). The mud mortar filling round the jambs of wooden lintels offered no resistance to twisting of lintels caused by waves travelling at an angle to the axis of the lintel and they twisted by 3° to 4° (Photo 11). There were diagonal cracks in the walls above lintels and combined with the action of twisting of the lintels, at places the whole filling above fell off (Photo-12).

Photo. 9 Wall Constructed Building
Little Damage

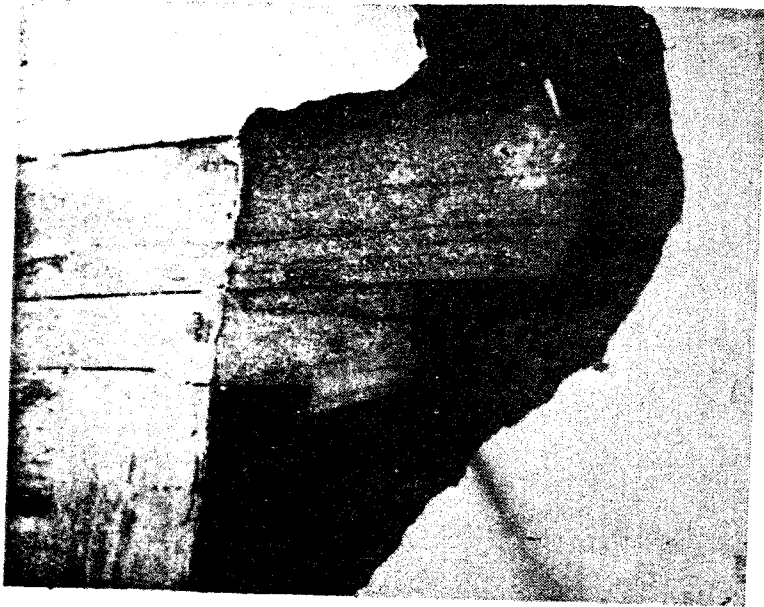
Photo. 11 Twisting of Lintel

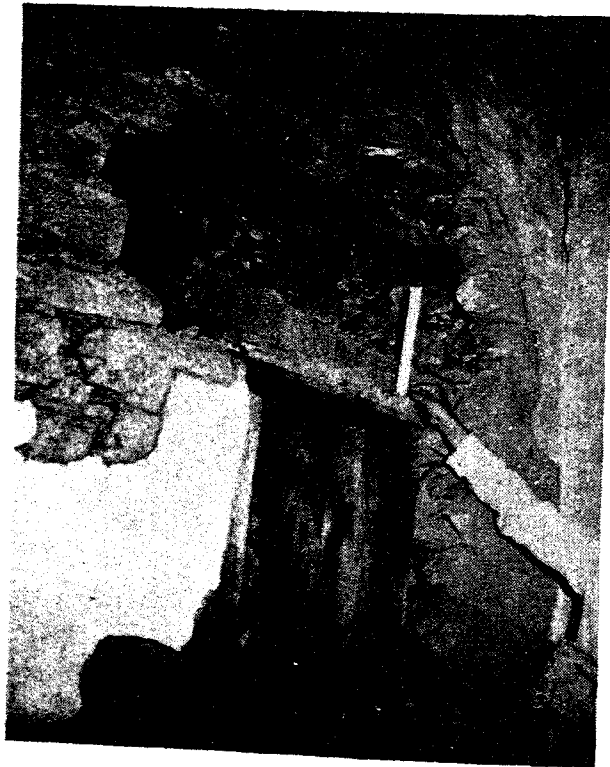
Photo. 12 Damage to Lintel
