THE AGADIR EARTHQUAKE OF FEBRUARY 29<sup>th</sup> 1960  
BEHAVIOUR OF MODERN BUILDINGS DURING THE EARTHQUAKE

J. DESPEYROUX

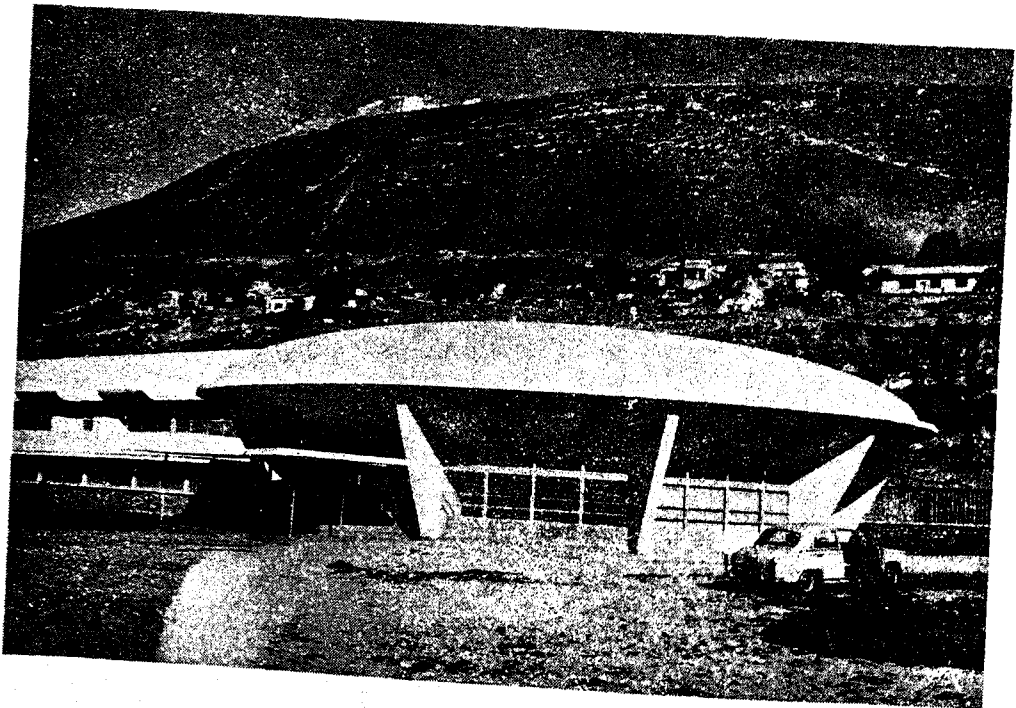
On the port platform, this construction is founded on 20 m long stakes, drawn in thin sand fills and the harbour slim, and anchored in the limestone. It is a reinforced concrete cupola, very thick, having a 24 m diameter, and weighing on its own 750 tons. Considering its foundations, its mass, and the position of its centre of gravity, this construction was very sensitive to the earthquake.

Yet, it had been well projected. Its transversal stability under the wind pressure had been the object of a serious design. It is the reason of its solidity. The only important damage is a crack at the foot of a column but it is not dangerous and may be easily repaired. The crevice in the ground which can be seen on the annexed photography gives an idea of the shock it has undergone.

Fig. I-2 Customs House.

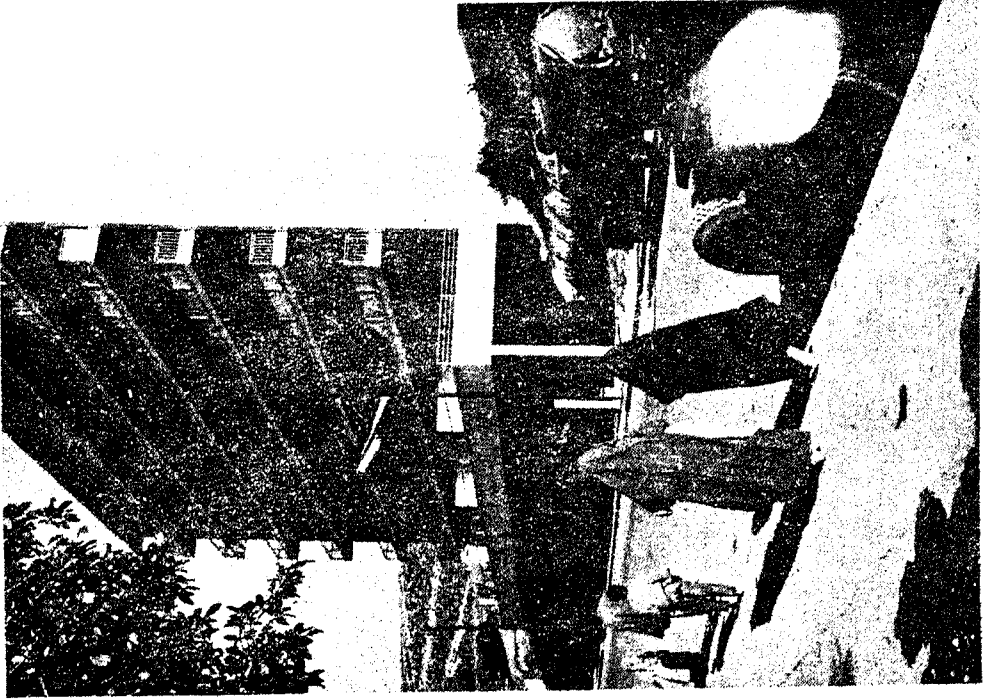
This Sea Front building has been founded on isolated blocks and on a slightly calcareous marl. Its reinforced concrete skeleton has been calculated only under wind pressure, but the design has been made correctly. The building has admirably been through the shock and damages are rather unimportant. It is interesting to notice that two columns in the ground floor have cracked under bending stresses, without anything grave resulting from the construction, and their examination shows they must have been very close to yielding point. This circumstance makes it possible to estimate the fictitious static horizontal effort capable of producing that result. Unfortunately, the direction of this effort is not well known ; This leads to a certain lack of precision in computations. We can thus find that it looks as if the building were under the action of an horizontal acceleration between  $g/12$  and  $g/10$ .

Fig. I-4 Eight stories building on Avenue de la République.

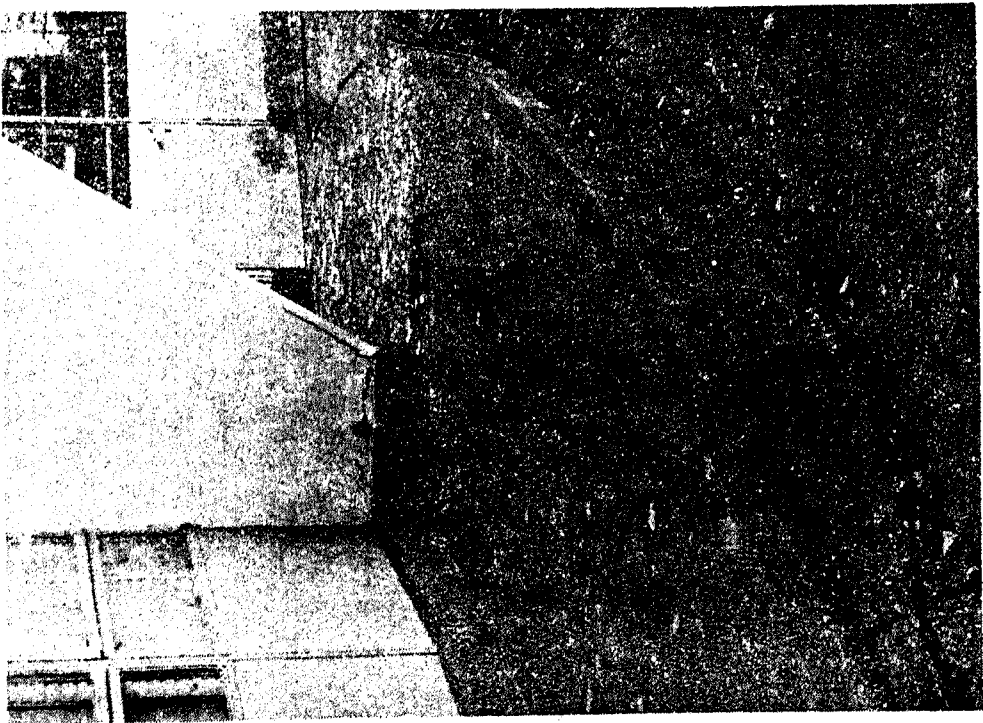
Fig. I-3 Customs House.

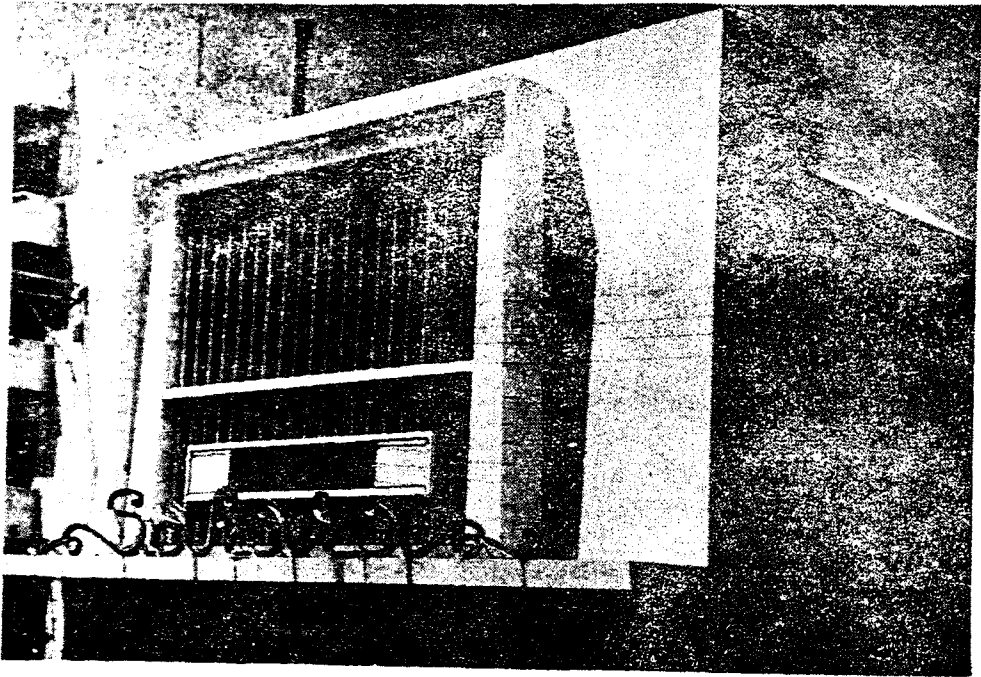
This construction is the only one in Talbordjt for which the builders have asked the co-operation of a technical control organism. It also is among the very scarce buildings remained upright and has had no serious damages.

Its hanging-over balcony has resisted very well to seismic efforts though it were loaded by a numerous crowd when the earthquake happened. No other building regulations than normal ones had been applied.

Fig. II-1 Sahra Cinema in Talbordjt.

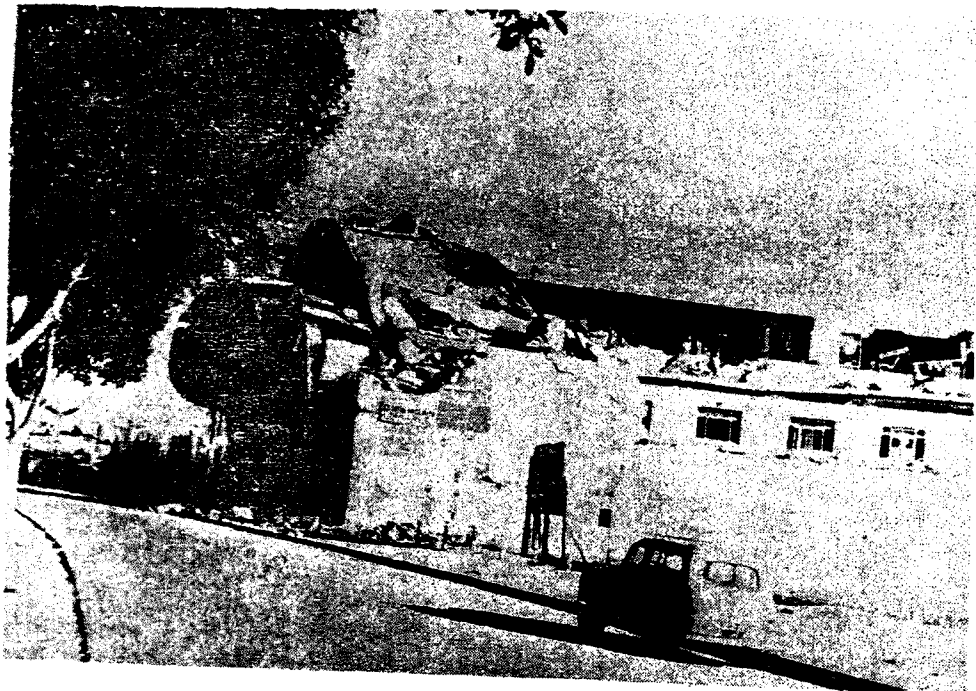
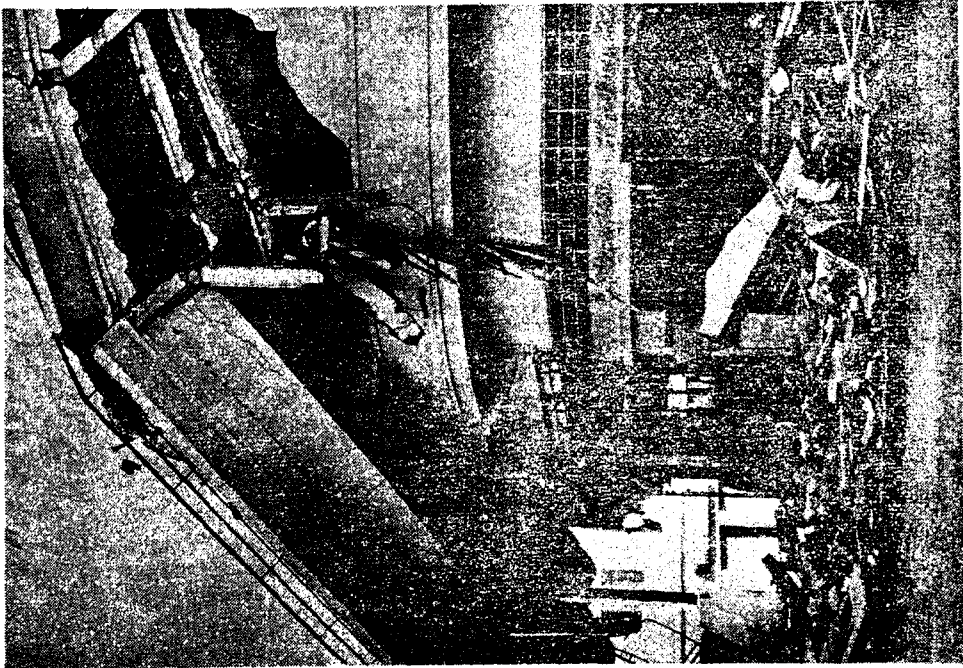
That New Town building had two square parts forming an L. The joining of the two branches was constituted by a great rounding. From the first floor the façades overhung, but in the curve the jutting almost reached 3 m.

Those brackets were designed for normal vertical loads but not for dynamic efforts due to an occasional earthquake. In its fall, the rounding pulled on the façades, causing their translation. In spite of this severe treatment, the building has not completely collapsed.

Fig. II-2 South Building.

Fig. II-3 South Building.

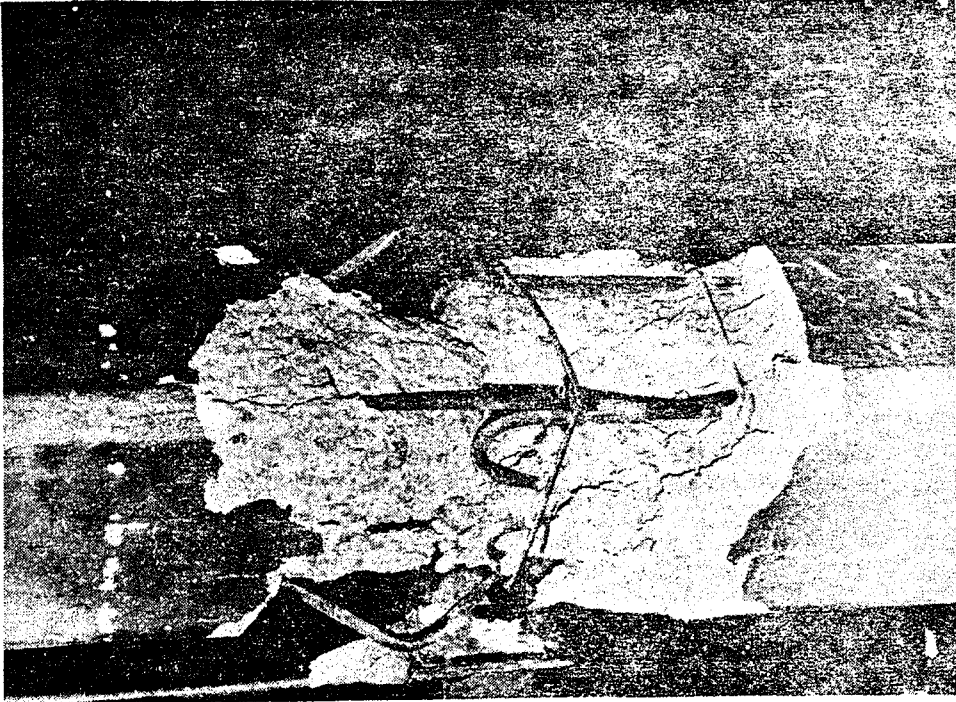
- Insufficient anchoring of longitudinal reinforcement in beams or even in columns with as a consequence the disorganisation of joints.
- Absence or too great spacing of transversal reinforcements, in the columns, with as a consequence the buckling of longitudinal reinforcements.
- Existence of hooks in the columns reinforcements, with as a consequence the splintering of the concrete and even the rupture of the column.
- Absence or insufficiency of upper reinforcements in support zones.

Fig. III-3 Example of rupture in a column caused by reinforcement hooks.

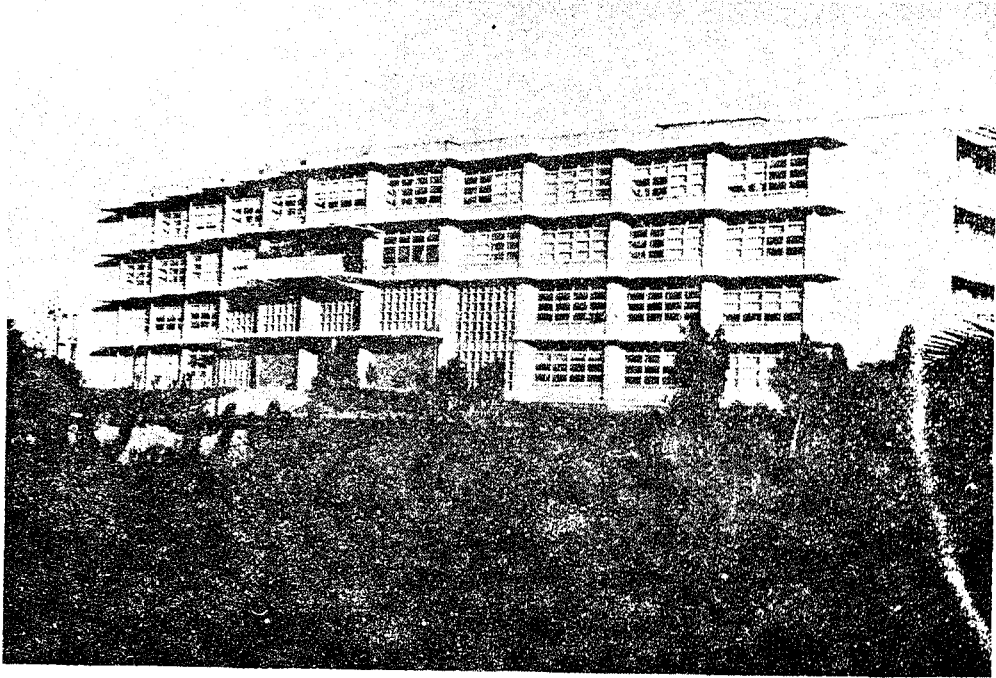
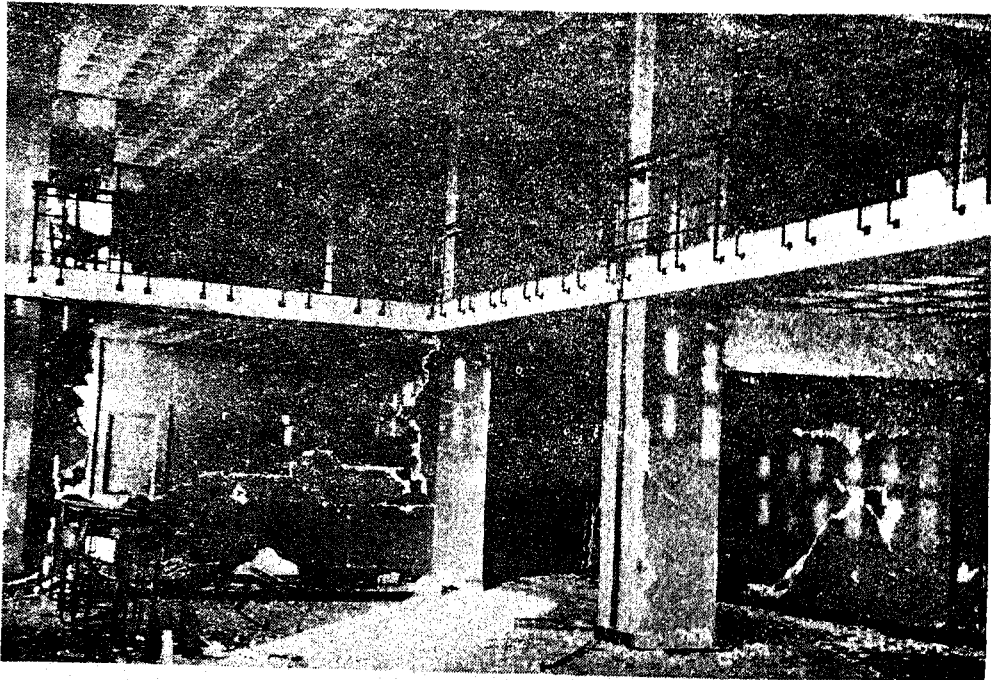
That nice building has also resisted and its exterior aspect is undamaged. Yet there are damages inside where many partitions have broken. The framework itself has cracks.

The causes of this less good behaviour are to be found in the skeleton, which was very well designed and capable of supporting great efforts, but which was precisely very rigid. In fact, the columns had outstretched sections giving them a great inertia. Pre-existing statically indetermined efforts were very important and internal stresses have been liberated by the shock. Moreover, the deformation energy accumulated in the skeleton during the earthquake must have been brutally restituted to the prejudice of the partitions.

Fig. II-4 Town Hall (Outside)

Fig. II-4 Town Hall (Inside)

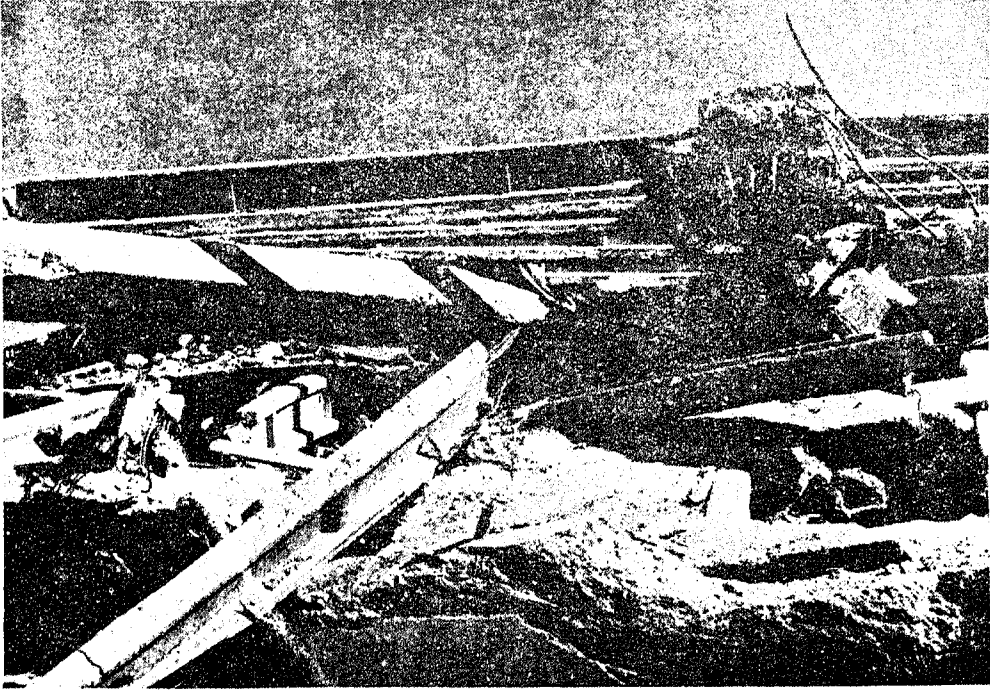
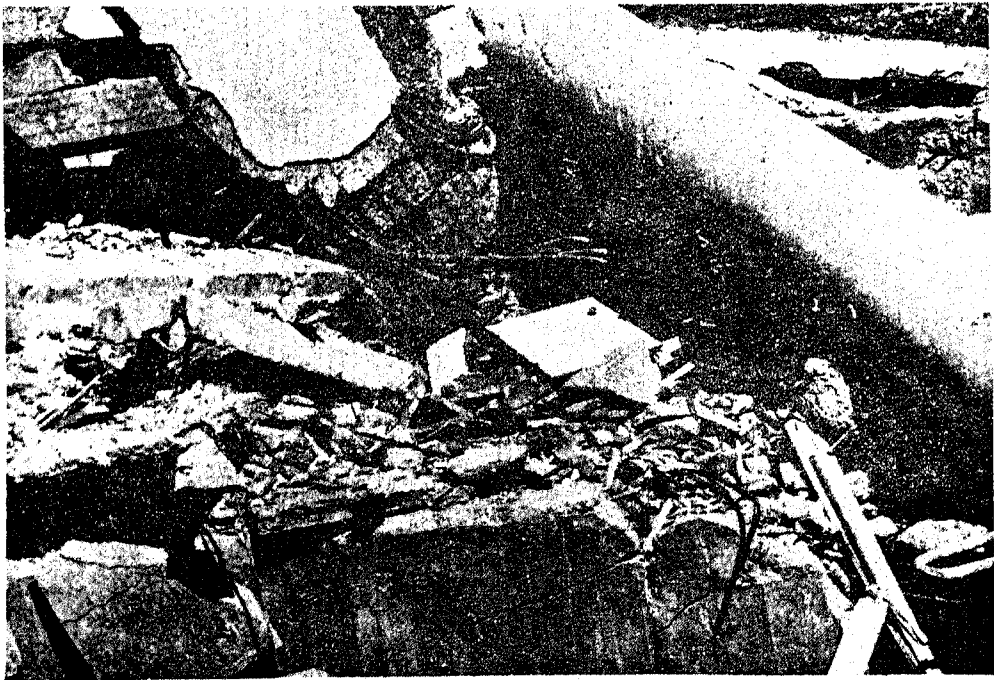
This seven stories building sheltered the Chamber of Commerce offices. It had a reinforced concrete framework made of longitudinal porticoes by which were supported the precast reinforced concrete joist floors. There were no transversal beams, the floor had no concrete slab on the joists. The circular shape of the columns did not allow them to equilibrate important hendings. Because of this design, the structure could not resist to important transversal forces.

Beams were computed with wrong hypothesis concerning the distribution of bending moments between supports and spans, so that reinforcements were insufficient in supports zones and important in the middle of the beams.

At last, reinforcements were not well placed. In the columns, they were too close to the center and thus were practically inefficient. In the joints beams-columns they formed dense panels and did not allow a correct casing by concrete which had moreover a bad adhesion force.

The design far too non-traditional of the structure is enough to explain the bad behaviour of the building. The irregularities in the project and the realization have evidently made the danger more grave.

Let us notice finally that the absence of slab on top of the joists has much contributed in making the collapse terribly murderous because the lack of monolithism has permitted to each joist to act independently. This design is not forbidden by normal regulations but it is very rightly that antiseismic regulations proscribe it.

Fig. III-1 Consular Building. Example of defective technical disposals.

Fig. III-2 Consular Building. Example of defective technical disposals.

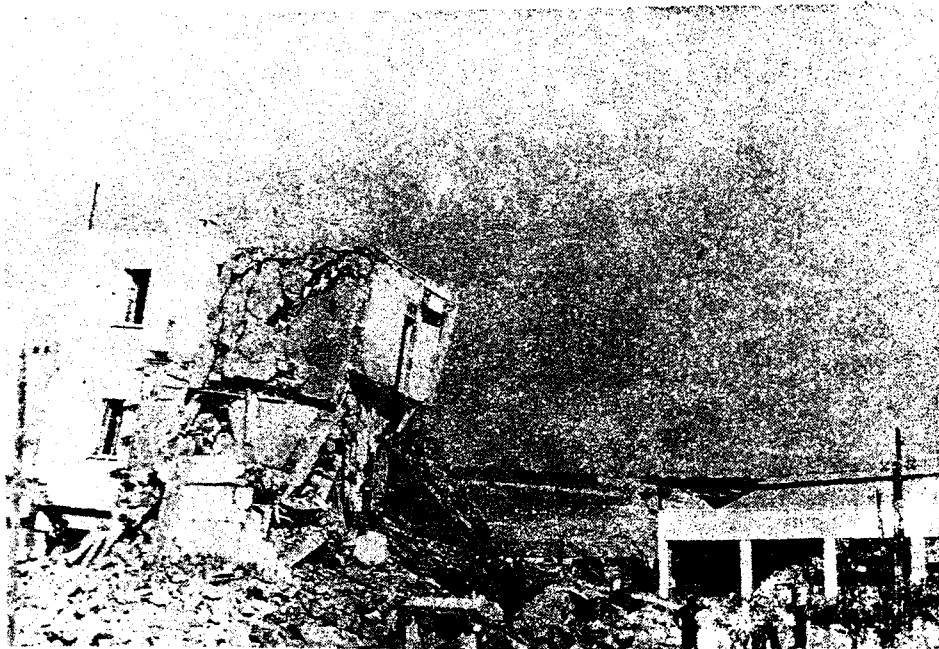
Fig. III-4 Example of mediocre building in the New Town.
