BEHAVIOUR OF A STEEL PLANT UNDER MAJOR EARTHQUAKES

S Y N O P S I S

This paper refers to the effects of the earthquakes of May 21st and 22nd, 1960, on the installations and facilities of an integrated Steel Plant owned and operated by Compañía de Acero del Pacífico, CAP, at Huachipato, San Vicente Bay, 10 miles West of Concepción, Chile.

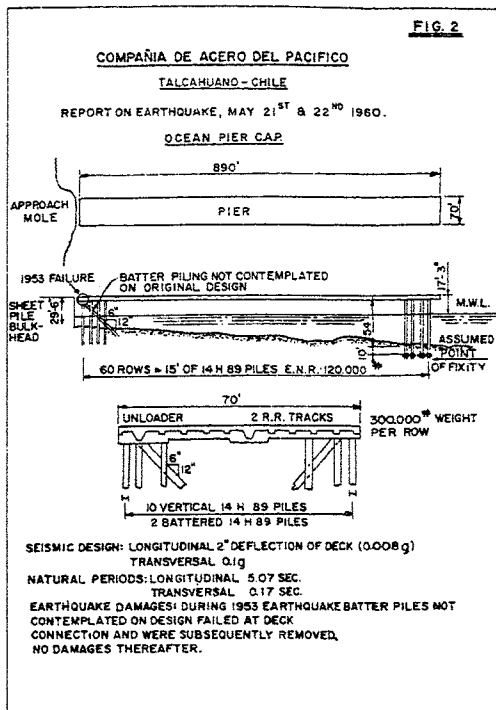
Fig. 2 Pier

The pier has not suffered in any of the earthquakes of 1953 and 1960, except for the cutting of rails at the approach mole, and damages to some unconsulted piles at the shore end. (Fig. 2).

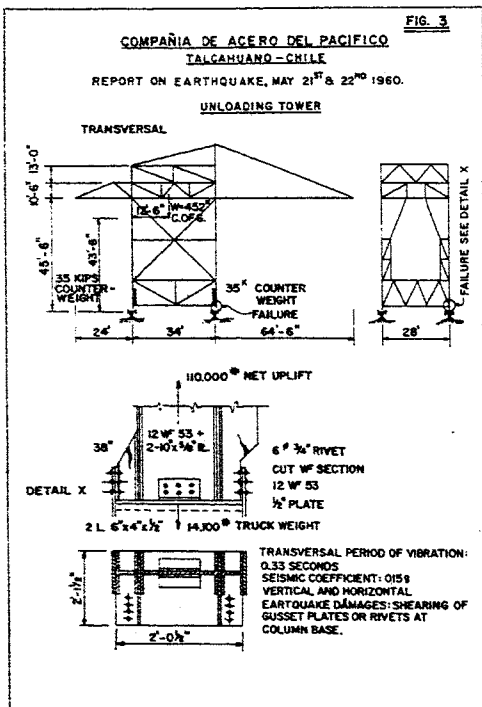
Fig. 3 Unloading Tower

The earthquake of May 21st, 1960 caused the failure of connections between the main columns and wheel trucks of the ore unloader, as illustrated in Fig. 3 and 4. At the time of the earthquake the tower was not in operation and the bucket had been removed for repairs.

The structure was designed for seismic coefficients of 0.15 g both vertically and horizontally, and 35,000 lbs. concrete counterweights were provided to avoid overturning. Natural period of vibration was computed at 0.33 sec. in a transversal direction.

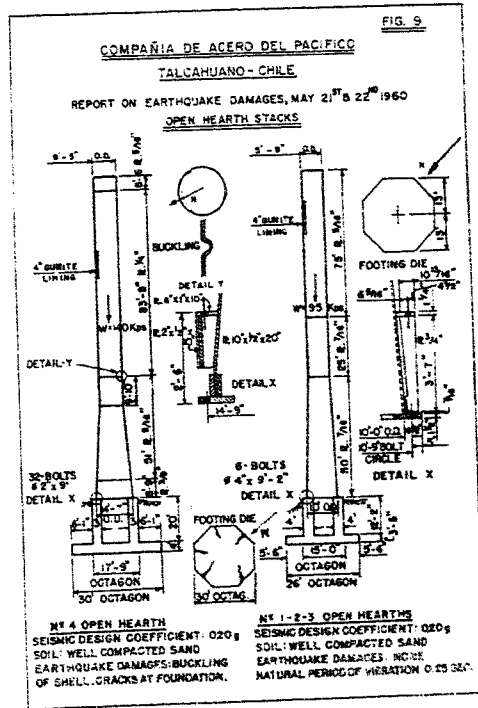
Fig. 9 Open Hearth Stacks

During the May earthquakes the most common failure was buckling of the shell plate, at the second ring over the tapered section, accompanied by vertical cracks in the concrete footings, both on the northern and southern faces (Figs. 9, 10 and 11). The above type of failure was noted on two of the old (pre-1957) and both of the new stacks. Other defects were: failure of anchor bolt connections (in two cases) and opening of the girth weld by tension, opposite a buckle (one case).

It is interesting to note that most failures occurred as a result of the May 21st earthquake. The second shock, on May 22nd, did little additional damage, even though the stacks had their anchor bolts loose, one of them was out of plumb, and buckled shells had not been repaired.

A description of structural properties and damages of some of the stacks is given in Figs. 9 and 10.

Failures of the stacks are attributed to two main causes: inadequate methods of seismic design and unreliability of formulas used to determine buckling strength of the shells.

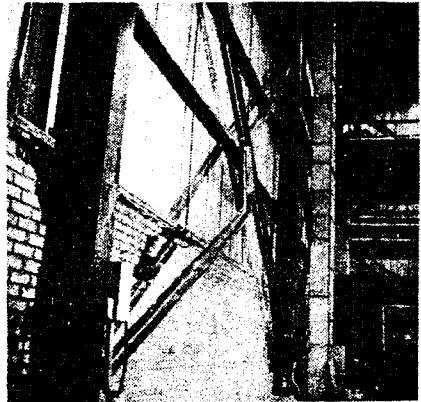
Fig. 15 Mill Buildings - Diagonal Bracing

- c). Failure of bracing at front walls. Bracing was generously provided on front walls, both to furnish lateral supports to columns and to obtain additional strength at low cost. The wall was thus converted into a plane of much higher rigidity than the frames and, because of the effect of roof bracing which acts in a manner similar to a slab, it took earthquake forces for which it had not been designed. Collapse of the diagonals is shown in Fig. 15.

- e). The use of tension diagonals should be avoided, unless means are provided to furnish initial stresses.
- d). Close attention should be given to details. The possibility of forces acting in any direction must be considered and strength provided accordingly. In Figs. 17 and 18 some recommended details are suggested.
- e). Anchor bolts are up to yield, and details should be such that an appreciable length of the bolt is visible, out of the foundation, in order to allow the possibility of tightening and locating failures.
- f). Columns should probably be welded or riveted to the base plates, and these anchored to the foundations with ribs or any other suitable means. In any event, base connections must be designed to resist horizontal shears.

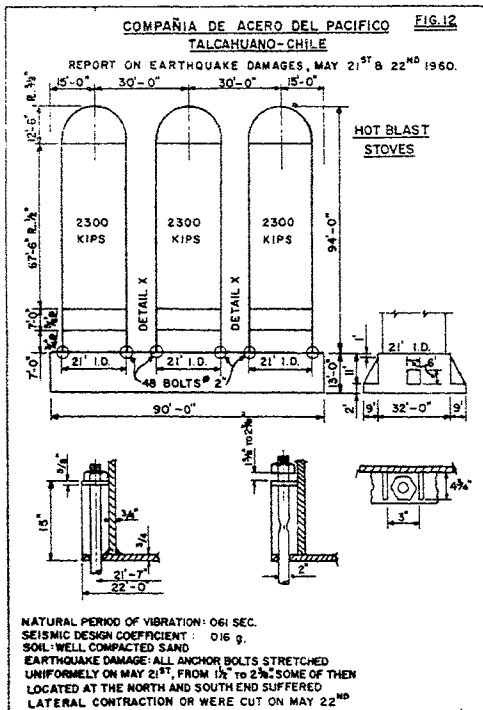
Fig. 12 Hot Blast Stoves

The earthquake of May 21st stretched all bolts in a more or less uni-

form pattern, from $1 \frac{3}{8}$ " to $2 \frac{3}{8}$ " and many of them showed signs of lateral contraction (Fig. 12). The second earthquake, the following day, worsened the condition and a few bolts were cut.

A rough computation, assuming uniform horizontal acceleration, indicates that static seismic factors of 0.3 g and 0.5 g are necessary to cause yield and rupture of the bolts.

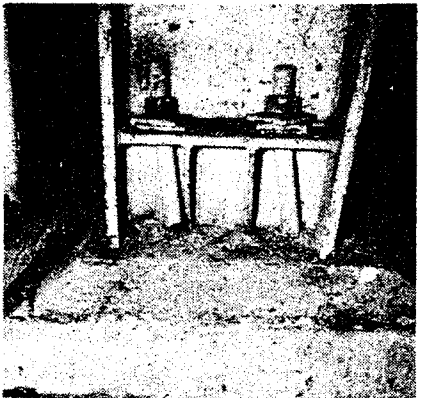
Fig. 16 Mill Buildings - Column Base

- f). Sliding of column base and bending of anchor bolts. Because of the large size of base plates, they were shipped loose to the field with no connection provided to the column. (Fig. 16). Friction and the bending strength of the bolts were not sufficient to resist horizontal shears, and the columns slid over the base plates as much as 2", deforming the anchor bolts.
