ENGINEERING ASPECTS OF CHILEAN EARTH-  
QUAKES OF MAY 21 AND 22 - 1960.

By RODRIGO FLORES A. (1)

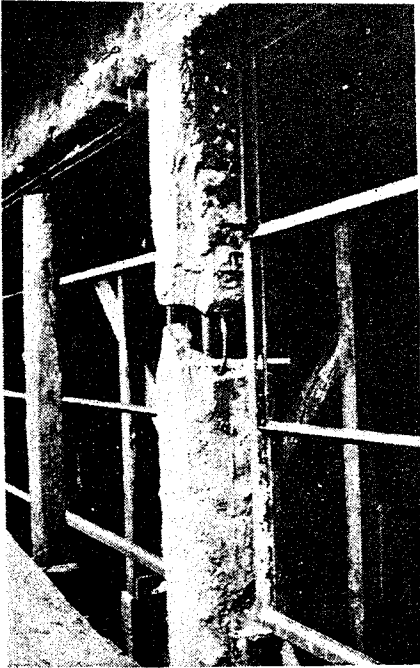
Fig. 1.11 School in Coronel. Two buildings 50 m. long each collided in third floor causing considerable structural damages.

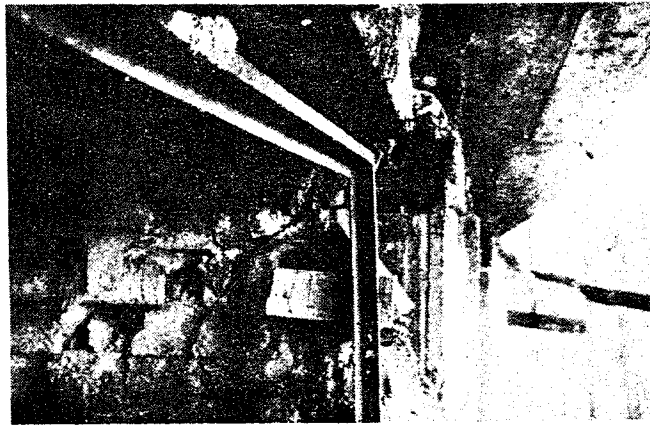
Fig. 1.12 Ditto. Broken wall and column are shown.

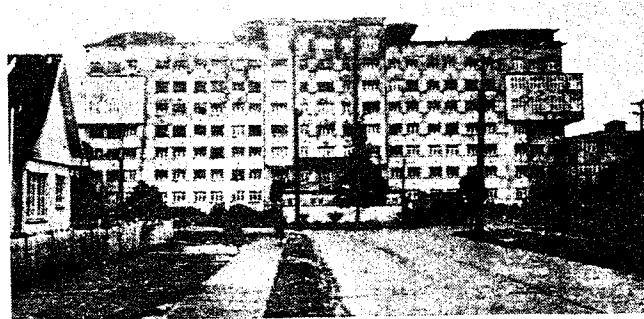
Fig. 1.14 Regional Hospital in Valdivia. General view.

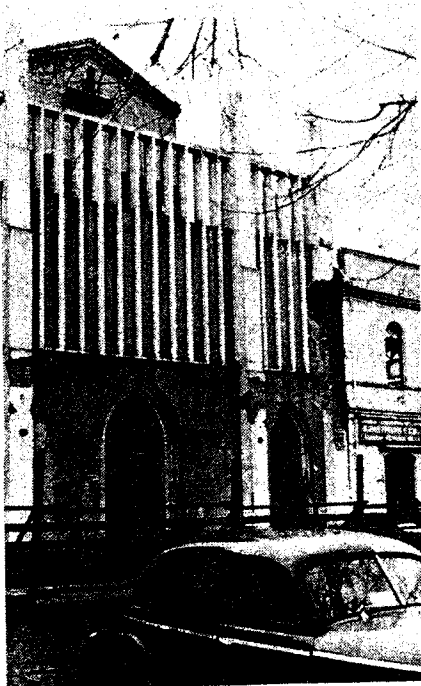
Fig. 1.13 Church in Valdivia. Unreinforced masonry wall destroyed by impact of adjacent buildings.

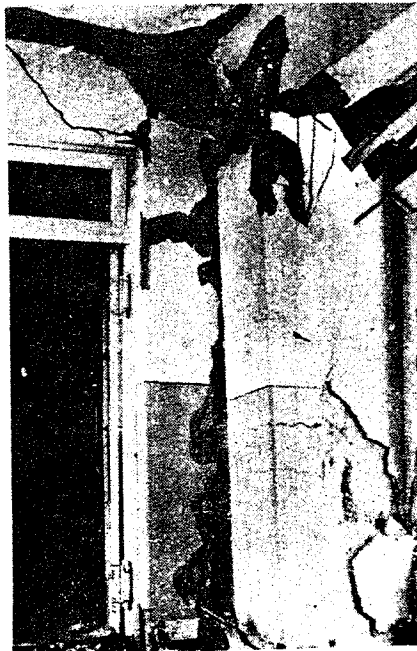
Fig. 1.15 Ditto. Collision between main building and central aisle (7th floor).

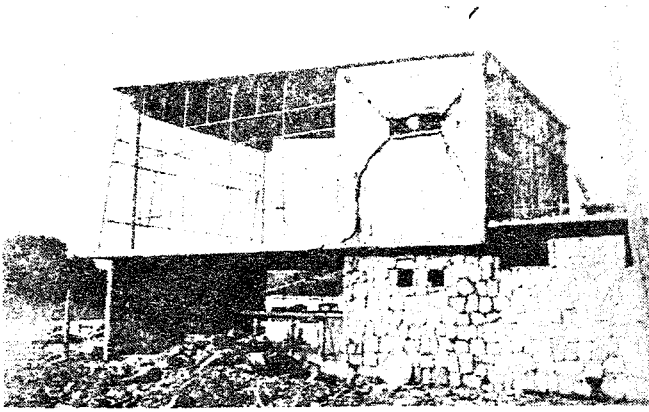
Fig. 1.21 Club in Concepción. Effect of horizontal torsion.

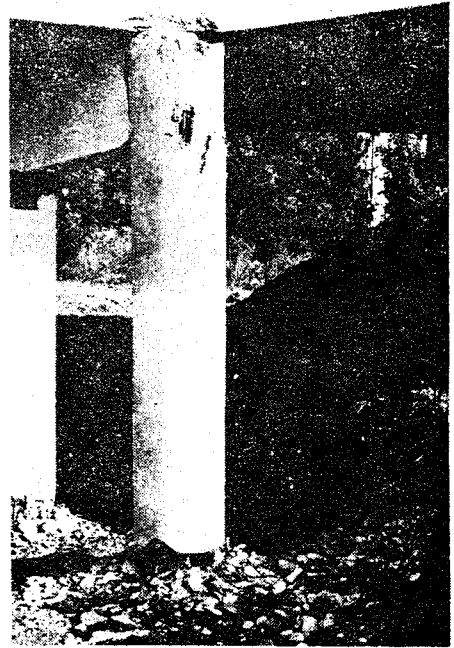
Fig. 1.23 Damage in upper and lower ends of central columns.

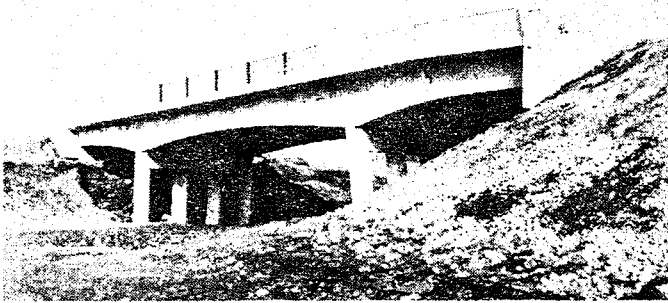
Fig. 1.22 Skew bridge near Osorno over Panamerican highway, Gerber type. The settlement of foreground abutment caused a horizontal torsion which destroyed upper and lower end of supporting columns. General view.

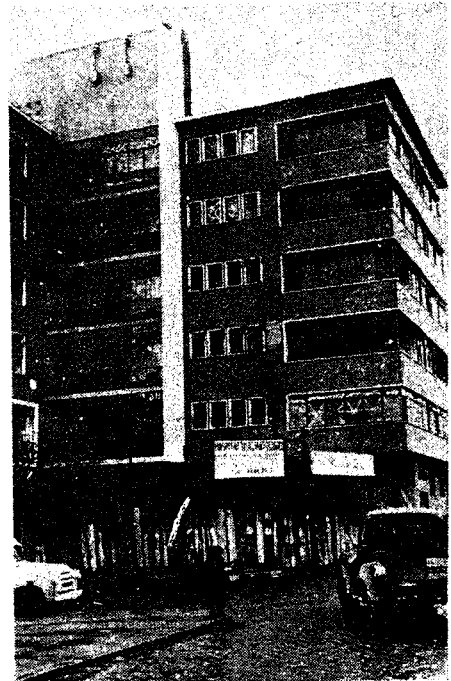
Fig. 1.25 Traumatological Hospital in Valdivia. Highly asymmetric disposition of supporting elements. General view.

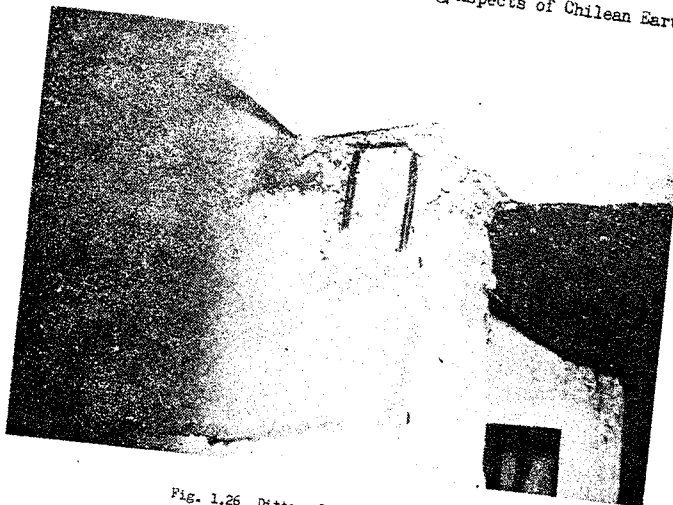
Fig. 1.26 Ditto. Column in first floor.

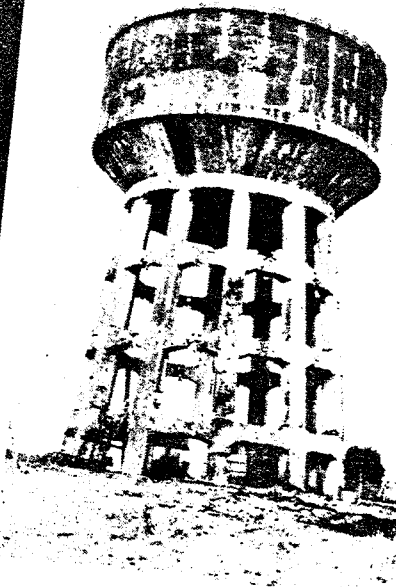
Fig. 1.31 water tank in Rio Negro. General view.

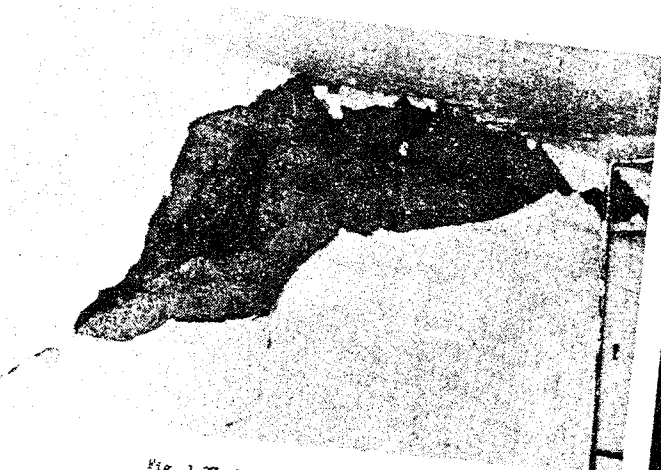
Fig. 1.27 Ditto. Shear cracks in reinforced concrete wall in first floor.

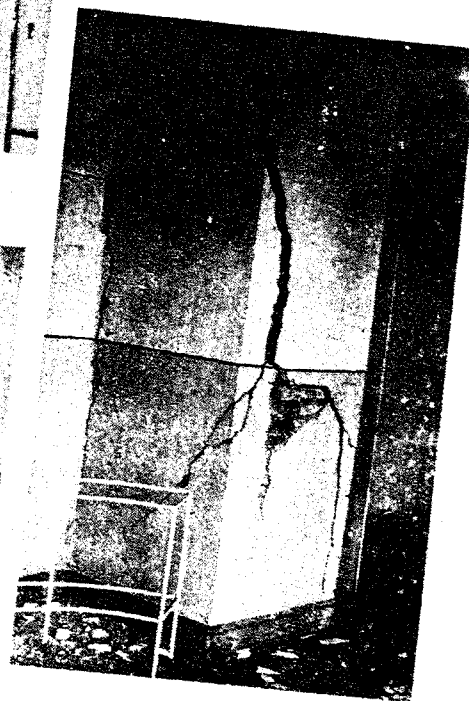
Fig. 1.35 Regional Hospital in Valdivia. Unreinforced masonry. Lack of anchorage to main structure.

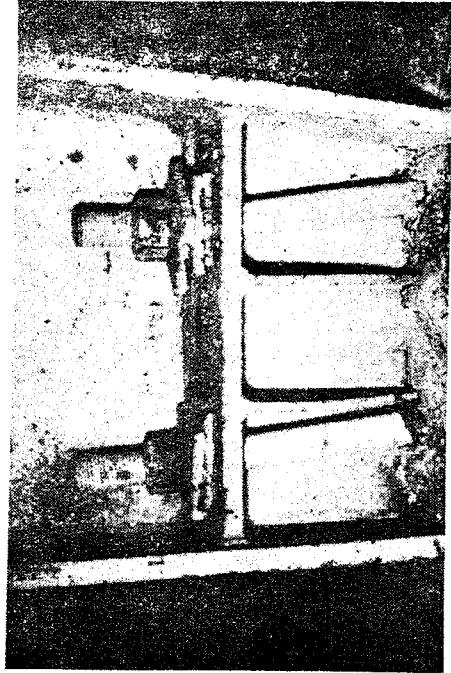
Fig. 1.37 Appreciable sliding between column and base plate.

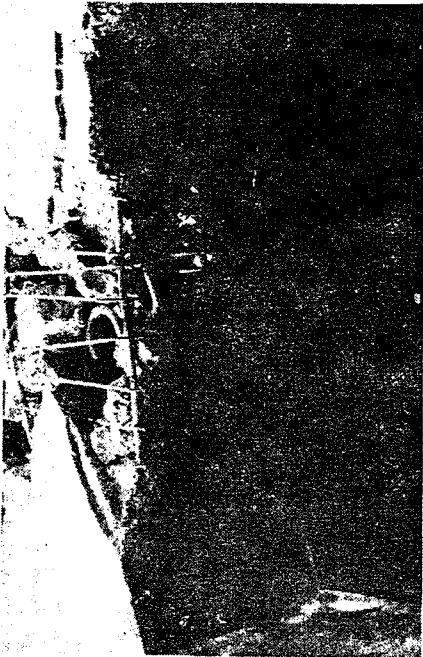
Fig. 1.33 Ditto, Observe the hooks ending at the same section and open stirrups.

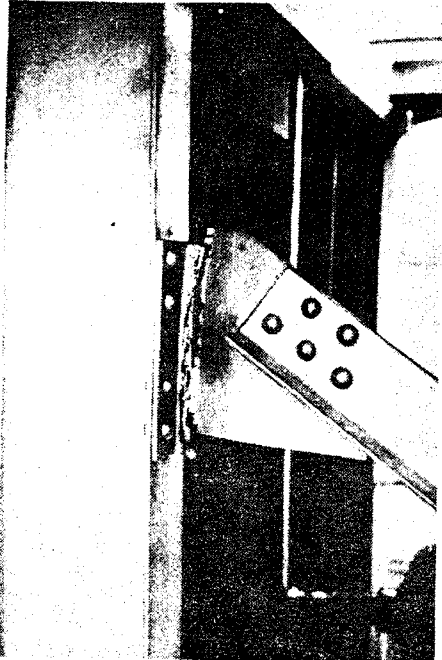
Fig. 1.36 Incorrect connection between beam and diagonal member.

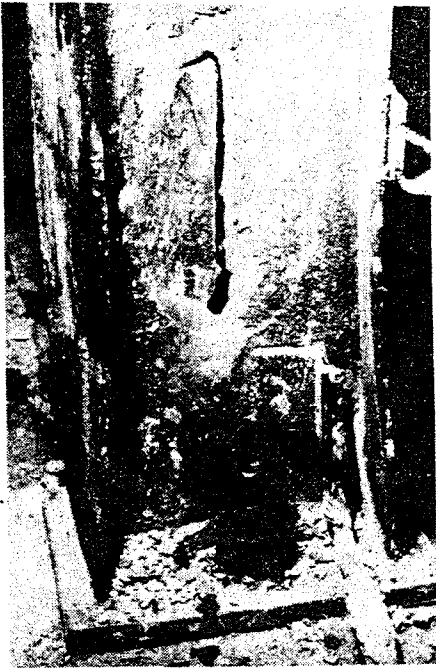
Fig. 1.38 Diagonal member torn out web of column which has no transversal rigidity.

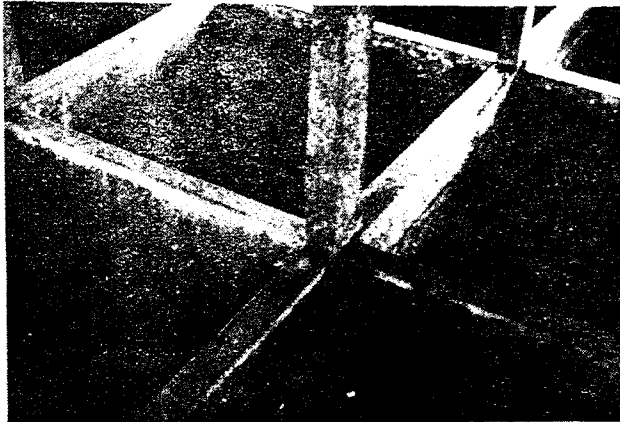
Fig. 1.42 Damage at base of roof columns.

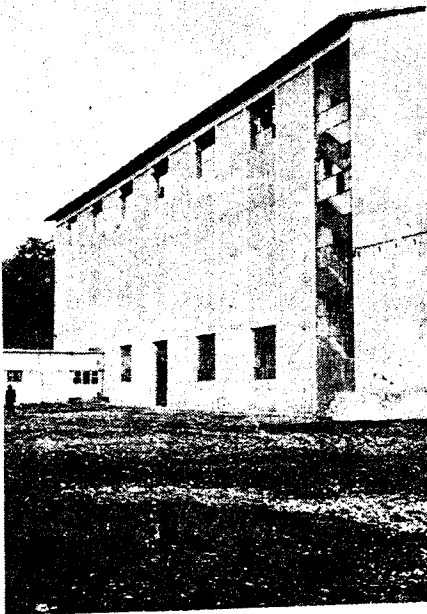
Fig. 1.41 Silos in Osorno. Main structure composed of silos of large lateral rigidity. Roof supported on top of silos through flexible columns. Reinforced staircase of less rigidity than main structure. Considerable damages at the level of top of the silos and in staircase. General view.

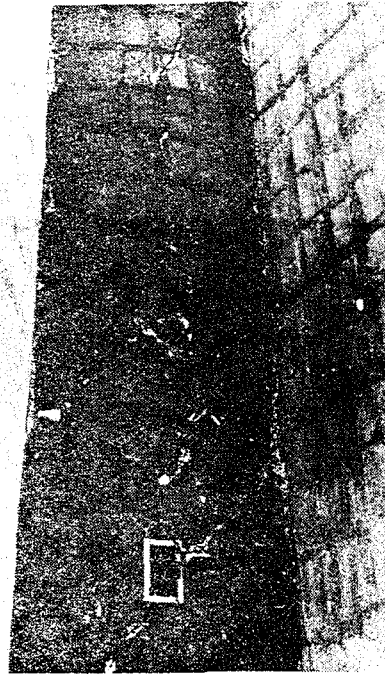
Fig. 1.46 Ditto. Damage in cylindrical  
ventel wall.

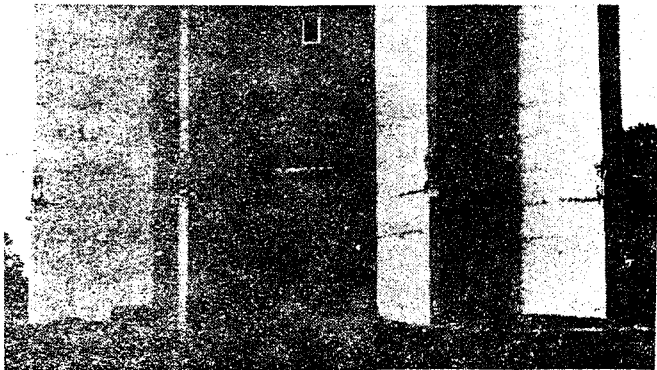
Fig. 1.48 Ditto. Damage in stiffening  
columns.

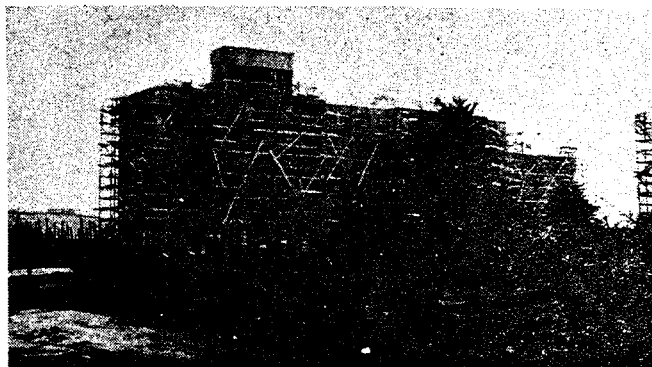
Fig. 1.51 Building development in Concepción. Reinforced concrete water tank supported by masonry wall. The walls collapsed partially. Reconstruction work is shown.

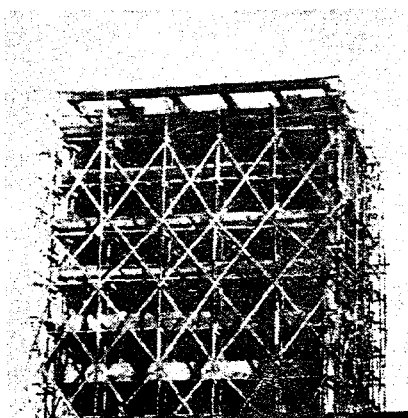
Fig. 1.52 Building in Osorno. Considerable damages on highly unsymmetrical top structure. General view.

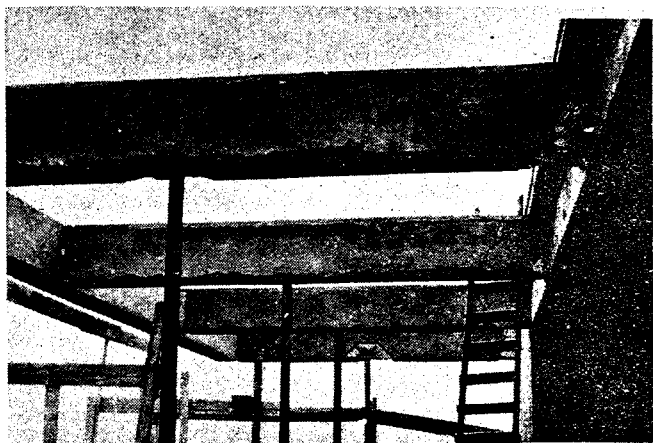
Fig. 1.53 Ditto. Overhanging top structure supported on steel pipe columns.

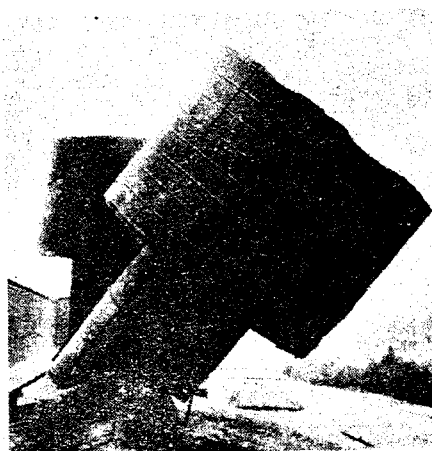
Fig. 1.55 Steel mill, Concepción. Light fan collapsed.

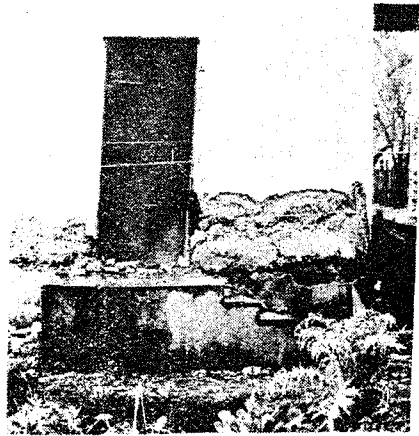
Fig. 1.62 Ditto. View of failure in construction joint.

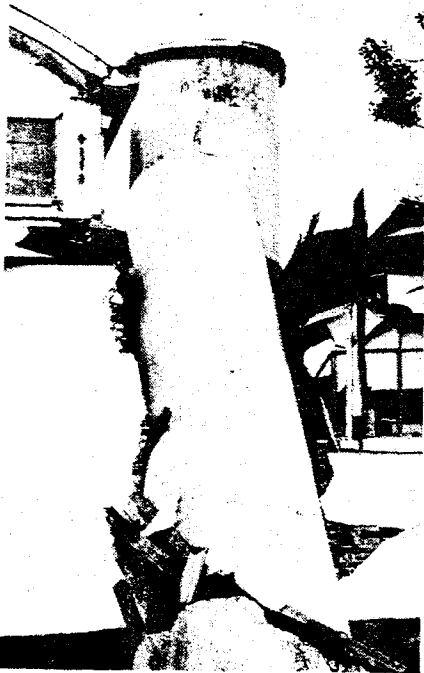
Fig. 1.64 Industrial Plant near Valdivia. Power Plant. Reinforced concrete chimney collapsed at construction joint.

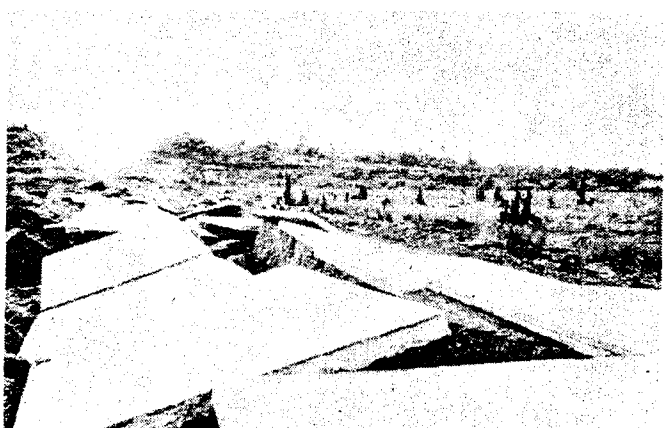
Fig. 1.71 Soil failure in highway connectin Puerto Montt and Puerto Varas. Loose fill over a swamp.

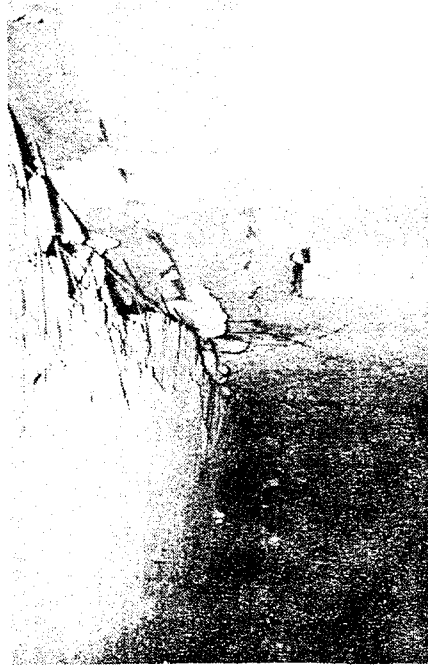
Fig. 1.75. Severe damage in basement ceiling.

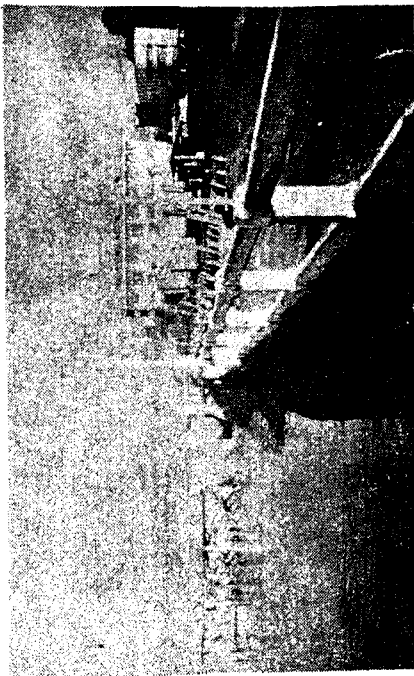
Fig. 1.72 Hotel Puerto Montt. Big sliding on the foundation toward the sea. General view.

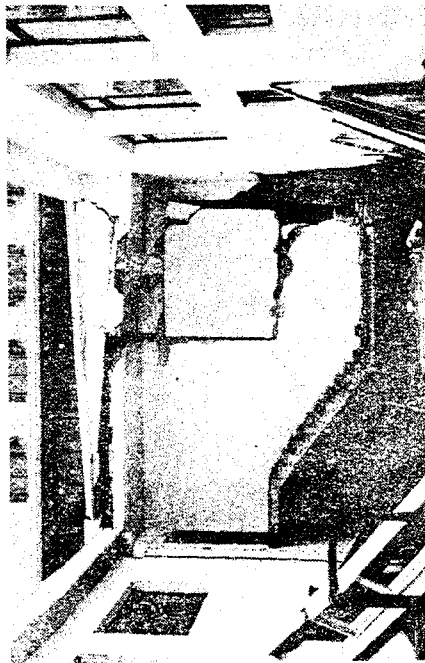
Fig. 1.74 Cracks on exterior masonry wall filling an ancient window.

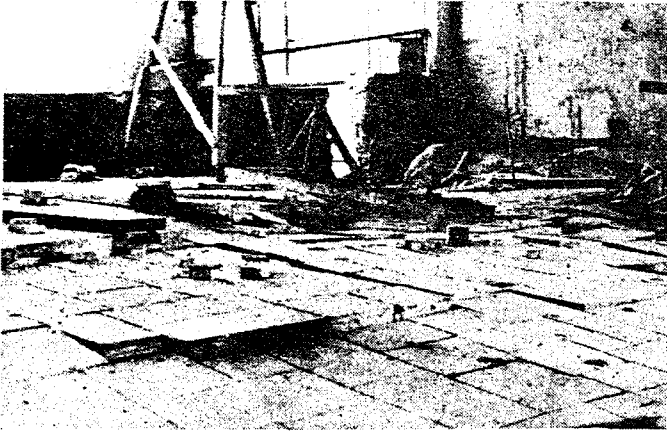
Fig. 1.76 Ditto. Interior view on first floor.

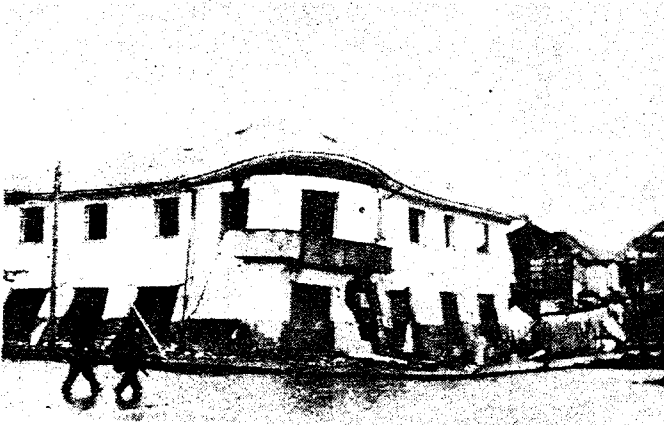
Fig. 1.77 Settlement of a house in Valdivia.

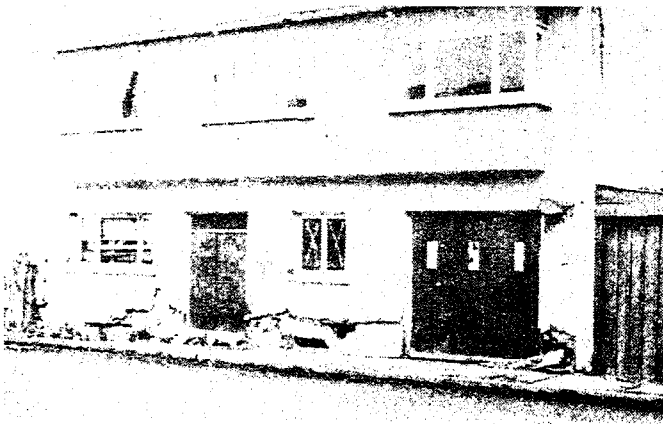
Fig. 1.78 House in Osorno. Settlement and sliding of soil foundation toward a small ravine.

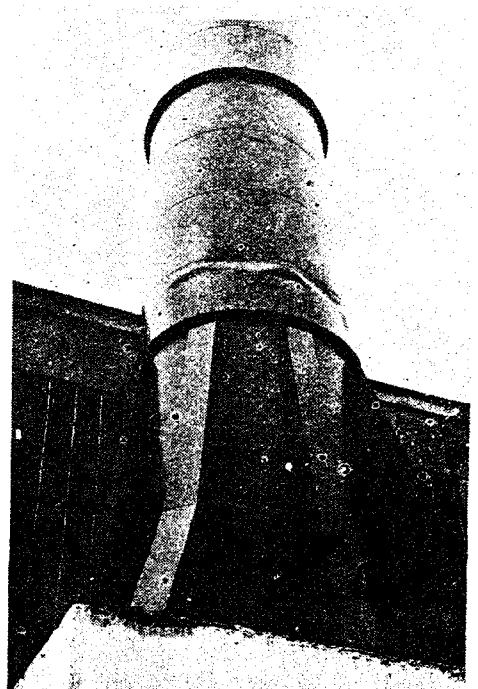
Fig. 1.81 Ilaquihue sugar Plant. Chimney in power house. Buckling of Steel mantel.

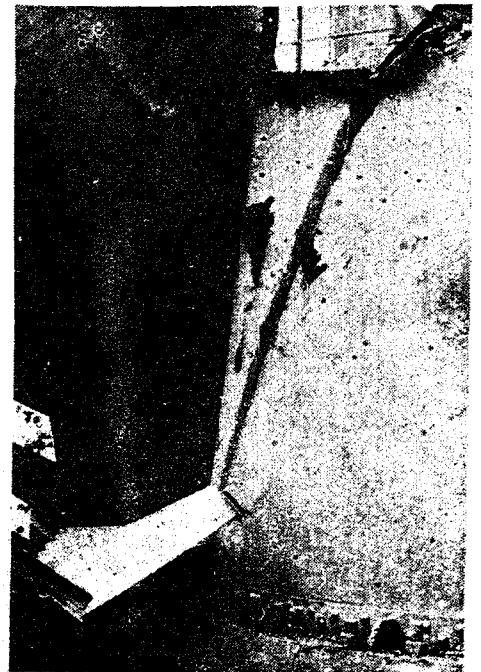
Fig. 1.83 Ditto. Close up of the failure zone.

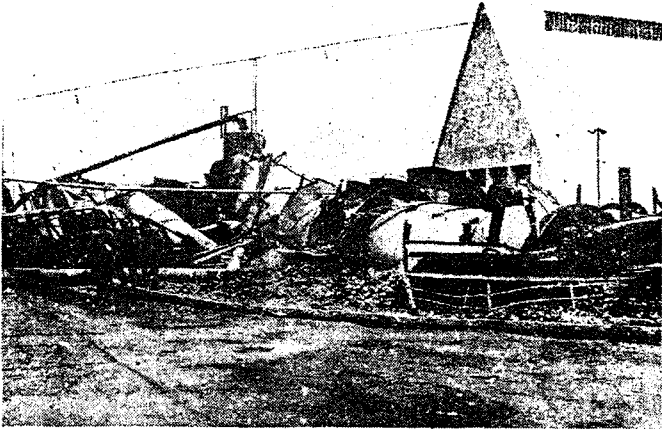
Fig. 1.82 Ilanquihue Sugar Plant. Limestone furnace. The 30 mts. high tower collapsed due to the failure of the first row of rivets.

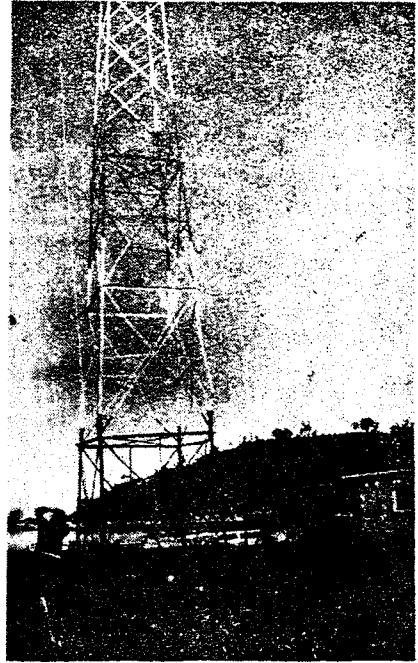
Fig. 1.84 Buckled member in steel structure.

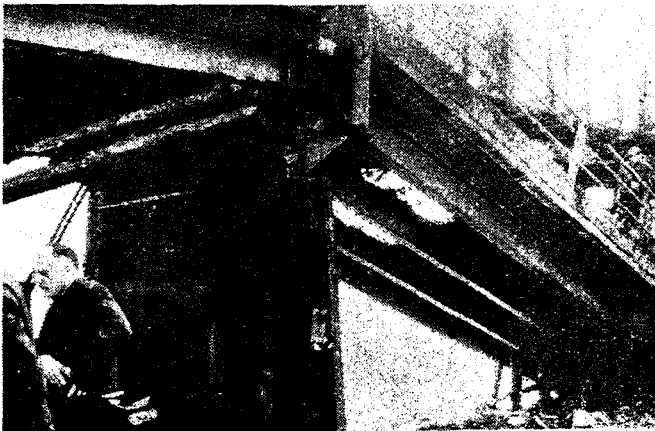
Fig. 1.87 Bridge over Bfo-Bfo. Lack of lateral resistance of piers.

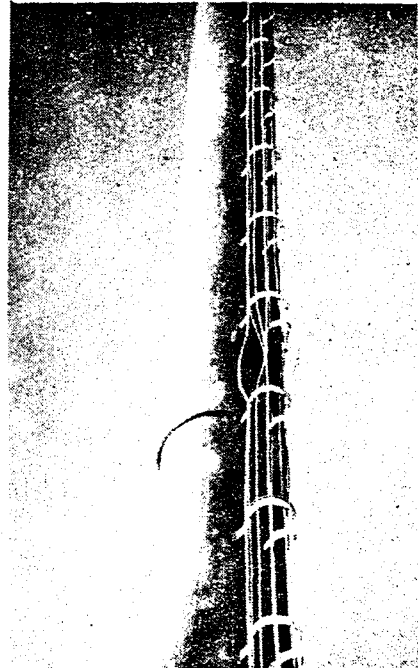
Fig. 1.86 Buckling of a chimney in steel mill in Concepción.

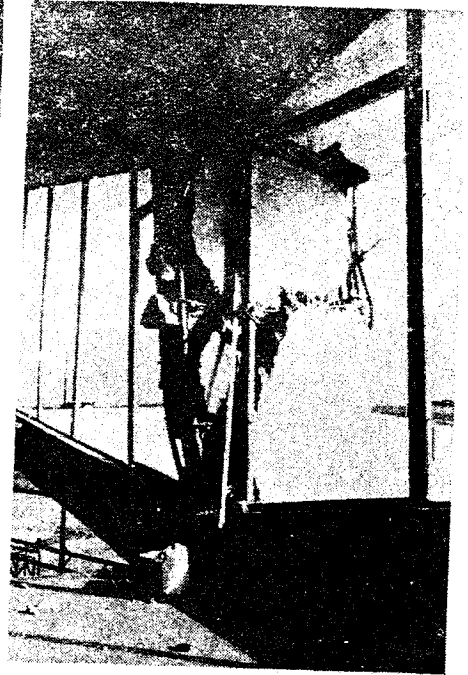
Fig. 1.89 Ditto. Failure in exterior rigid columns.

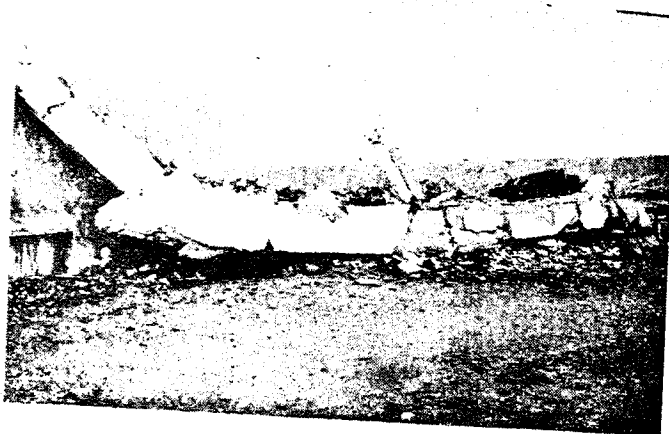
Fig. 1.92 Ditto. Collapsed curved tie beam.

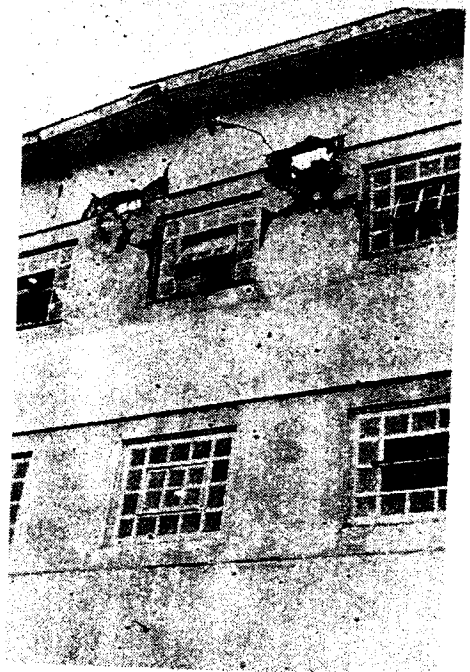
Fig. 1.94 Ditto. Detail of failure in parapet.

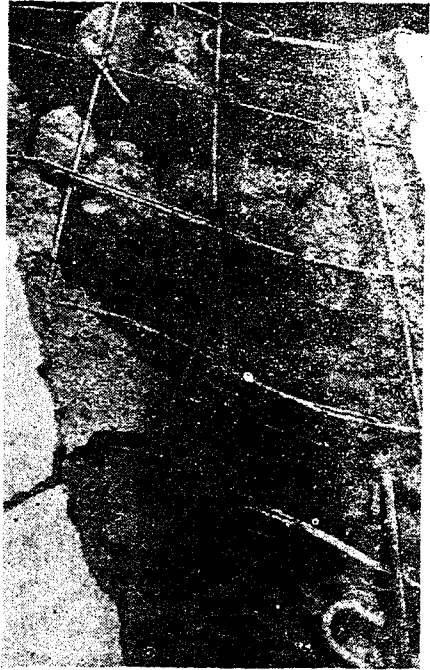
Fig. 2.12 Ditto. Oversize stones in the concrete of reinforced concrete wall.

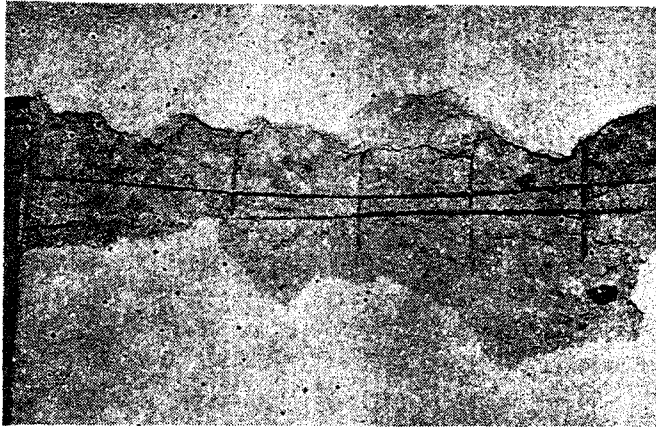
Fig. 2.11 Regional Hospital in Puerto Montt. Faulty disposition of reinforcing bars in reinforced concrete wall.

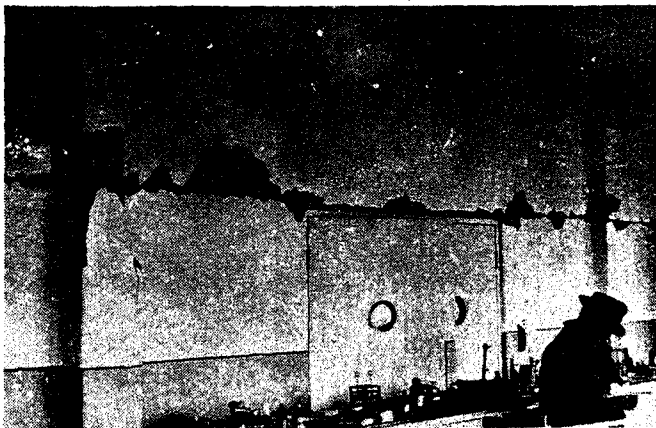
Fig. 2.21 Ditto. Poor bond between masonry and supporting structure.
