THE SKOPJE, YUGOSLAVIA EARTHQUAKE OF JULY 26, 1963

W.E. KUNZE*, M. FINTEL** AND J.E. AMRHEIN***

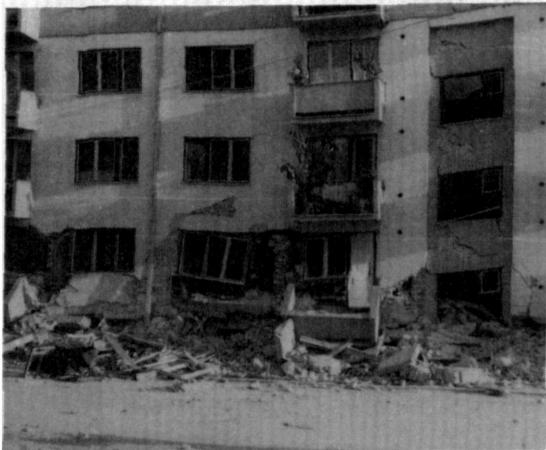
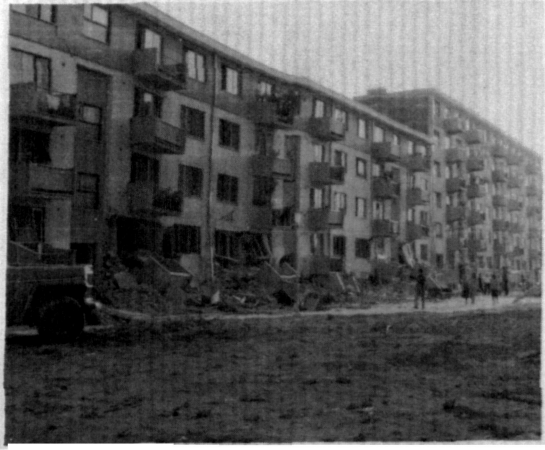
Four types of construction are found in wide use in Skopje. Adobe construction is used for small homes and some damage and loss of life was experienced in these when tile roofs collapsed. However, most persons live in apartment buildings, usually built with load-bearing brick walls supporting concrete floor slabs. These masonry walls are unreinforced and

are not tied in any way to the floors. Lime mortar is used throughout and these structures were designed for vertical loads only.

The quake occurred at 5:17 a.m. - at a time when the residential buildings were most highly occupied. As a result, most of the deaths occurred when the walls crumbled (Figs. 3 and 4).

Figure 3-4. Four story brick masonry apartments that collapsed.

Considering that seismic forces were not applied to structures during design and that construction methods were frequently substandard, it may be assumed that framed buildings performed well and in a predictable manner. The disaster emphasized that tall unreinforced masonry wall bearing structures without ties between walls and floors are unsuitable in seismic zones, especially if a weak mortar is used in joints.

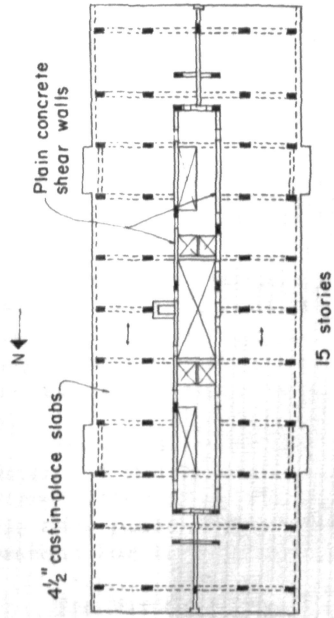
Figure 9. Plan of Carpoš Building.

An apartment building in the Karpos area demonstrates typical performance of the concrete frame type of construction. (Fig. 8.) This structure contains 15 stories plus a penthouse. It was built with a reinforced concrete frame plus a concrete core that includes two elevator shafts (see Fig. 9). The core is unreinforced. The cast-in-place frame includes 4 ½ inch thick one-way solid slabs. The building is supported by a single mat foundation that extends five feet beyond building lines at all four sides. Soil pressure under the mat is approximately 1.7 tons per square foot.

The building did not sway severely enough as to move furniture about. Diagonal shear cracking was observed above doorways that were located in the core. This type of cracking decreased from lower to higher floors. Diagonal partition wall cracking observed on many floors generally followed paths of embedded electrical conduits.

The southeast corner column failed, as shown in Fig. 10. However a core specimen taken from the column after the earthquake indicated a concrete strength of 2250 psi instead of 4250 psi required in the design. Two other identical structures in the Karpos area performed considerably better and experienced no structural distress.

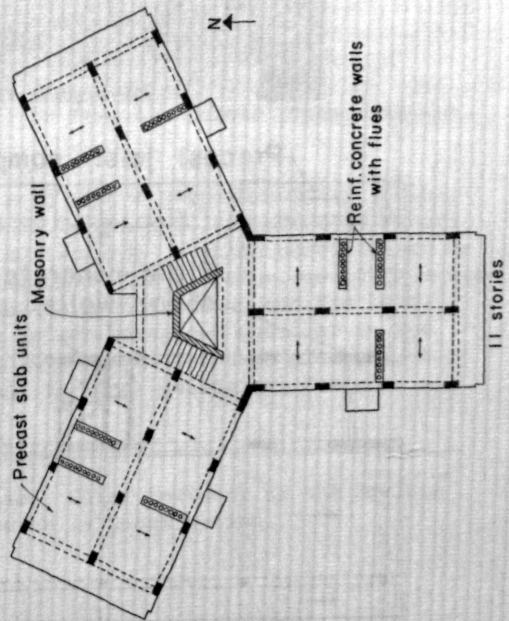
Figure 12. Plan of Y shaped building.

Another example of a reinforced concrete frame building in Skopje was designed in a "Y" shape. (Fig. 11). This 11-storey apartment building, built in 1956, was reported to be the first high-rise structure in Skopje. As shown in Fig. 12, it contains a core, but this is of unreinforced concrete and extends only to the mid height of the second storey. Above this level the core utilizes only unreinforced brick masonry. The slab system is composed of precast single-T units simply supported on ledger beams.

Lateral load resistance is supplied by the shape of the structure, by reinforced concrete walls in each wing that contain chimneys, and by the action of the cast-in-place frame. Partition wall and plaster cracking were observed in the building but no structural damage occurred except for slight column distress at the outside corner of the southwest elevation.

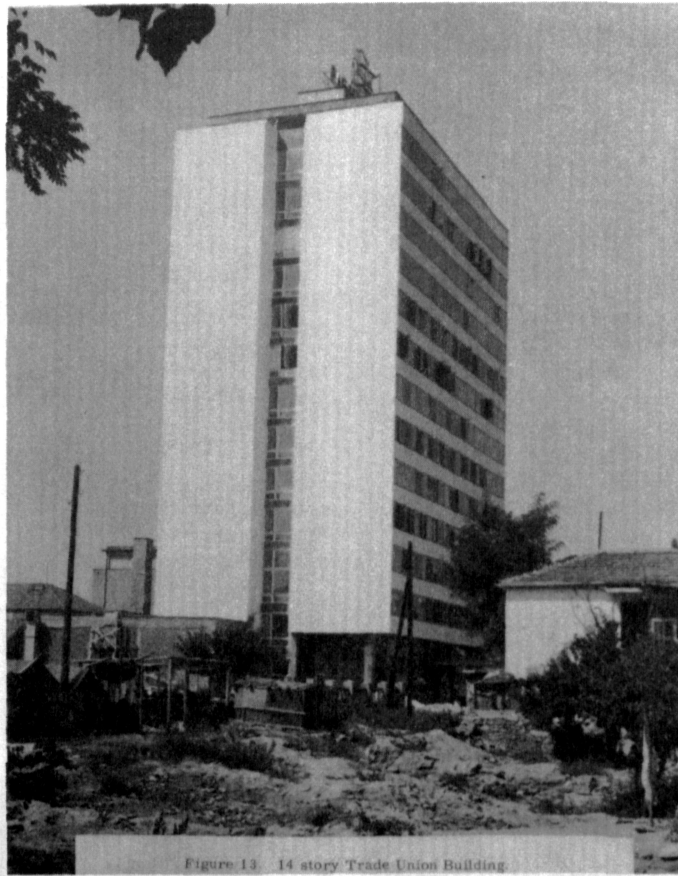
The Trade Union Building, (Fig. 13) a 14-storey office building completed in 1962, was reported to be the best-performing tall building in Skopje. According to instrument observations made by the Technical University, the structure was not a millimeter out of plumb after the earthquake.

During the earthquake, cleaning women reported being thrown to the floor and across the room. Furniture was strewn about. There was slight damage to elevator shafts but in general no structural damage of significance in the building. Partition wall and plaster cracking occurred and there was some damage to marble finishes on the ground floor. This damage resulted from a hammering of the tall structure against a shorter adjacent building.

Figure 13. 14 story Trade Union Building.

The earthquake emphasized again that buildings should be properly spaced or jointed to prevent hammering of adjacent parts.

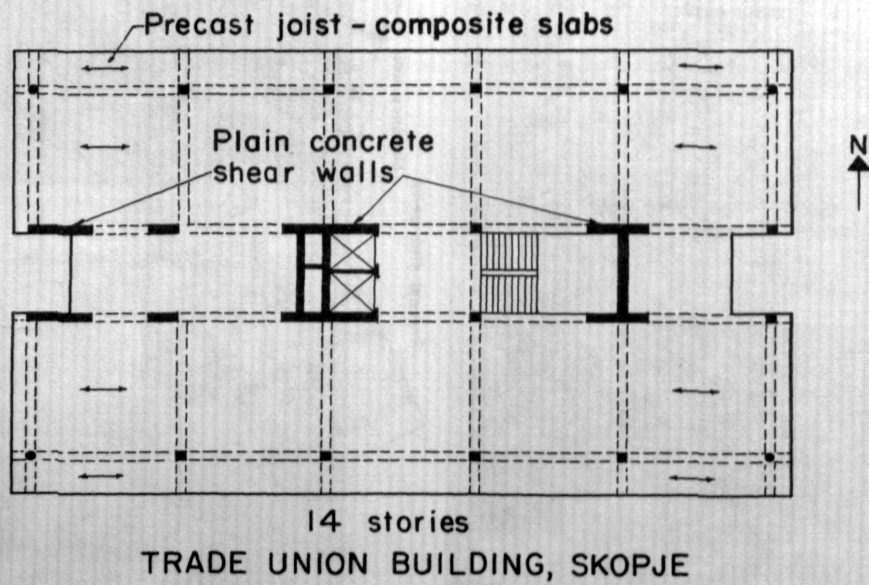
Figure 14. Plan of Trade Union Building.

The structure utilizes a reinforced concrete frame (Fig. 14) plus three concrete core elements designed to carry all lateral loads. Cores are unreinforced except in the basement and first floor. All beams designed for vertical loads are continuous but without frame action with columns. The first floor and roof slabs are cast-in-place but other floors consist of precast joists and a cast-in-place unreinforced topping.
