A REPORT ON THE BUYIN EARTHQUAKE (IRAN) OF SEPT. 1, 196.

S. Omote*, K. Nakagawa*, H. Kobayashi**
S. Kawabata***, E. Nakacka****

SYNOPSIS

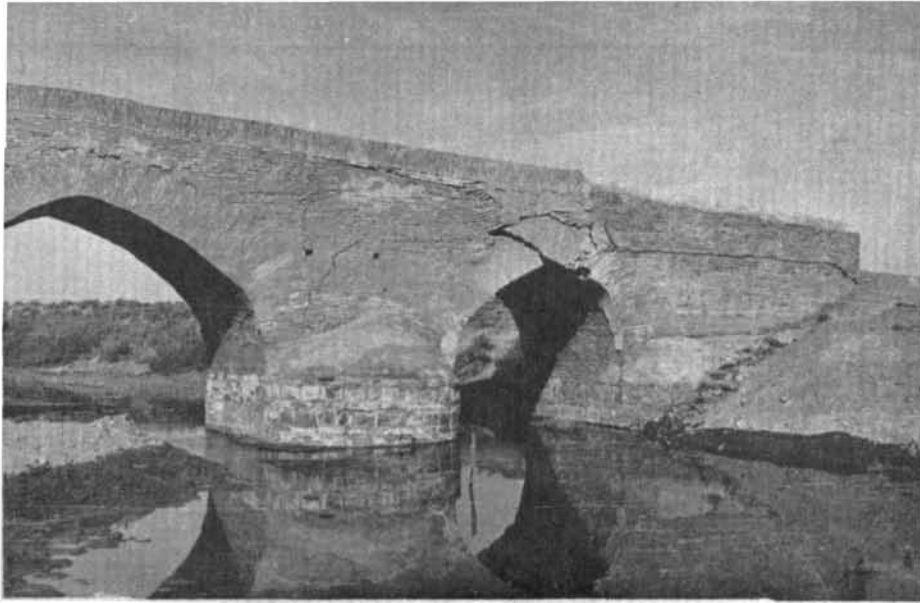
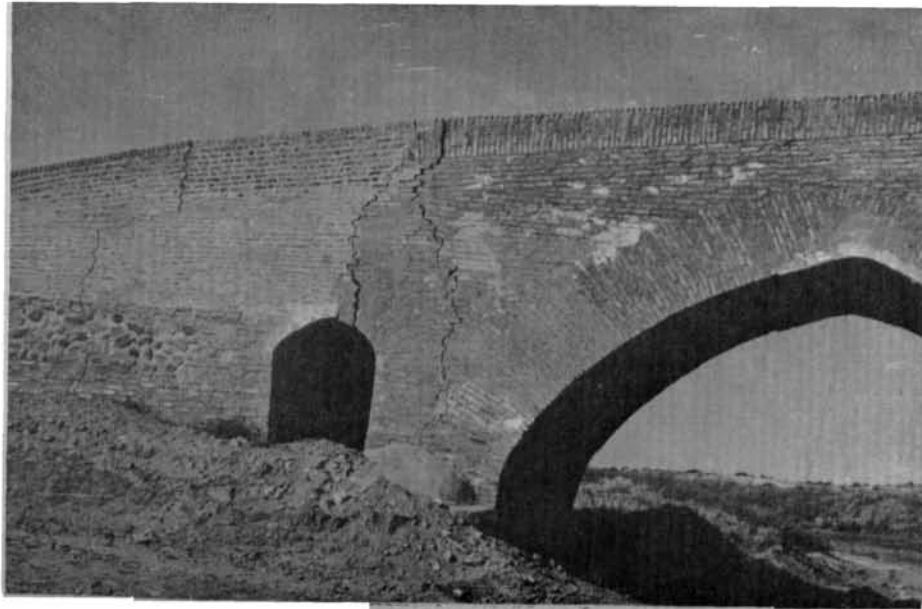
Photo 1 Bridge between Qazvin and Buyin

The distribution of general damage due to the earthquake is mentioned in section IV. As to the damage to civil engineering structures, damage to ganates was most conspicuous. As to the bridges, we noticed that only one stone bridge, which was constructed more than 400 years ago, suffered large damage (Photos 1, 2). In this section there are explained the processes by which the destruction of buildings have taken place. Before we give these explanations, in the first place, we shall classify the types of buildings that are found in the damaged area into following four types:

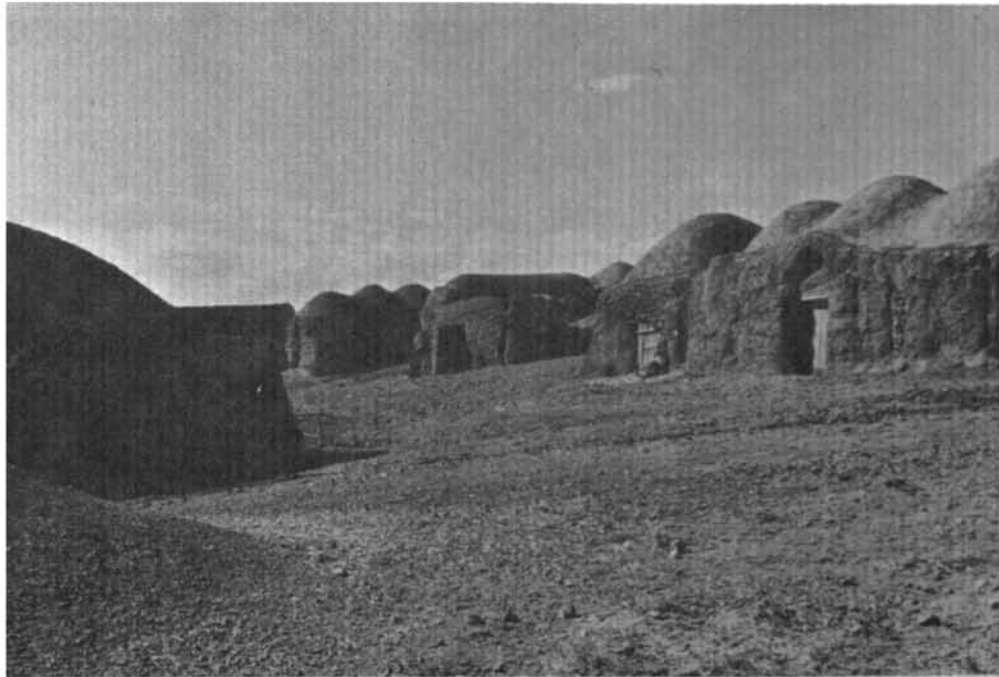
Photo 3 Qaraturbaq

Roof: A dome is supported by brick arches and or walls, diameter of the dome is about 3-4 m, thickness of a brick arch or wall is about 20 cm. The dome is made of sun-dry bricks and is covered with mud. The thickness of the sun-dry brick is about 20 cm and that of mud is 20-30 cm. Sometimes a cylindrical roof is employed as a modification of the dome shaped roof (Photo 3).

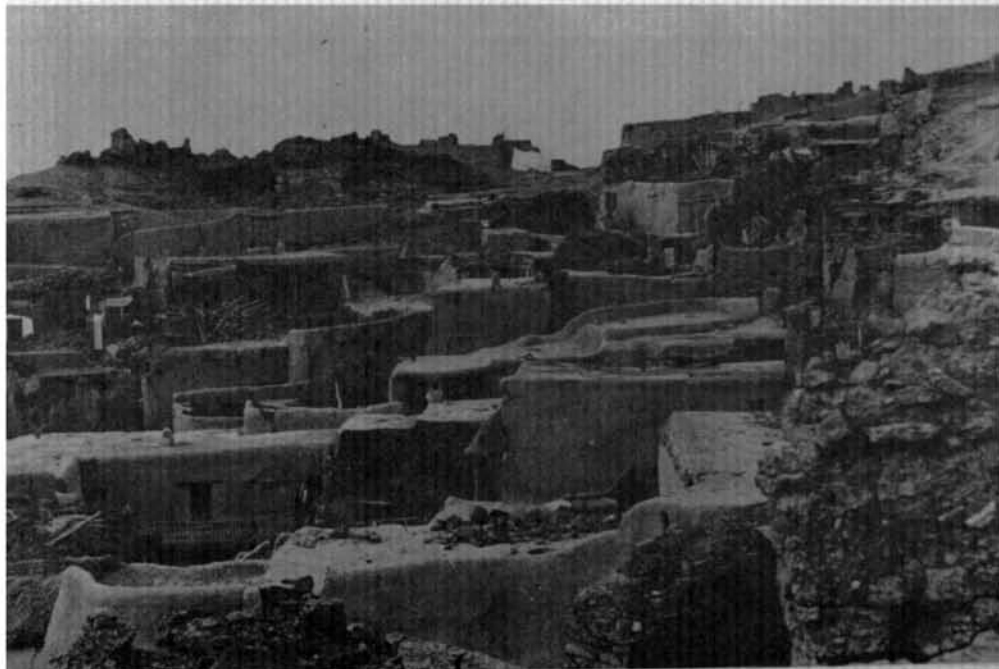
Photo 4 Qulanjin

Roof: Logs are put as beams on the top of a wall spacing 30-40 cm apart. Lepironia mats or small wooden branches are spread over these logs and covering all these, a thick layer of mud, having a thickness of 30-50 cm, is laid to form a flat roof. In a case of a large building, sometimes a girder and a column are employed in order that they may support these logs. A girder is formed by a big log or a bundle of logs which is often plastered with mud. A column is of nearly the same construction as a girder (Photo 4).

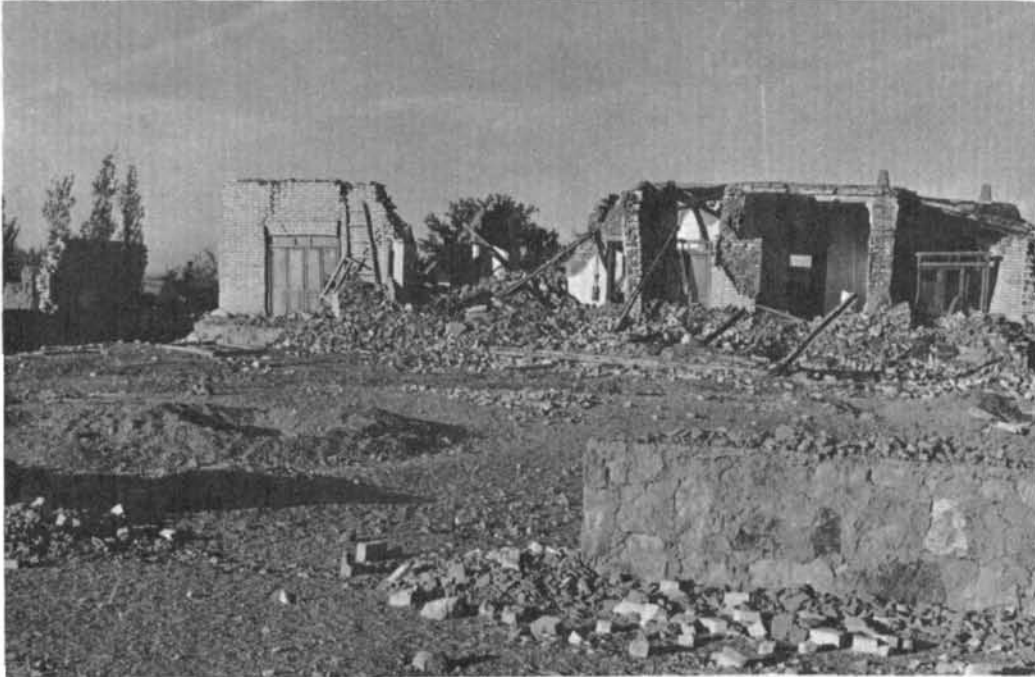
Photo 5 Danesfahan

There are not many buildings of this structure in the damaged area. One of them which was found in A-be-garme seemed to have received only a slight damage on its wall. However, examining it in detail we found very clear shearing cracks, especially on the wall facing south. Steel beams and brick arches were not destroyed but it was considered that this building was not safe enough to be dwelt in. Another example of building of the same structure which was found in Danesfahan suffered heavy damage. The roof had fallen down and the walls had also been destroyed almost completely. There being not many examples of this type of structure the area investigated by us, somewhat hesitate to make any conclusions (Photo 5).

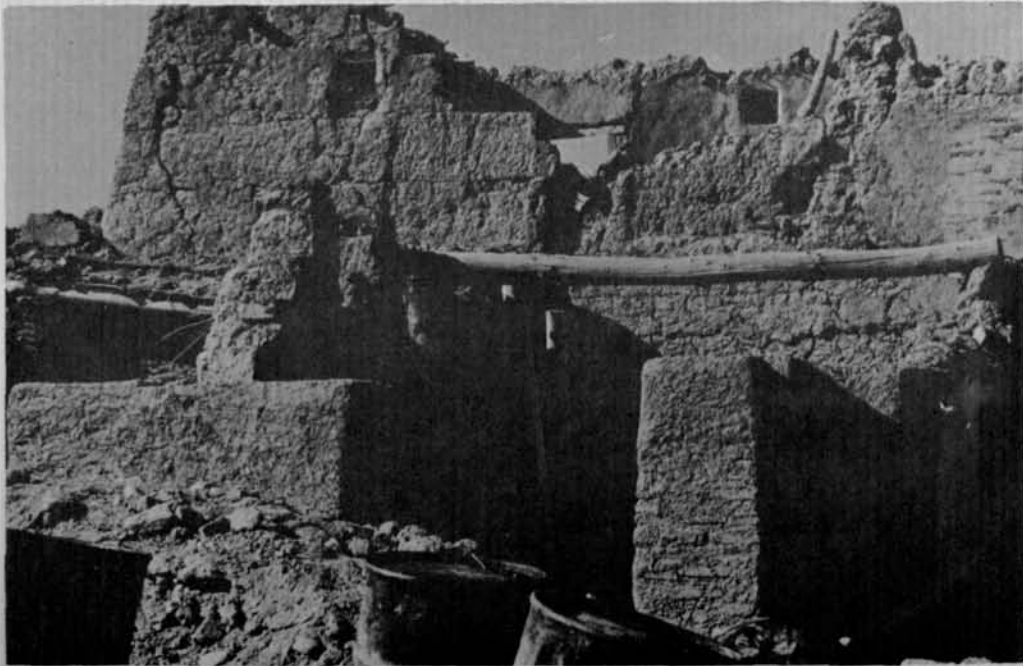
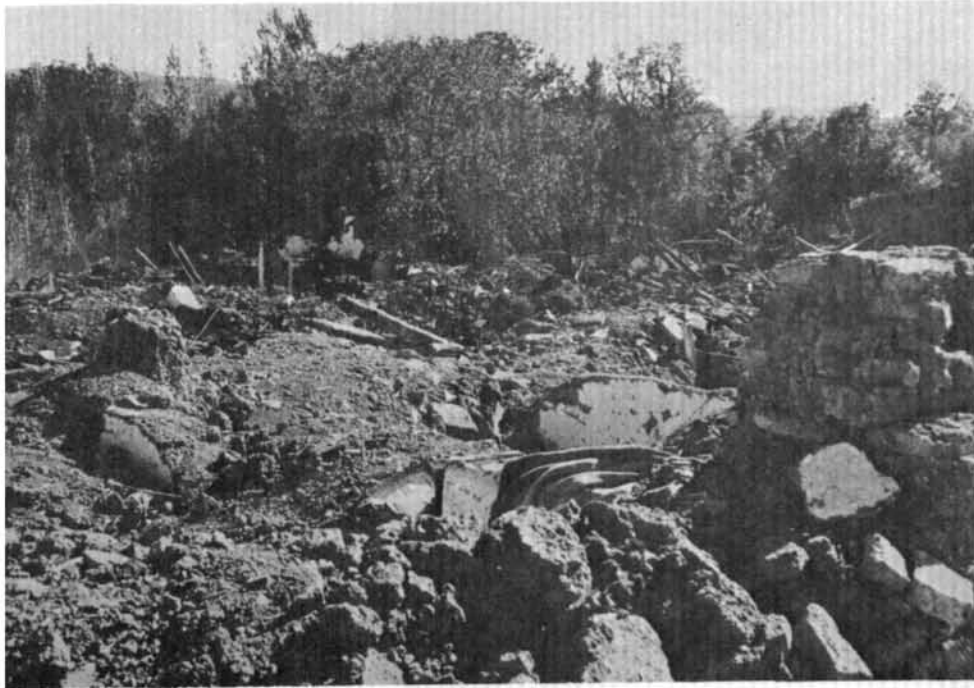
1. Some cracks are formed on a wall at a corner of a room.
2. Wall is overturned toward outside on the weakest side.
3. If the wall of the fallen side is not supporting the wooden beams, then the roof may remain on the other walls.
4. If the fallen wall is supporting the wooden beams, then roof falls down and this in turn pushes the other walls towards outside.
5. In this way the walls are made to stand alone just like a cantilever, so that they easily overturn separately (Photos 6, 7).

Photo 6 Danesfahan

Photo 7 Rudak

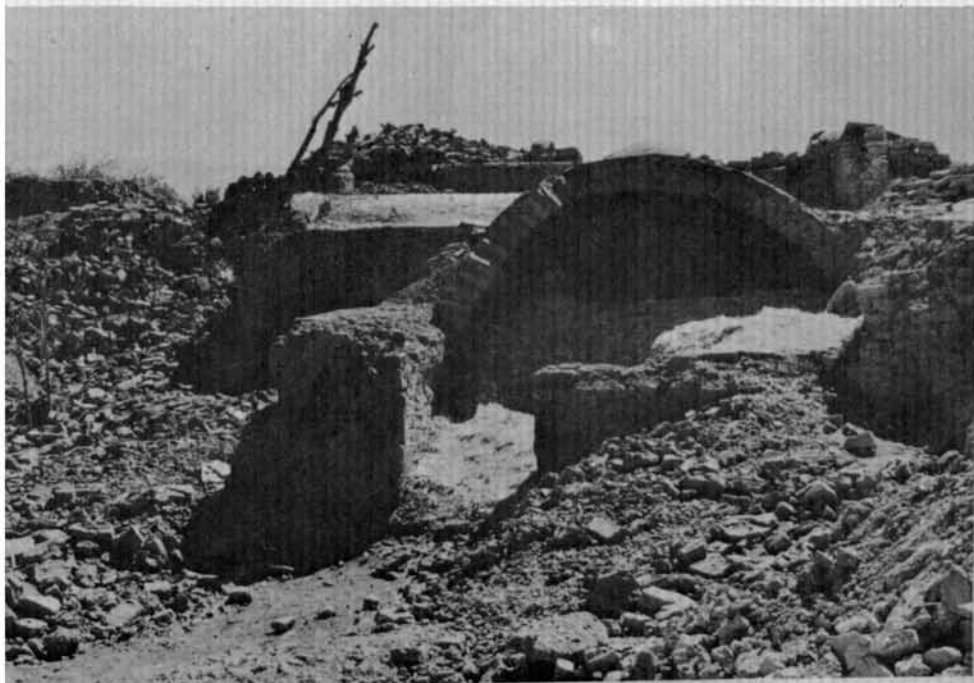
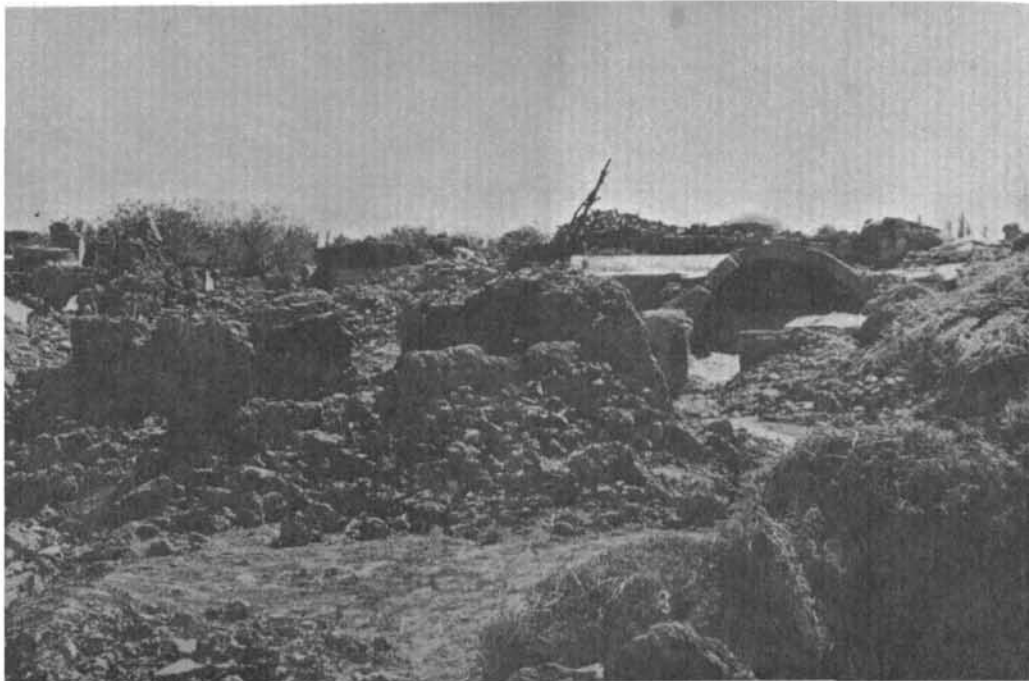
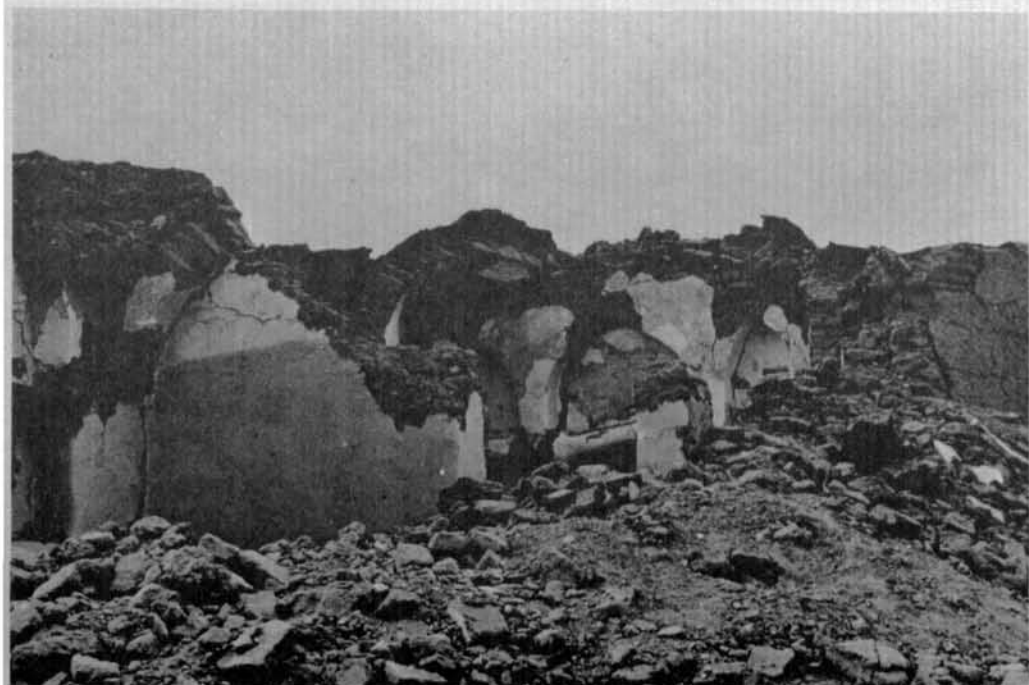
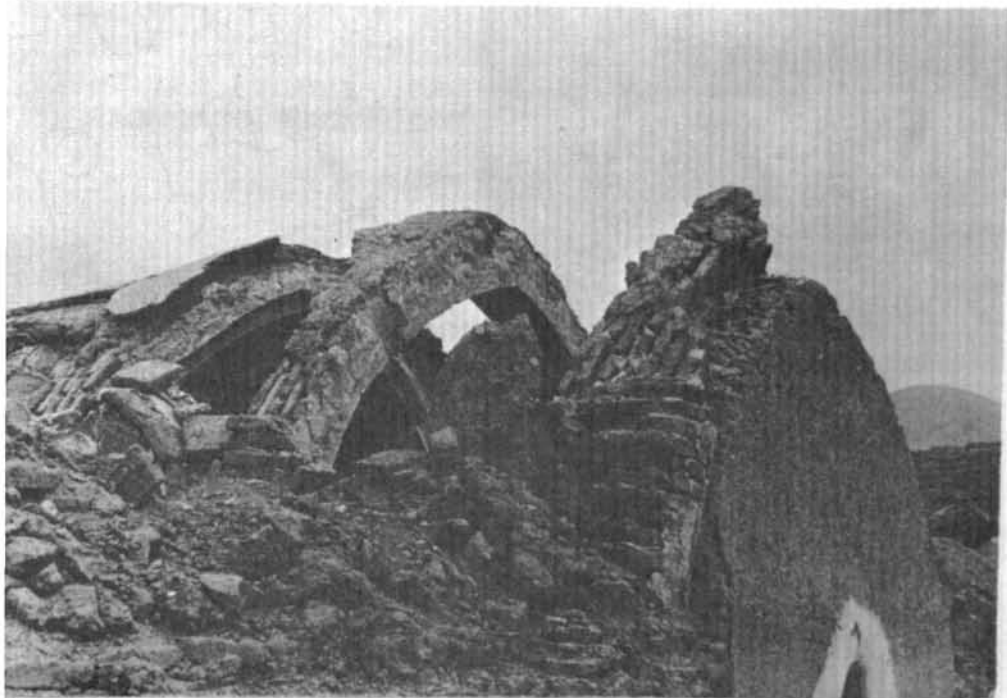
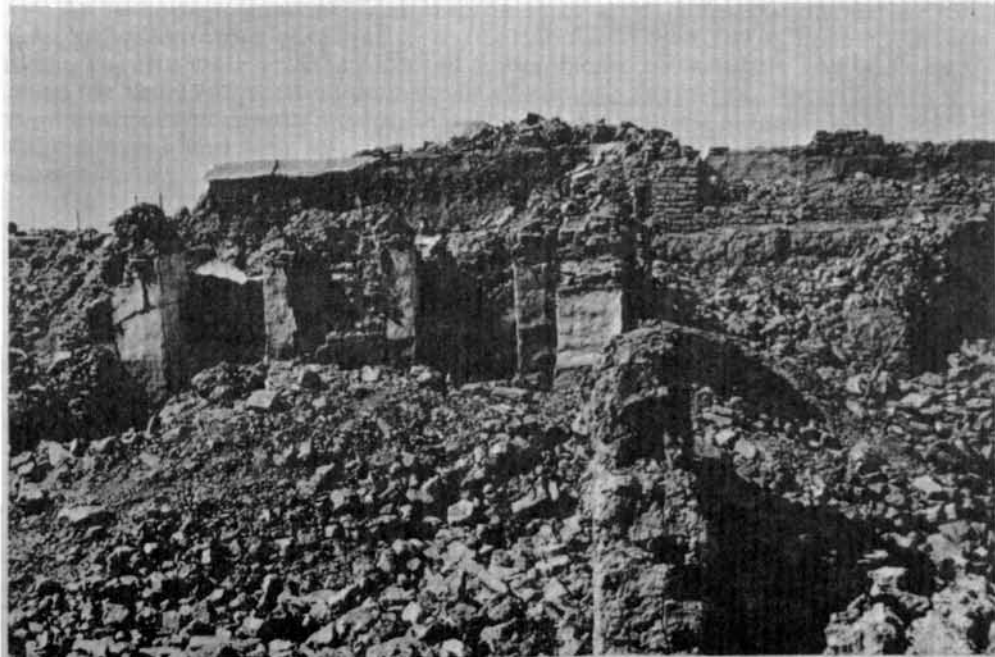
1. The top of wall is displaced by the formation of cracks.
2. By this dislocation, even though it might be only a very small one, cracks are easily formed in the arch or dome, then these cracks run up towards the top of the dome.
3. As will easily be understood, the arch and dome are of no use for binding up the top of walls. On the contrary, they produce a force to push the top of wall outside, and the walls are destroyed more easily.
4. Structures having an arch or dome roof usually have large openings and this in turn causes the structures to be destroyed easily by the earthquake motions (Photos 8, 9, 10, 11, 12).

Considering these processes, we find that this type of structure is like a box structure. However, in reality, it makes no use of excellent points of box structure. The walls do not cooperate with each other and slabs and domes are of no use for binding the top of the walls. In addition to this, before the earthquake many cracks must have been formed on the wall by shrinkage, so that these cracks must have accelerated the destruction of the building. For this reason steel binder at the top of the wall is very useful for an anti-seismic reinforcement. Considering the damage from the point of materials, we find that a stone wall is destroyed most easily, a sun-dry brick wall follows it, and mud wall is rather strong having a stronger nature in its structure. But it must be kept in mind that the strength of a wall would greatly be affected by the condition of filling.

Photo 8 Buyin

Photo 9 Buyin

Photo 10 Abarik

Photo 11 Ipak

Photo 12 Buyin
