THE ACAPULCO, MEXICO, EARTHQUAKES OF MAY 11 AND 19, 1962

By Reuben W. Binder⁽¹⁾

ABSTRACT

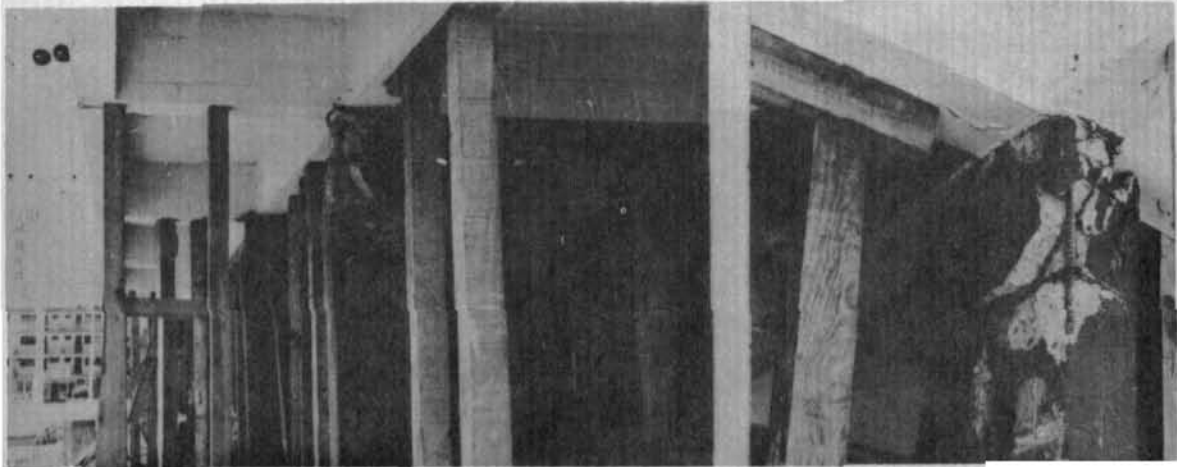
NON-TYPICAL DAMAGE
FIGURE 8

Along Aleman Boulevard, at the beach, there was some typical and non-typical damage. It might be presumed that in many instances damage would be typical for the same type of structure; however, this is often not the case because, among other things, workmanship is far from being uniform. This was particularly true in this area, as was seen by the varying damage pattern. Fig. 8 shows damage for the 1962 shocks which is non-typical because an expansion joint between two structures at right angles was used as a good place to dump excess pour material.

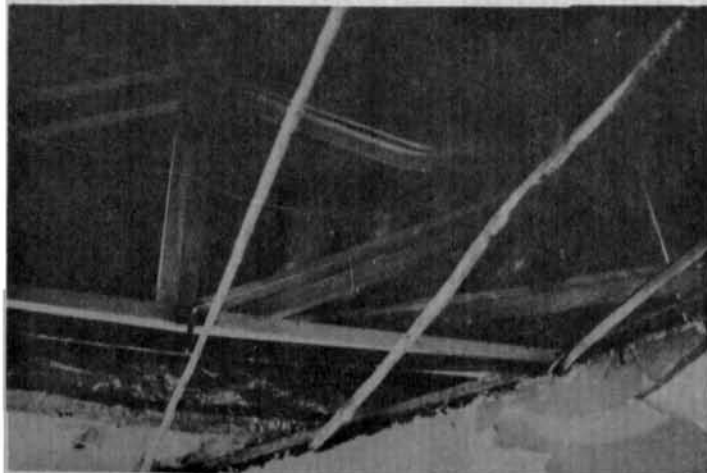
COLUMN FRACTURES
FIGURE 9

The column fractures shown in Fig. 9 are not as dramatic as some that might be shown; dramatic shots generally prove the dictum that poor use of materials, lack of design, inadequate supervision, etc., are often the facts of life in earthquake damage areas.

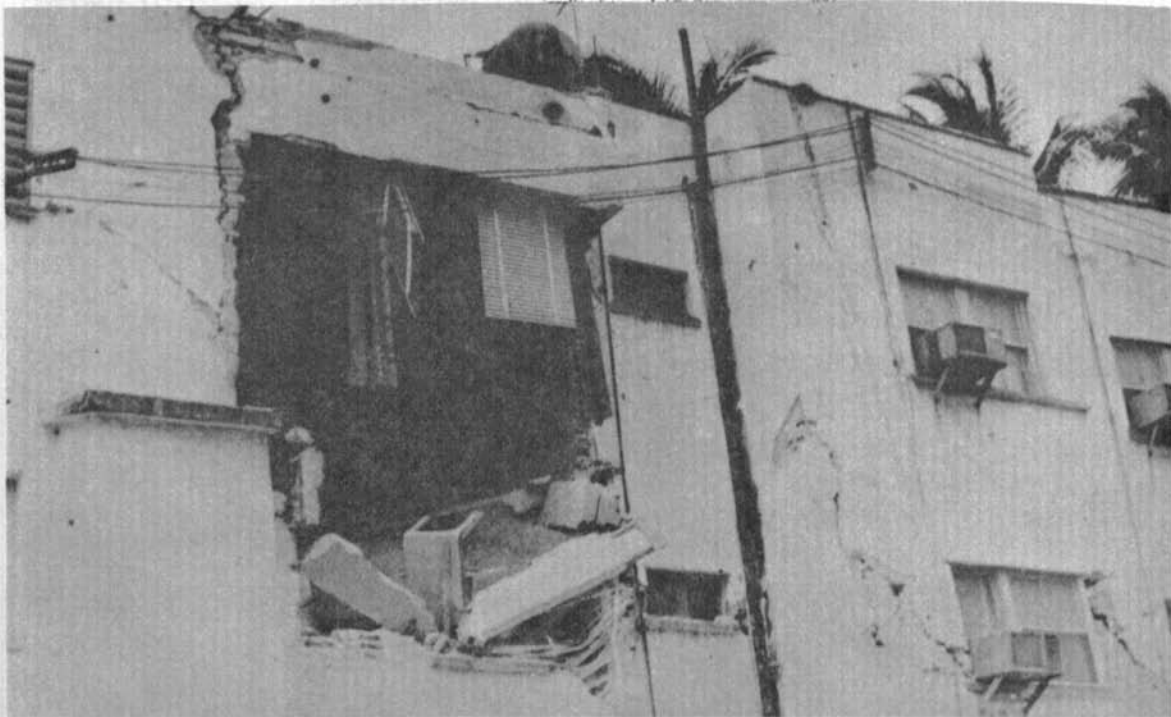
MAY 11, 1962 DAMAGE

At one site on the Boulevard, Fig. 13 shows a structure after the May 11th shock and the same structure after the May 19th shock.

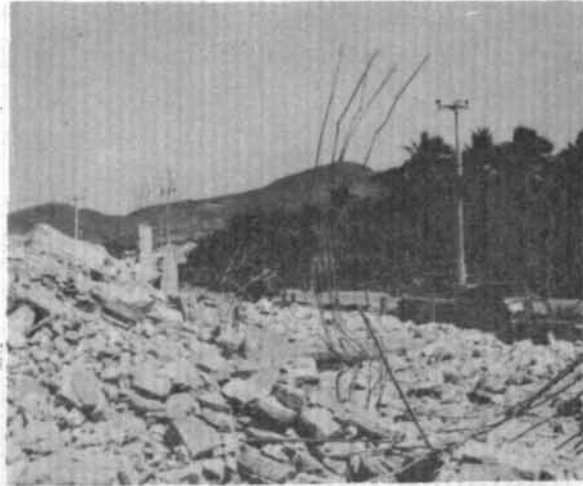
THEATRE
FIGURE 14

Fig. 14 shows a mass of ruins. Fortunately, enough pressure had been placed upon the management of this particular structure to close the place down before the May 19th shock.

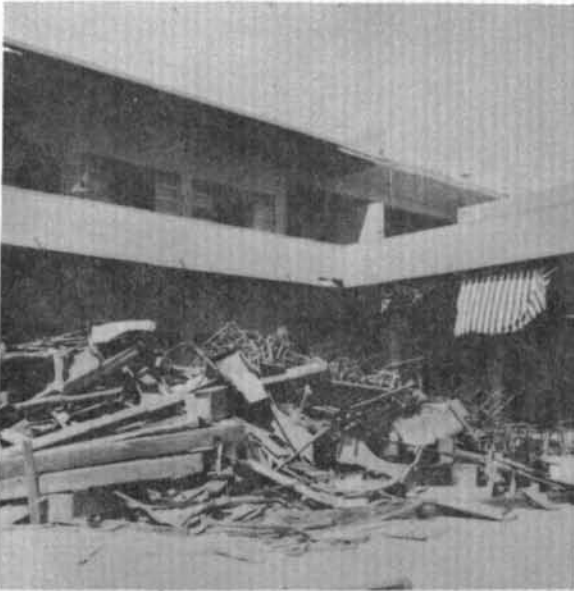
PARTIALLY COLLAPSED SCHOOL
FIGURE 15

Fig. 15 shows the school which was partly collapsed and Fig. 16 shows one which was seriously damaged and which was torn down. Fig. 17 shows the third structure under discussion, a secondary school in which there are many column fractures. This three-story school structure was damaged in the 1957 shock, after which the third-story columns were enlarged. In the 1962 shocks, column fractures developed in the first and second stories, at the top or bottom or at both top and bottom, except for one case in the first story where a fracture occurred in the center of the story. Naturally, this fracture became a subject of much consideration and discussion by engineers.

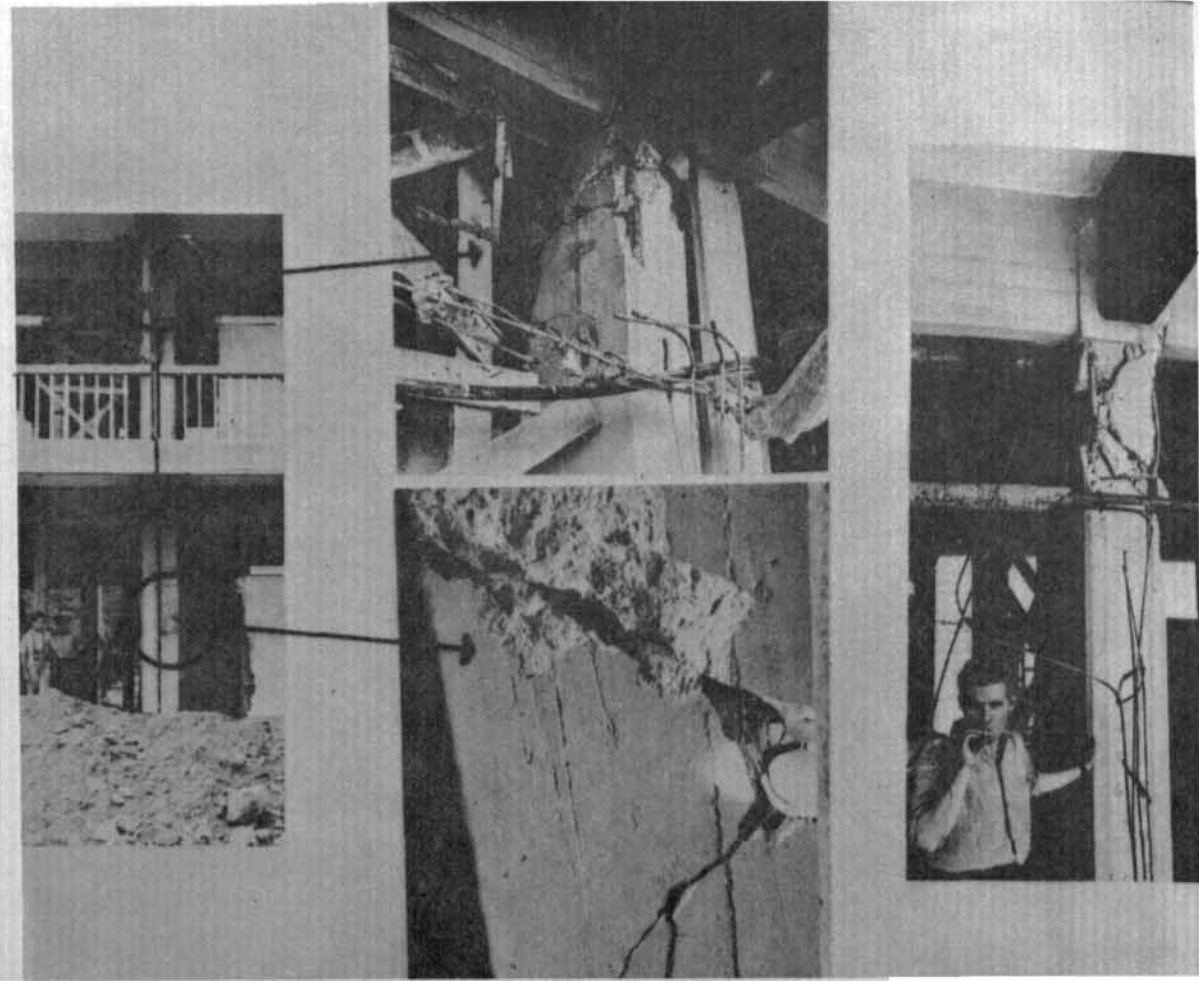
COLUMN FRACTURES IN SCHOOL BUILDING
FIGURE 17

"An engineer was assigned the task of determining the cause of the mysterious cracks in the secondary school column. His verdict: mainly torsion...The curtain wall did not reach all the way up but left a space for a window. Somehow it was tied to...the column. Why should the crack form at that elevation? For one thing, if due to torsion it could form anywhere...But judging from what we saw in the second story it was a fairly haphazard business. This may have sharply localized the main crack. The picture is clearer if we think in terms of alternating torsion..."

"With regard to the possibility of torsion explaining the cracks in the column, my only reaction at the time I looked at the building was that it could not have been overall torsion of the structure. However, it could very easily have been torsion in isolated portions corresponding to unbalanced forces acting on the curtain walls...In any event, there are still some difficulties in explaining the Acapulco damage incidents. I am still convinced there was a much higher vertical effect in Acapulco than in Mexico City and that this contributed to damage to the columns...in Acapulco...There is also an influence of the foundation conditions which may have contributed to a greater torsional effect in a number of buildings. I do agree...that torsion would have permitted the crack to form anywhere in the column, and flexure could not explain the position of the crack. Some force had to be exerted on the column at the location of the crack, but this might have come from the curtain wall if it was firmly attached.

It may be of interest to mention that on one of the visits to the secondary school, in addition to observing and studying the column fractures, there was observed (1) loose soil displaced at the first floor by the earthquake ground motion and (2) a water table was located approximately 6 feet below the first floor and about 1 foot above the top of the pad of the spread footings.

Several questions come to mind. How much damage was caused by horizontal acceleration and how much by vertical acceleration? How would the structure have responded if a more effective first floor slab had been placed on well-consolidated soil and the slab had been firmly attached to the columns? What was the influence of the 1957 repairs in the top story of this structure? Was there no visible damage in the lower stories as a result of the 1957 shock? One can put all these factors together and get a complicated damage picture. Ground motion records might have given us a better quantitative breakdown.

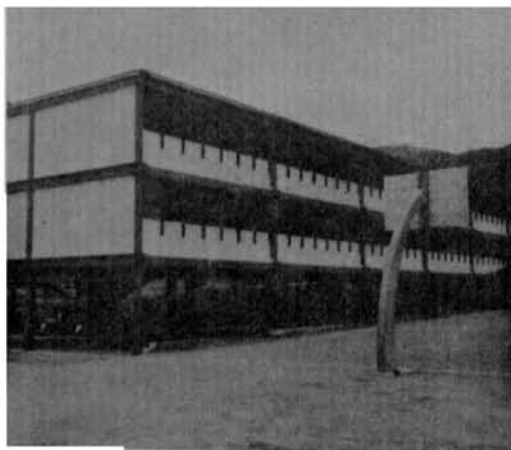
UNDAMAGED SCHOOL
FIGURE 18

A fourth school not far from those described above had a minimum of damage. Fig. 18 shows this building, a framed structure with curtain dado walls. A close inspection indicated that the frame was undamaged and that only the curtain walls and crosswalls showed some damage in the form of diagonal cracking. Following careful inspection, classes continued uninterrupted.

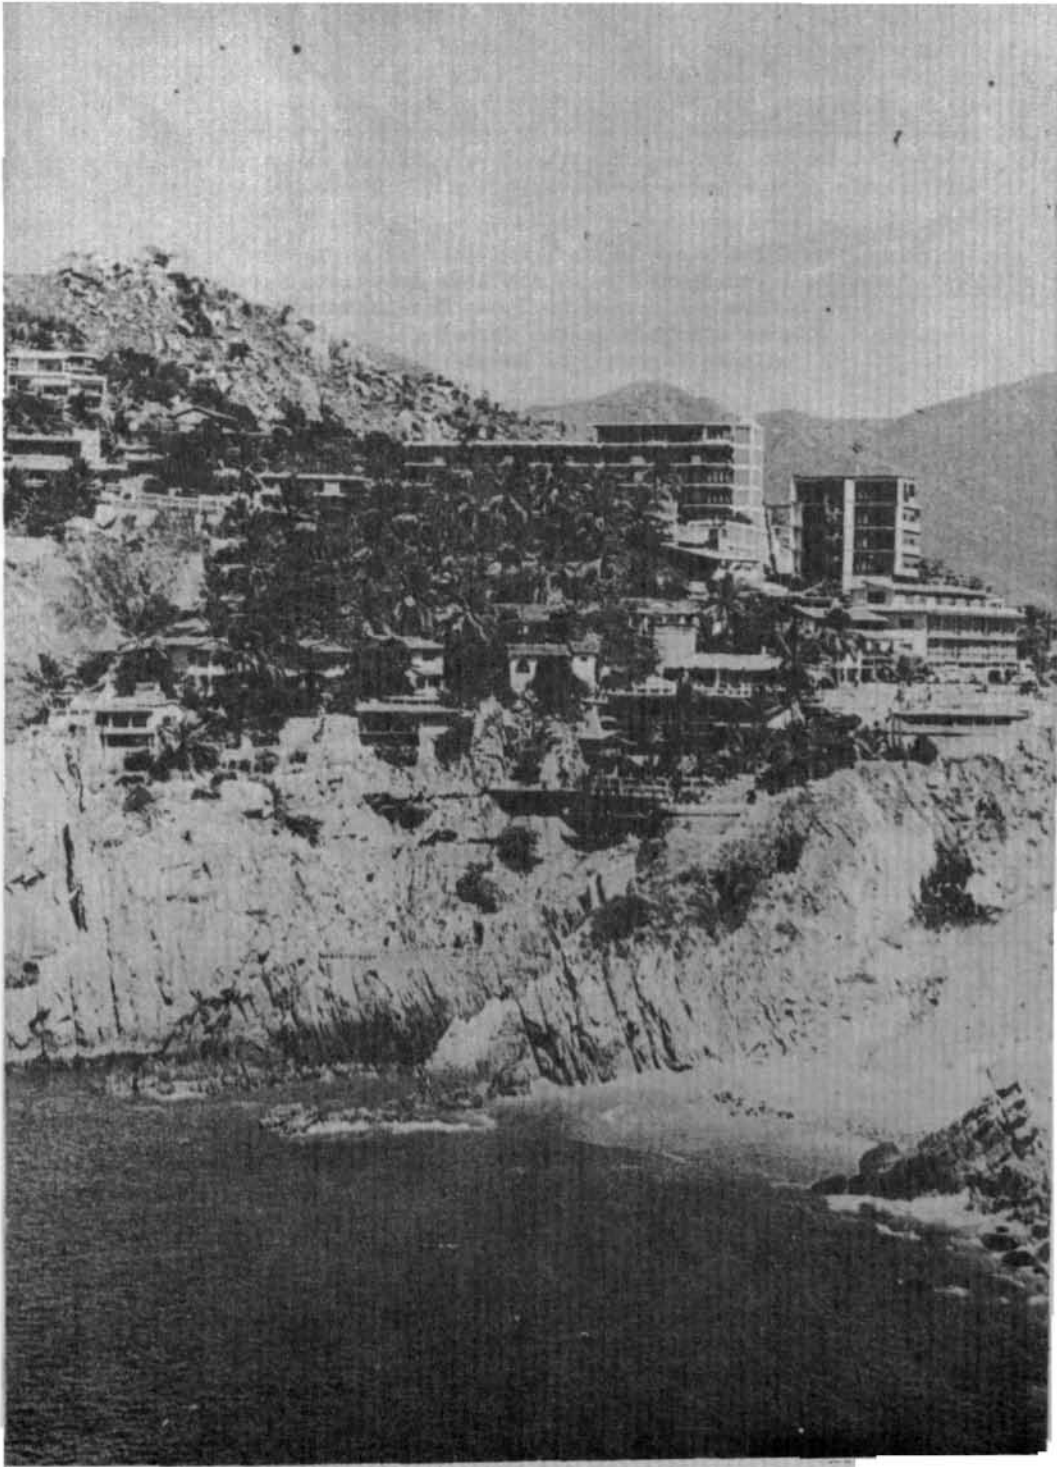
STRUCTURES ON FIRM SOIL
FIGURE 19

A matter which merits serious consideration in regard to earthquakes is the question of soils. Fig. 19 shows a bluff of rock formation, an area which suffered little, if any, damage. If one marked on a geological map the locations of the structures which were seriously damaged, partially damaged, barely damaged (from visual and critical observation), etc., one would conclude that the effects of ground motions on these buildings varied according to geology, soil conditions, and foundation design, along with other items previously mentioned. One observer commented that the greatest damage occurred where structures or foundations were located on "false" soils.
