SAN FRANCISCO'S NEW ASIAN ART MUSEUM

Stan J. Tuholski¹, Paul E. Rodler²

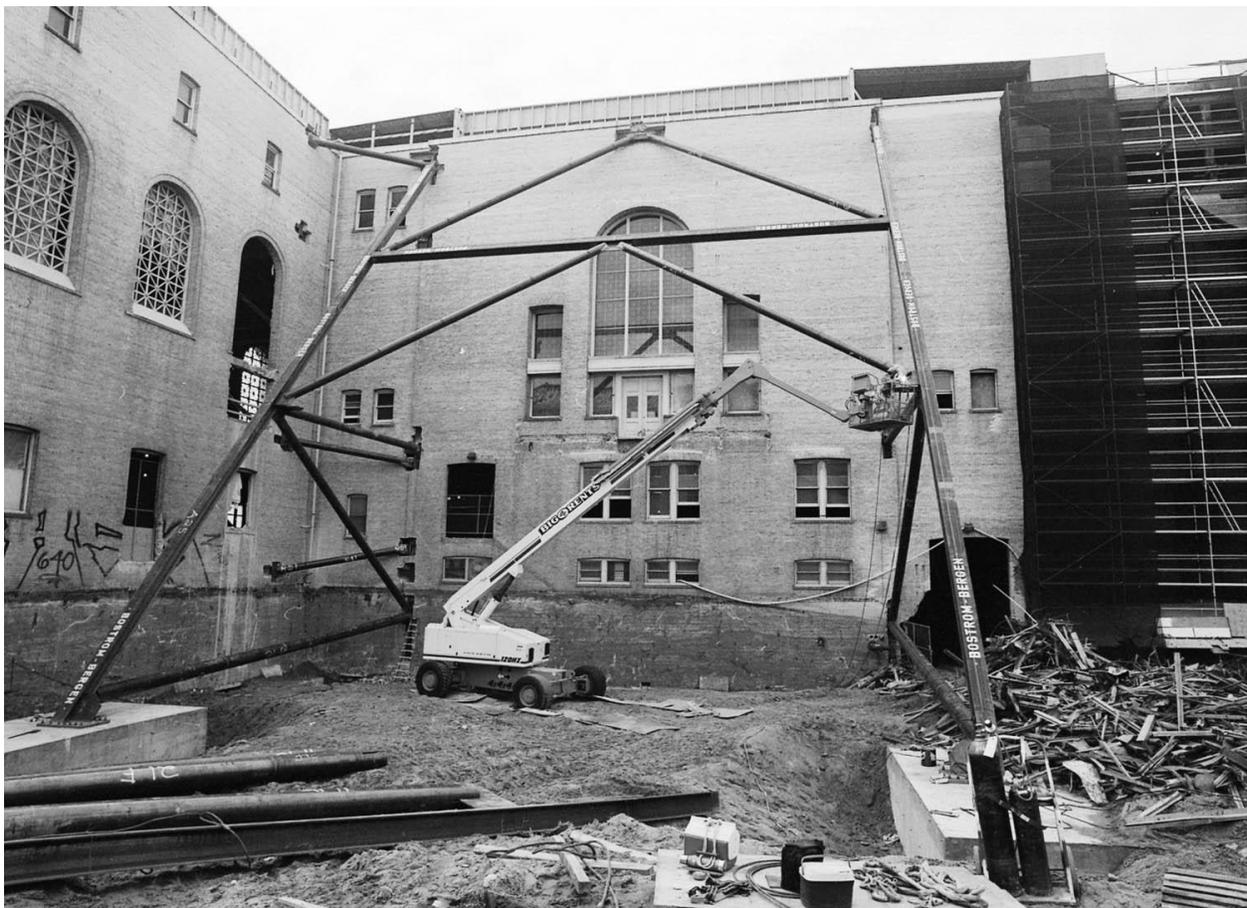
Figure 11 - Great Hall Temporary Bracing

The great hall served as the catalogue room for the Old Main Library. The great hall was distinguished by its voluminous space, travertine tile floor, faux travertine walls and pilasters and faux travertine hexagonal ceiling. One of the key elements of the seismic upgrade called for the installation of concrete shear walls around the great hall perimeter. To hold historic finish lines, it was necessary to install the new concrete shear wall in place of the previous unreinforced masonry walls. To accomplish this task, the plaster ceiling and walls were first backed by an intricate, self supporting, self bracing steel frame system. This framing provided stability and protection for the plaster walls during construction. The brick walls were subsequently demolished and concrete was poured in their place. Mechanical ductwork was sandwiched between the plaster and concrete walls to provide humidity, air and temperature control to the gallery spaces from rooftop equipment. The final step was to attach the temporary steel frame to the surrounding shear walls.
