Recent Review of Earthquake Practices on Emergency Response and Influence in Taiwan

ABSTRACT :

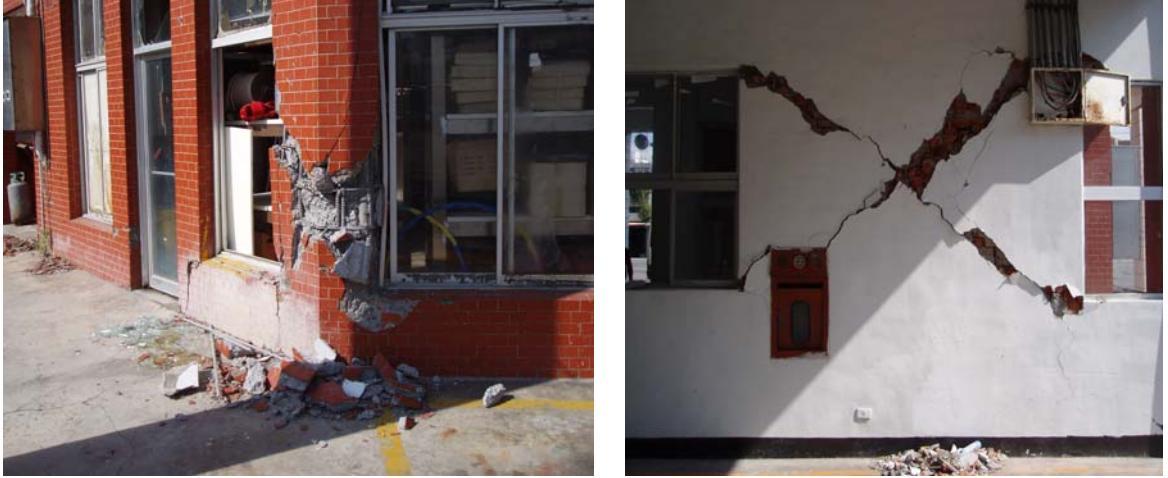
After the earthquake, there wasa 8-minutepower outage of 7,225 households approximately. Despite there were structural damages of the building of Taitung County Fire Department, the backup power supply immediately switched on and the operation was not intercupted. "Emergency Operation Center of Taitung County" was established abided to "The Regulations on the Emergency Operation Center of Taitung County against" Several units including county government agencies Taitung University, Ping Tung University of Science and

Fig.2 Structural damages on Taitung county fire bureau building

- (4) The most damaged structure in the Taitung earthquake was the fire bureau building, yet the command center was still established there. It is suggested that a reserve supporting mechanism should be prepared in the future to make sure the emergency operation system can operate normally when disaster occurs. Besides, an overall seismic evaluation should be proceeded to all vital structures which are needed be versatile in disaster situation such as fire bureau, police station, or hospital, etc., to avoid them to be damaged by earthquake and deprived of their proper functions.

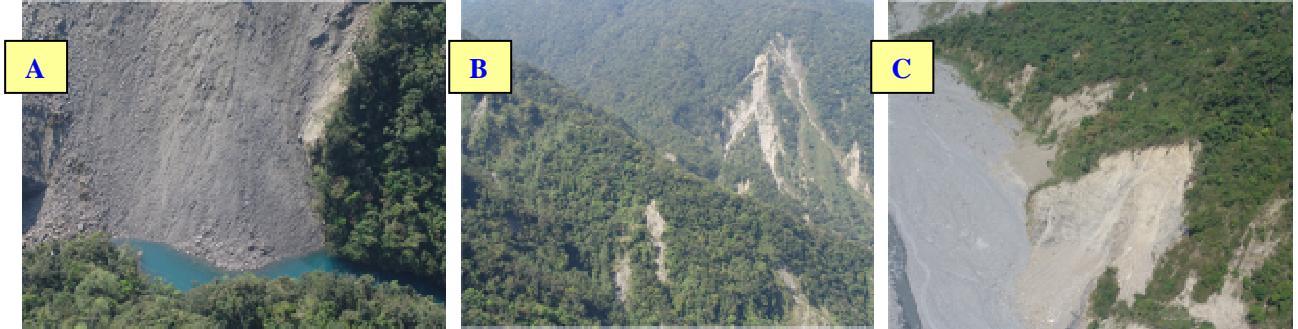
After the quake, the county government put its focus on local watershed areas where was listed as the high risk potential area of landslide. As consequence, the airborne service was applied on July 2nd to conduct aerial investigation over Zhiben and Taimali watersheds in order to evaluate the safety after the quake. After the Long-Wang typhoon on October 17th, 2005, some landslides at upper stream of Zhiben river occurred, where a barrier lake was immediately formed to hamper the river flow. Through the aerial investigation and images, it concluded the current state of the barrier lake remained stable, but the close monitoring should be required for possible aftershocks and the restricted access to the areas was also announced to ensure the general public's safety. Although the landlide area at the upstream of Zhiben River Basin had not been worsened after this earthquake, the slope stability in this area was still unable to be confirmed question mark. The slope scouring by typhoon and torrential rains -were still to be the top concerned issue, but the Taitung County reminded people living or working along the downstream areas of being alter to the sudden change of weather report, especially heavy rains. Details are shown in Fig-3.

Fig.3 (A) Barrier lake in Zhiben River (B) The upstream of Zhiben Rver (\overline{C}) The up stream of Taimali River **2. Briefing of the Hengchun Earthquakes and emergency operation**

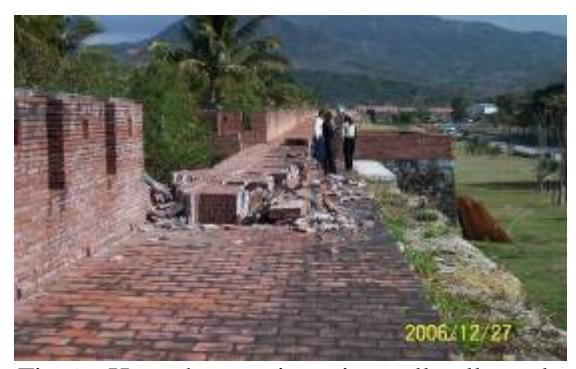
Two casualties were reported after the earthquake and 42 others wounded. The collapse of Zhengxing furniture shop in Pingtung county claimed two lives and injured six, which is the spotlight of news during emergency operation. In Hengchun area, the quake flattened three houses. The quake also 134 damaged schools and 10 of them needed further structure inspection to ensure students' safety. Among damaged campuses, the Shanhai primary school reported falling rocks in playground and structural cracks were easily found in the classrooms. (NCREE & NCDR . 2007). Furthermore, some broken sections were found in the ancient city walls, a culture heritage spot, of Hengchun. (See Fig-6). (NCREE & NCDR . 2007)

Fig.6 Hengchun ancient city wall collapsed After the earthquake, the emergency operation center was established by the Fire Bureau of Pingtung County band the Disasters Prevention and Protection Commission and administrative offices of the Pingtung County received the situation report on the quake. The county government then established the "Pingtung County Calamities Operation Center" and immediately formed a advanced command post at Hengchun area. Local assistance foundation (Ping Tung University of Science and Technology) was also immediately stationed in the emergency operation center to handle public requirements. (NCREE & NCDR . 2007)

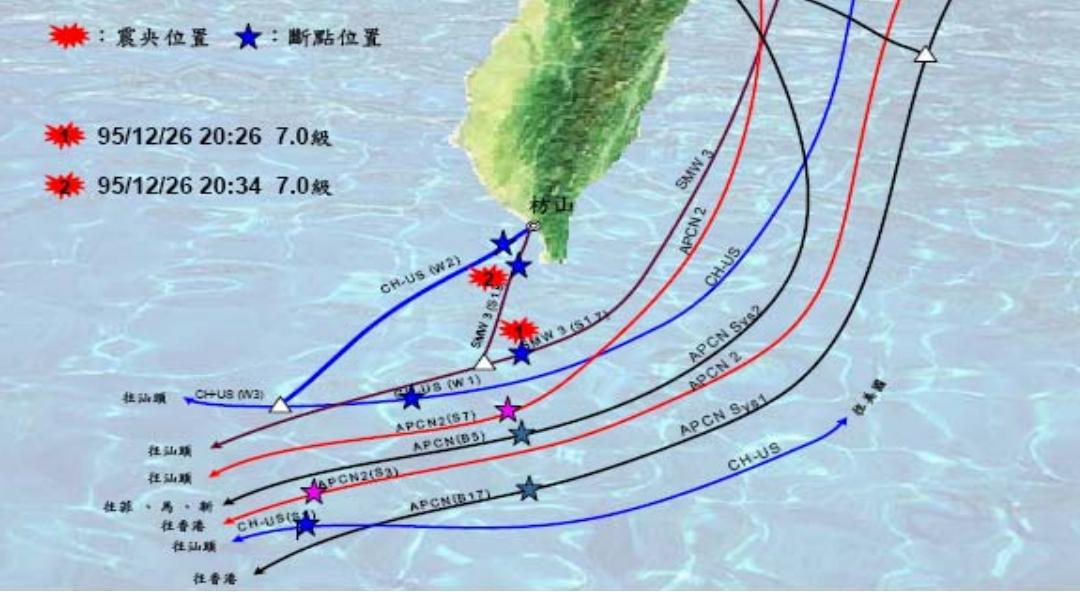
through the eastern and southern offshore of Taiwan. They include APCN2, APCN, SMW3, CH-US, F/RNAL, EAC, and C2C, etc. Seven international undersea cables passed through Taiwan can be seen in Fig-7. This earthquake caused 17 snap-off points, as shown in Fig-8. Right after the earthquake, the Chunghwa Telecom Company started the "Command Center for Natural Disaster" to promptly gathered the related personnels to discuss and handle the situation based on their standard operation procedure. (Zhi-Ming Wu. 2007)

Fig.8 The snap-off points of the undersea cables

According to the analysis by Chunghwa Telecom Company, the snapped undersea cables were mainly caused by 3 main reasons below:

- (1) The undersea cables were snapped immediately by powerful external forces, especially SMW3 which was located at the epicenter, embraced enormous external forces which finally snapped it to six.
- (2) The earthquake induced seabed movement and turbid flow which then snapped-off the undersea cables and flushed them away from their original route.
- (3) The earthquake induced seabed movement, collapsed soil or turbid flow which then snapped-off and buried the undersea cables which were located at a seabed valley or cliffy slope areas.
