PROPOSAL TO SAFEGUARD EXTERNAL WALLS
AND PARTITIONS DURING EARTHQUAKES

C. Baggio (I)

M. Cestelli Guidi (I)

F. Piccarreta (I)

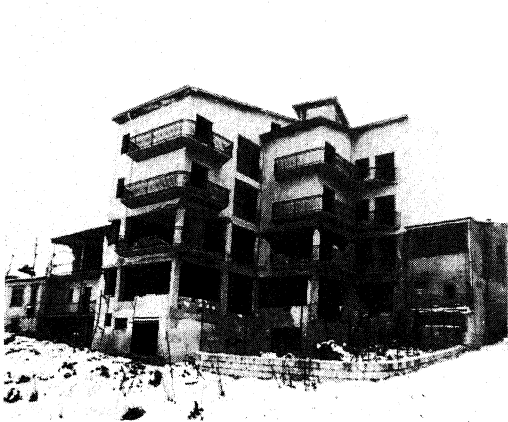
crease in stresses in the infilled frames (Run A), none of which was damaged in Run O. In the consecutive runs, A, B and C, "sequential" failure occurred both in the infilling panels and in the columns, always at about the same acceleration of around 1 m sec^{-2} . In Run D, failure of panels and columns occurred at ground acceleration of 2 m sec^{-2} , while failure of some columns due to combined compressive and bending stress occurred at this level of acceleration. In Run E, three infilling panels on the first floor and three on the second remained. Five of these failed even at an acceleration of about 2 m sec^{-2} . Total failure of the first and second floor panels virtually occurred on this run, while damage on higher floors was still slight, with some panels on the verge of collapse. The accompanying photographs of the building provide a general picture and the more significant details of the damage encountered after the November 1980 earthquake (Ref.5). It can be seen from Photo 1 that there was total failure of the brick panels on the 1st and 2nd floors, while the amount of damage to the external walls and partitions of the higher floors is slight. Photo 2 details the shear failure of Column 21 at the 2nd floor (see also Photo 1), detected in Run A of the analysis. Photos 3 and 4 both relate to the 2nd floor. They illustrate the amount of damage that occurred to the partitions, the external walls and the columns.

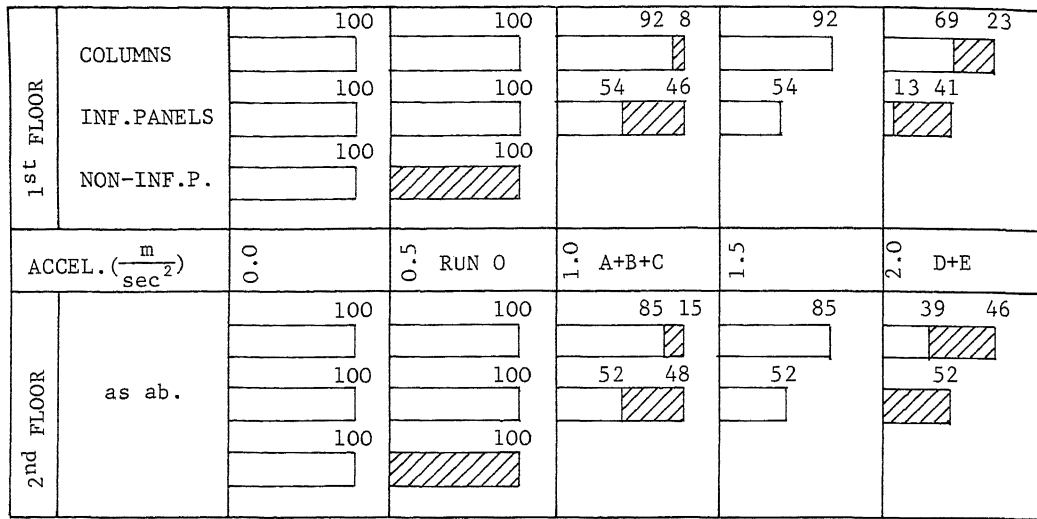
Fig. 4 - Progression of damage to columns and panels in the six steps of the calculation, for the first two floors of the building above ground. The elements damaged are expressed as a percentage of the total (shaded area)

Six computer runs were performed, namely O, A, B, C, D and E. The results are given in Fig. 4 which indicates the failures of brick panels and columns gradually eliminated in the successive runs. Comparison of runs O and A reveals the contribution of the non-infilling panels: these fail at accelerations of around 0.5 m sec^{-2} (so they were eliminated in Run A) resulting in an in-

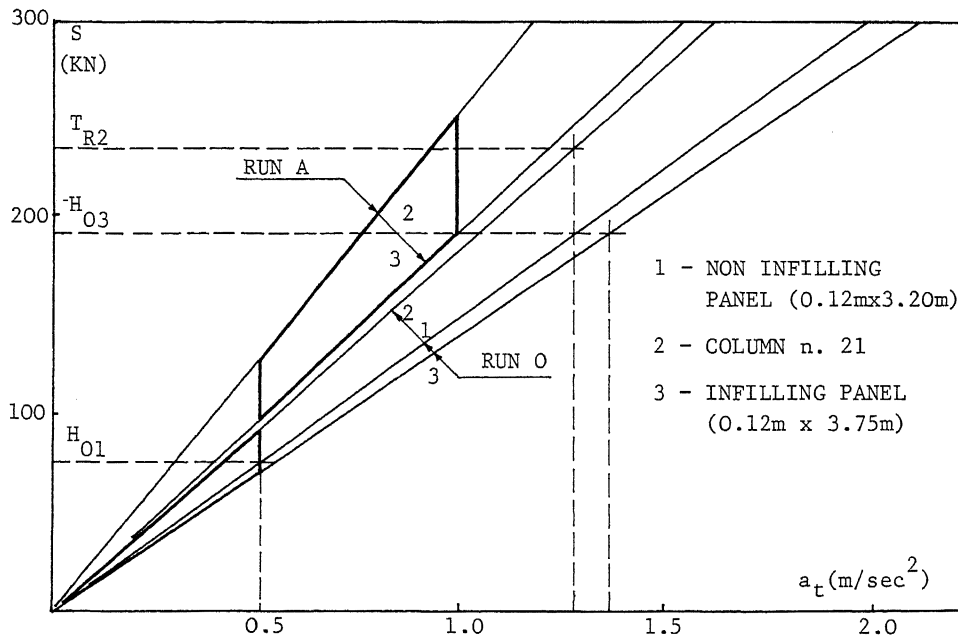
Fig. 5 - Shear forces as a function of ground acceleration, at RUN 0 and RUN A, on three structural elements (the first to reach collapse, for each category)

Buildings of the type considered suffer quite considerable damage even at low seismic intensities. To reduce repair costs the strength of all the non-infilling panels must be increased, thus ensuring an indirect benefit for all the other structural elements too. This fact is evident from Fig.5 which indicates as a function of a_t the trends of the shear forces on three typical elements - each representative of a category - at Run O (when all the panels are present) and at the following Run A (when the non-infilling panels have disappeared). Hence, to bring ground acceleration which results in the collapse of the first structural elements (non-infilling panels) to about 1.3 m sec^{-2} , the increase in strength required is defined, with reasonable accuracy, by the ratio $H_{03}/H_{01}=2.5$, and can be obtained by improving the connection between the sides of the panels and the horizontal structures.
