# GEOLOGICAL CONDITIONS AND SOIL DEFORMATIONS IN THE JULY 17, 2007, CHUETSU OFF-SHORE EARTHQUAKE

KEYWORDS: Chuetsu Offshore Earthquake, sand dunes, crack patterns, infrared images

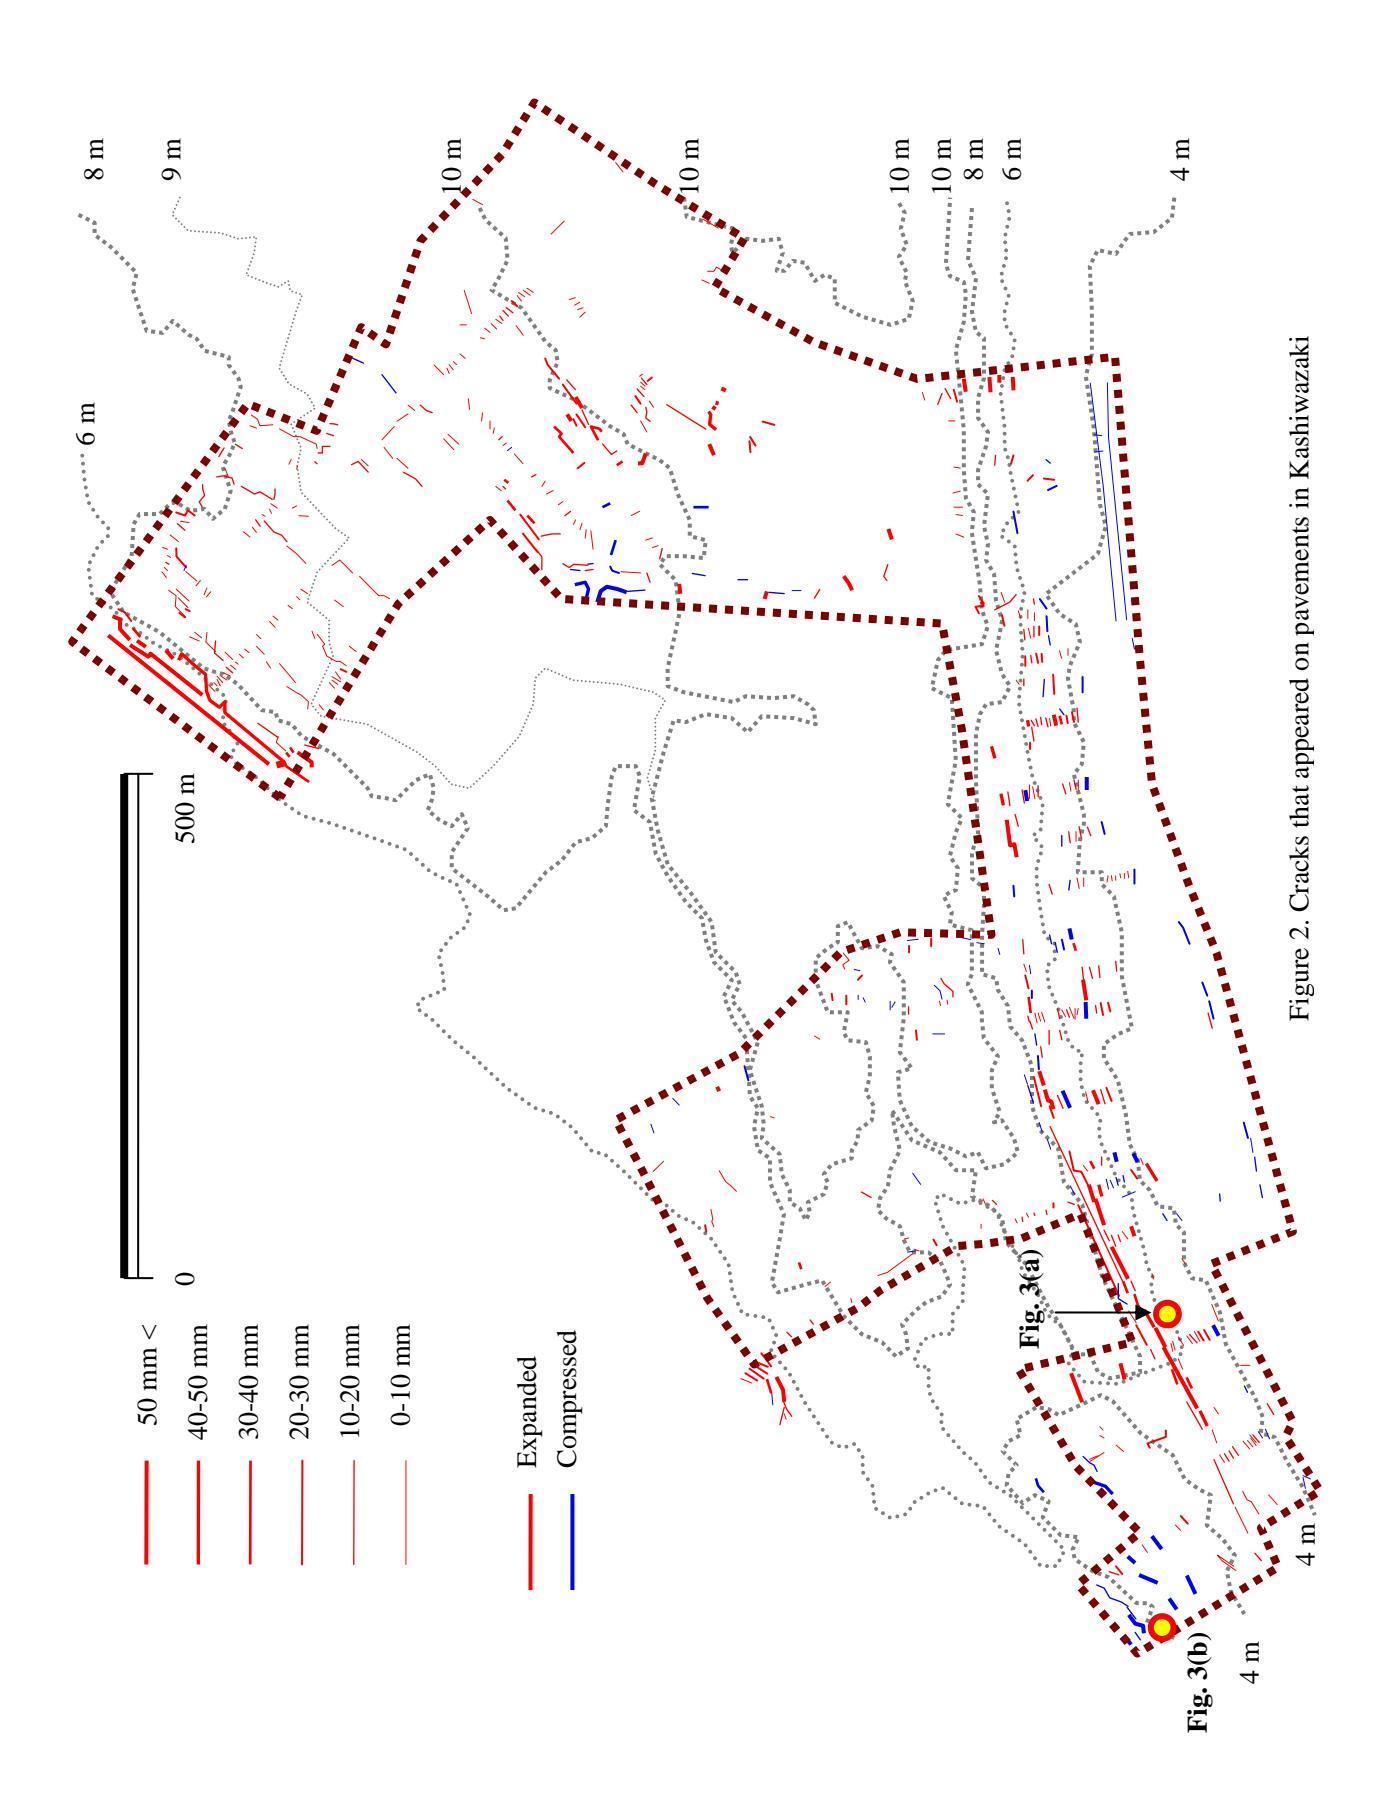
Fig. 2 is a map of cracks that appeared on pavements in the area enclosed with broken line in Fig. 1. Red and blue lines show respectively open cracks (Fig. 3(a)) and compressed marks (including those colliding over the others, buckled up; see Fig. 3(b)). Most clusters of open cracks are found along ridges of the sand dunes while many compressed marks were found along toes of the dunes and some were found along an S-shaped sagged zone among the sand dunes. These cracks and compressed marks show that the steep slopes of these sand dunes have subsided towards wet flatlands and sagged zones, and many dwellings were flattened near these "slip faces".

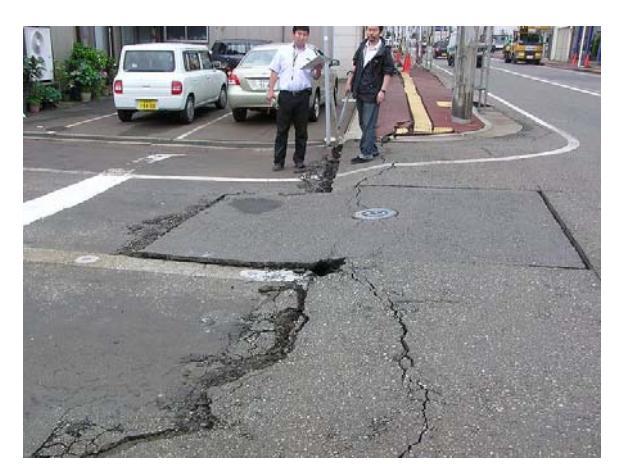
(a) Crack opened along ridge of sand dune Figure 3. Cracks and buckled m (b) Pavement buckled up along the toe of sand dune

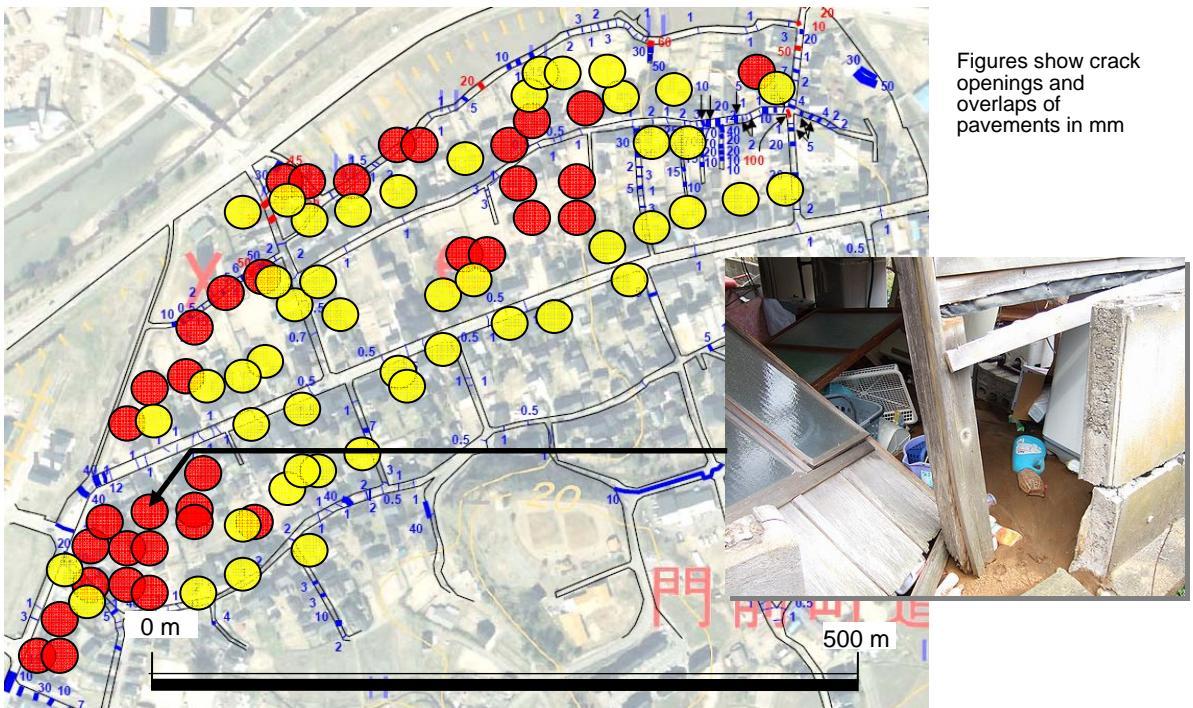
Figure 4. Dwellings in Toge, Wajima City, destroyed in the March 25<sup>th</sup> 2007, Noto Earthquake. Yellow circles are severely damaged houses, while red circles are completely flattened.

This case example is remarkably similar to the damage to dwellings due to the March 25<sup>th</sup> 2007, Noto Earthquake. The earthquake shook Toge, a remote habitation of Wajima city. Though damage to houses was all severe, those completely flattened were only found within an about 100m-wide brush as shown in Fig. 4. Within this wide brush, both open cracks and compressed marks of road pavements were densely found. Though either the crack openings or overlaps of the pavements are small, they may have been large enough to dislocate houses

off their foundations (Photo in Fig. 4).

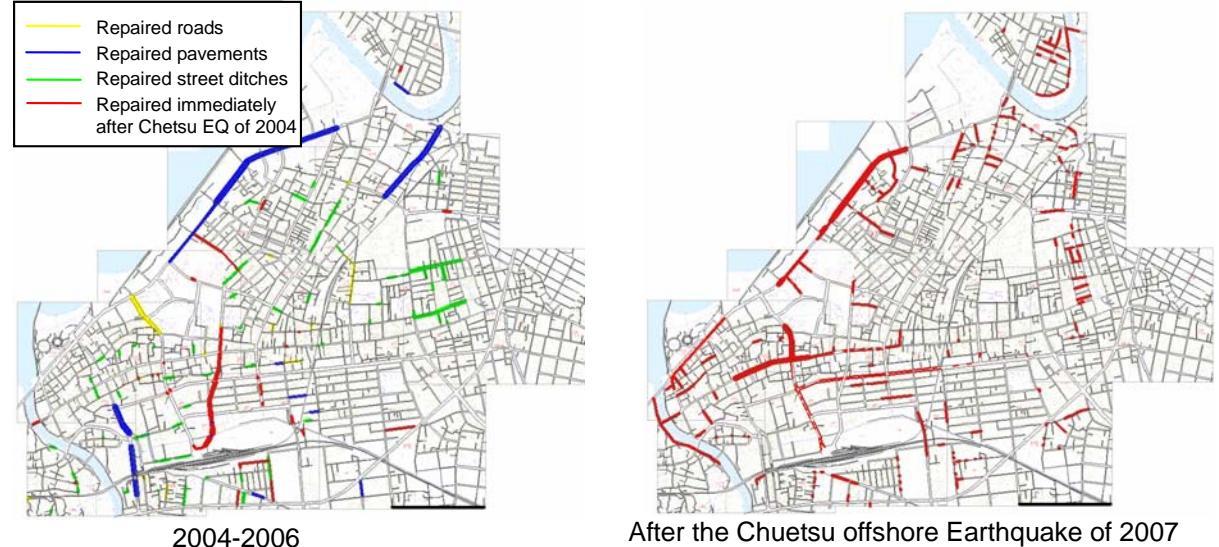
Figure 5. Repair works before and after the 2007 Chuetsu offshore earthquake Location of lower left corner of the satellite imagery: 37°21'37.48"N, 138°32'34.43"E

It is also noted that the crack pattern that appeared on the pavements in Kashiwazaki overlaps the locations of ordinarily occurring repair works in the city (see Fig. 5). In other words, ordinary geotechnical problems may hint possible damage to lifeline facilities. A further study will be needed to supply the scenario with more quantitative underpinning.

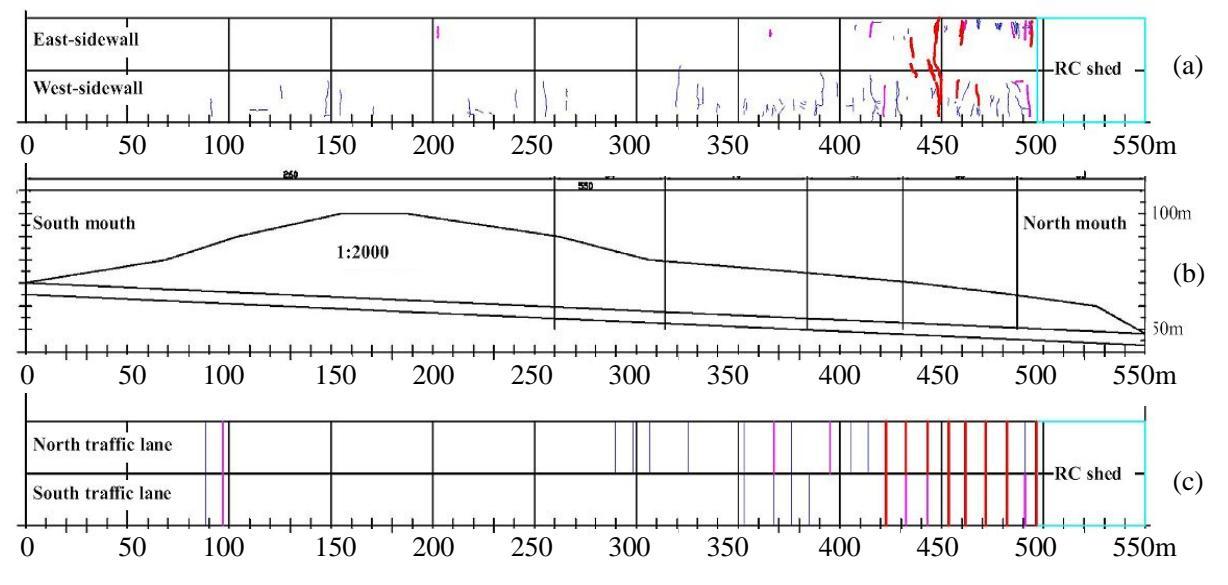
Kariwa Tunnel (South mouth at 37°26'15.61"N, 138°36'42.79"E) goes through a sand dune at a height of about 100m rising immediately behind the Kashiwazaki-Kariwa Nuclear Power Plant. This 500m-long tunnel goes straight north for the first 300m distance from the south mouth, and takes a gentle turn to west. The traffic through the tunnel was once suspended for a quick inspection, but it was called off immediately after confirming that there was no serious crack which could affect the serviceability. Though the cracks looked like nothing much to worry about, they can show how the surrounding sands have been displaced in the intense shake. Figs. 6(a), (b) and (c) show the development of the tunnel lining with its outer wall outside and the western side up, longitudinal section along the tunnel alignment, and cracks that have appeared on pavements, respectively. Most cracks were found within a 100m-long segment near the north mouth of the tunnel, and openings of these cracks were generally larger on the west wall than those on the east wall, indicating that the north end of the tunnel was bent northeast-wards, namely towards the toe of the sand dune. Fig. 7 shows the northern 100m segment of the tunnel. This part of the tunnel wall was covered up with a carbon-fiber sheet when the inner wall was first repaired in 2001, six years before the earthquake. It is noted that the sheet came obliquely off along the two thirds height of the west tunnel wall. This flaking of the sheet and diagonal cracks that appeared on the concrete north entrance of the tunnel indicates that the tunnel cross-section was diagonally deformed in oval probably due to soil pressure behind the west wall of the tunnel. Water leaks were more visible on the west wall of the tunnel than those on the east wall, suggesting that the tunnel is blocking underground water behind its west wall. Fig. 8 shows infra-red image of the carbon-fiber sheet that has flaked off in the earthquake. Behind the sheet, which has been stapled to the tunnel wall before the 2007 earthquake, there clearly appear cracks of the concrete wall. This shows that the damage to tunnel was severe where ordinary repair works were needed.

Figure 6. (a) Development of the tunnel lining, (b) longitudinal section along the tunnel alignment, and (c) cracks that have appeared on pavements

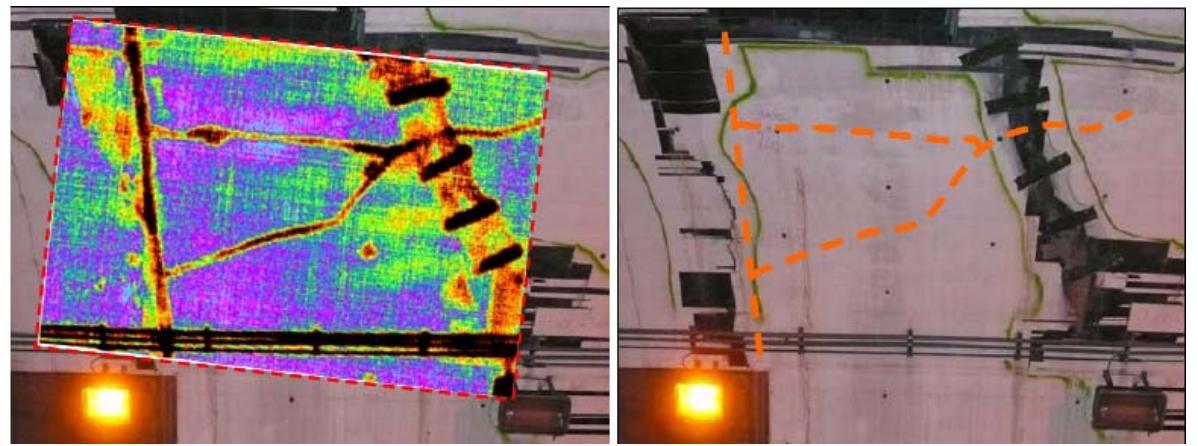
Figure 8. (left) Infrared image of cracks hidden behind carbon-fiber sheet covering the tunnel wall.

At Oumigawa station of the JR Hokuriku railway, where a landslide mass has covered its western approach, a infrared image of the escarpment clearly showed streaks of underground water seeping out at some locations along two major boundaries among the geological formations. The Infrared camera also allowed to detect cracks hidden behind the carbon-fiber sheet covering inner wall of Kariwa Tunnel. These pieces of information can be useful for quick recovery works.

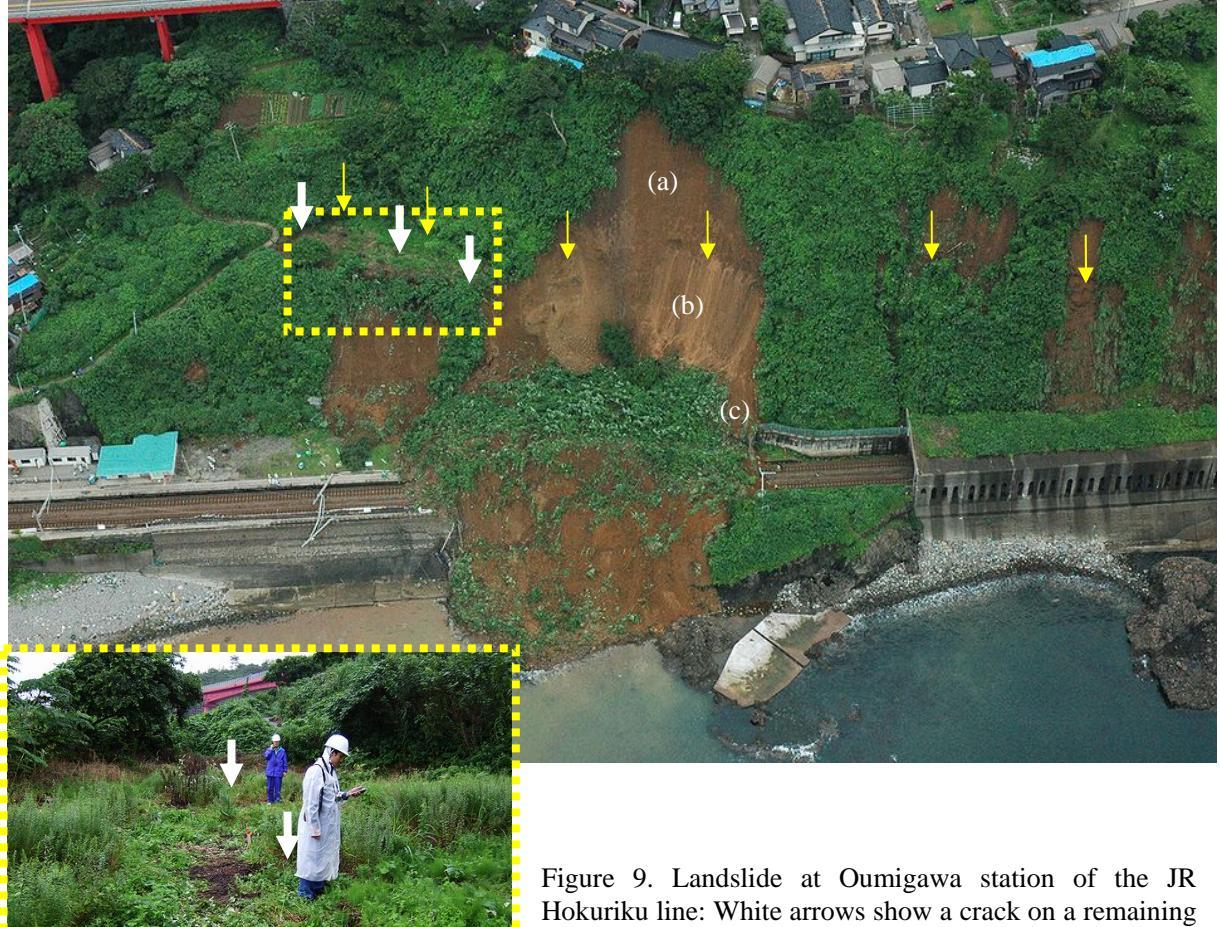
A slope failure occurred at Oumigawa station (37°20'46.24"N, 138°29'10.00"E) of the JR Hokuriku railway, and the soil mass covered its western approach (Fig. 9). Water is seeping out along a layer boundary slightly dipping west across the entire terrace (see yellow arrows in Fig. 9). At the time of our group's third visit to Oumigawa station on July 30, some recovery works have started and the soil mass covering the railway had been partially removed. The geological stratification was inferred from a close-up of the failure surface that appeared south behind the station. There are three major geological formations exposed on the failure surface: (a) sand and gravel terrace deposit, (b) inter-bedding formation of volcanic conglomerates and mudstones, and (c) mudstone, from the top.

This terrace deposits dates back to the geological time of about 0.11Ma (Kobayashi et al, 1995). Streaks from layer boundaries show that ground water is seeping out from the boundaries among the exposed geological formations. Yoneyama formation ((b) and (c) in Fig. 9), immediately below the (a) terrace deposits, is inferred as a base rock of Pliocene period. It has a strike in nearly E-W direction and dips about 8 degrees to north (Kobayashi et al, 1995).

This inter-bedding formation consists mainly of volcanic conglomerate. Thin lenses of mudstone are found bedding in at some locations along the boundary between two formations (a) and (b). These lenses are weathered, and are more compact than the overlying terrace deposit.

Hokuriku line: White arrows show a crack on a remaining soil mass on the left of the slope. (aerial photo from Aero Asahi Co.)

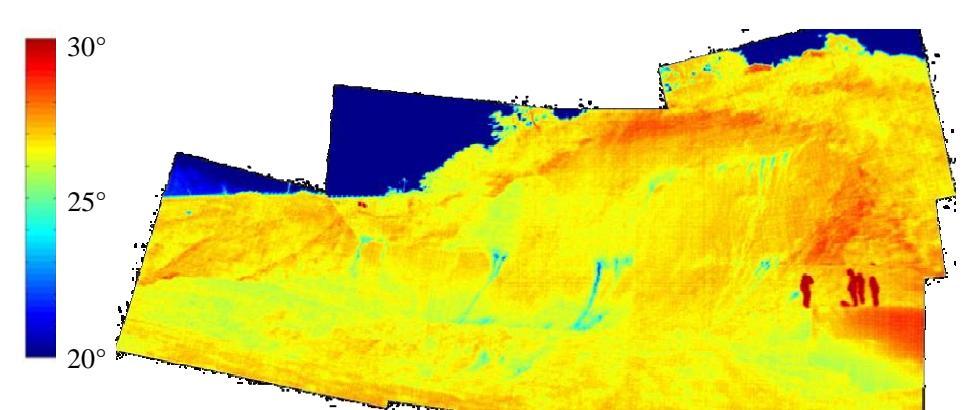
Figure 10. Infrared image of slope surface. Color scale shows "degrees" on Celsius temperature scale.

With an infrared camera (NEC SanEi TH702MV), we took images of the whole failure surface. Blue to green streaks of underground water (20-25 degrees on Celsius scale) are found seeping out at some locations along two major boundaries among the geological formations. This information together with the geological information can be useful for the recovery works. E.g. drainage installations can be concentrated in areas where waters are seeping out.
