PERFORMANCE OF BRIDGES IN LIQUEFIED GROUND DURING 1999 CHI-CHI EARTHQUAKE

D.B. Chu¹, S.J. Brandenberg² and P.S. Lin³

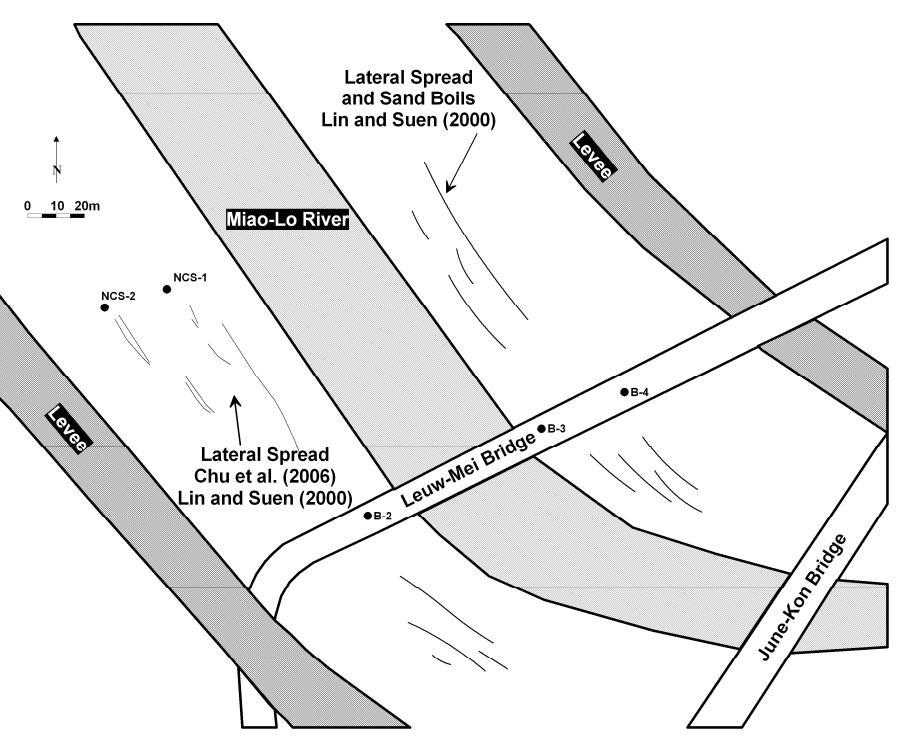
rection after the earthquake (Lin and Suen 2000). A 20 cm vertical offset was observed at the pier supporting one side of the steel cable stay span because the steel span was supported on taller bearings than the reinforced concrete span, and therefore settled more when the bearings crushed. No damage or permanent deformations of the foundations were observed after the earthquake, hence the cause of damage to the bearings was attributed to inertia loads.

The abutments of the Leuw-Mei Bridge were founded on spread footings, while the pier columns were founded on large 5m diameter reinforced concrete caissons embedded to depths of 17 man 80-cm-thick reinforced con- tions of soil site investigations. crete ring with the center backfilled with soil, except in the bottom 3m, which was filled with unreinforced concrete, and the upper 2m, which comprised a reinforced concrete cap. The caisson detailing in Fig. 3 is for man man man and the middle portion of the caisson at the location where the arrows are pointing in the figure. A total of 100 19¢ bars ran in the longitudinal direction around the perimeter of the wall, with 50 bars near the inside of the caisson and 50 near the outside. The lower portion near the tip of the caisson was more heavily reinforced presumably due to stresses anticipated during construction of the foundation. However, large demands near the tip of the caisson due to earthquake loading (either Figure 2: Photo of Leuw-Mei Bridge (Courtesy of Rob Kayen). inertia or lateral spreading)

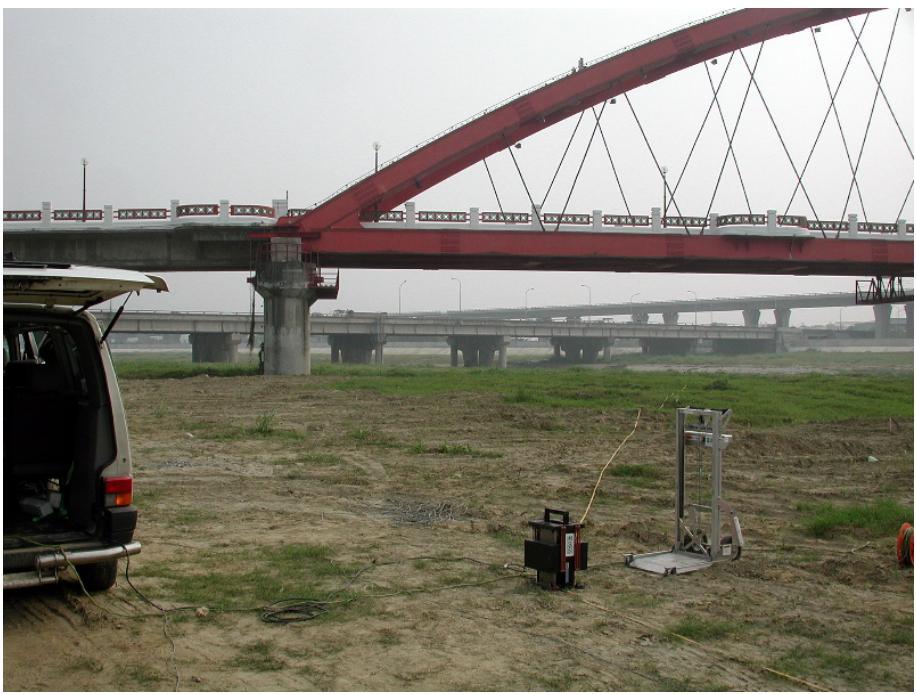
(Fig. 3). The caissons consist of Figure 1: Plan view of Leuw-Mei Bridge, observed lateral spreading, and loca-

While the bridge damage was attributed to strong shaking and resulting inertia loads, surface evidence of liquefaction and lateral spreading was also observed near the bridge. The young alluvial river bank deposits on both sides of the river liquefied and spread laterally (Lin and Suen 2000, Chu et al. 2006), with displacements as large as 25*cm* measured by Chu et al. (2006). Surface evidence of lateral spreading was not apparent in the soils along the bridge axis, but was apparent on both banks of the Miao-Lo River both upstream and downstream of the bridge. The presence of lateral spreading all around the bridge, but not along the axis of the bridge, leaves two possibilities: (1) the soil was stronger near the bridge, and therefore not as susceptible to lateral spreading as the soils upstream and downstream, and/or (2) the bridge components imposed forces on the soil that restrained downslope displacements, thereby reducing the observed lateral spreading amplitude. Possibility (1) will be explored first.

Liquefiable deposits were observed about 100 m north of the bridge by Chu et al. (2006) at a lateral spread site they referred to as "Nantou Site N" (see points NCS-1 and NCS-2 in Fig. 1). A saturated silty sand deposit with $(N_1)_{60}$ values ranging from 10 to 20 blows per foot was determined to have liquefied and caused the observed lateral spreading deformations of as much as 25 cm toward the Miao-Lo River. The water table was at a depth of only one meter at the time of their investigation. A similar deposit was encountered in the site investigation conducted prior to construction of the bridge (Foo-Ting Engineering Corporation, 1995) along the bridge axis about 100 m south of Nantou Site N (see points B-2, B-3 and B-4 in Fig. 1). The soils encountered at these two locations had high content of nonplastic fines and classification ranged from SP to ML. Uncorrected SPT blow counts are presented in Fig. 4 for the two different site investigations. The reason for using uncorrected blow counts is that insufficient information is provided in the report by Foo-Ting to correct those blow

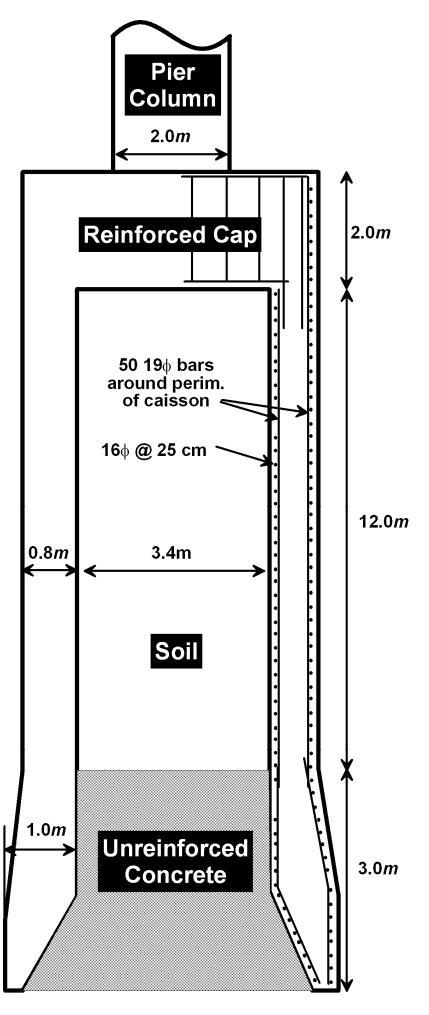
would not be anticipated since the caissons were embedded deeply in competent soil. Hence, the heavy reinforcing in this region is expected to have little impact on the seismic performance of the caisson.

Figure 3: Construction detail of reinforced concrete caisson supporting pier columns of Leuw-Mei Bridge.

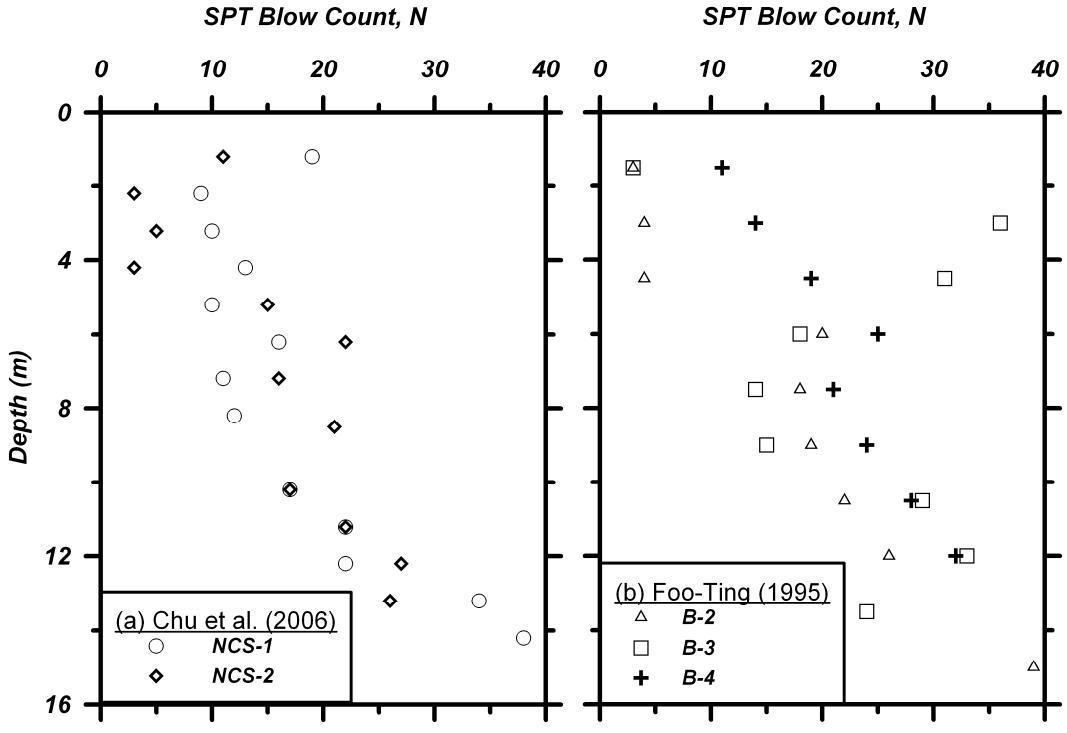
counts, and uncorrected blow counts likely provide a more direct comparison of soil conditions assuming that similar drilling methods were used for the two site investigations. The upper 5*m* of the soils on the east side of the river (B-3 and B-4) exhibit higher blow counts than the soils on the west side of the river (B-2, NCS-1 and NCS-2), though lateral spreading was observed on both sides of the river. Soils on the west side of the river exhibit similar blow counts whether encountered along the bridge axis (B-2) or 100*m* north of the bridge (NCS -1 and NCS-2). The similarity in blow counts encountered at these locations does not support the conclusion that the observed ground deformations can be attributed solely to differences in soil properties. Hence, it is reasonable to expect that the soil along the bridge axis would also have spread in the absence of restraining forces provided by the bridge components.

Figure 4: Soil borings near the Leuw-Mei Bridge by (a) Chu et al. (2006) and Foo-Ting (1995).

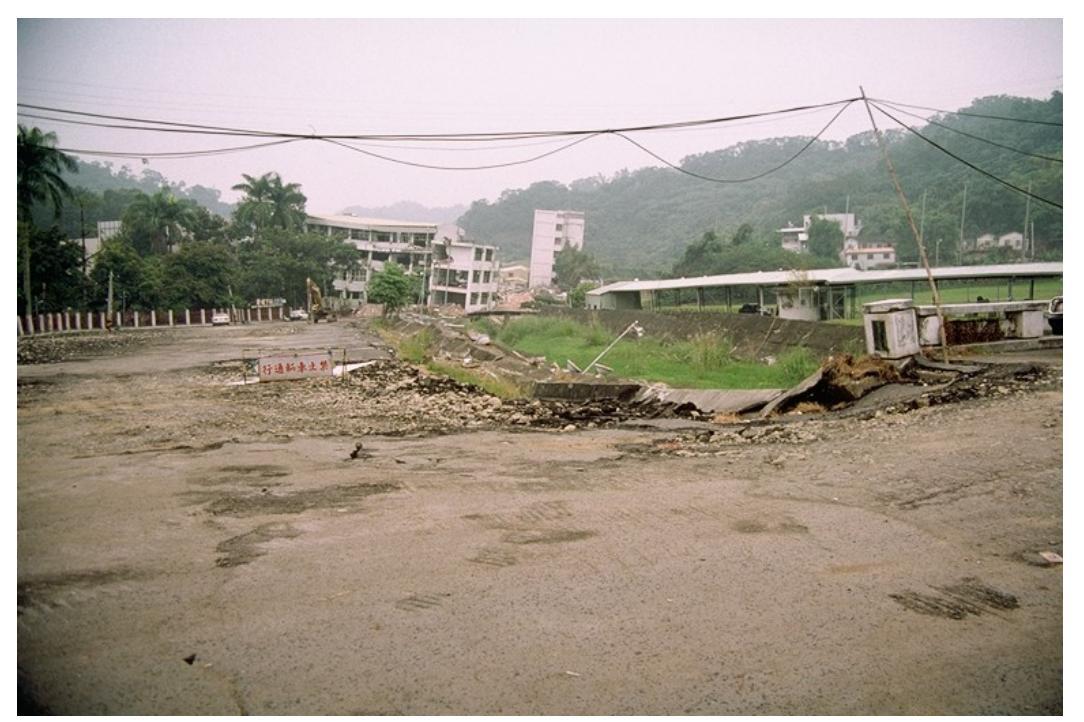
Chu et al. (2006) documented lateral spread features in the vicinity of three short single span bridges crossing creeks, and none of the bridges suffered structural damage in the earthquake. The Min-Yee (Fig. 5), Zen-Ho, and Lin-Shen bridges in Wufeng were in fact utilized for drill rigs and cone penetrometer equipment during reconnaissance efforts and site investigations of the lateral spread sites. The structural properties, including foundation properties, of these bridges is unknown by the authors, but the bridge abutments most likely rest on spread footings simply because deep foundations would be unlikely for such short spans. A typical pattern of ground deformation involved lateral spreading of the banks toward the creek at some distance from the bridge, with diminishing displacement amplitude approaching the bridge and no signs of deformation behind the abutments (Fig. 6). A likely explanation for this displacement profile is that the bridge acted as a strut that resisted lateral spreading demands via mobilization of compressive stresses in the bridge deck. Without bearings, simple supports, or connections to intermediate piers, the only possible mode of damage to the single span bridges would arise from excessive compressive stresses being mobilized in the deck. In the case of the three bridges documented here, the compressive stresses were in the tolerable range. However, liquefaction-induced settlement at the approach of a bridge may cause a vertical offset that must be re-graded to return the bridge to service. Hence, a bridge that is structurally undamaged may still fail to meet a performance criterion of immediate service when liquefiable soil deposits are present. Such cases were observed in the 2007 Niigata Chuetsu-Oki earthquake (Kayen et al. 2007). Immediate service may be necessary, for example, for emergency vehicles following an earthquake.

Figure 5: Photo of Min-Yee Bridge (right side of photo) and creek showing signs of liquefaction and lateral spreading (Courtesy of Raymond Seed).
