ON THE PROBABLE CAUSE OF THE FAILURE OF KANDLA PORT AND CUSTOMS OFFICE TOWER DURING THE 2001 BHUJ EARTHQUAKE

Suresh R. Dash¹, L. Govindaraju² and Subhamoy Bhattacharya³

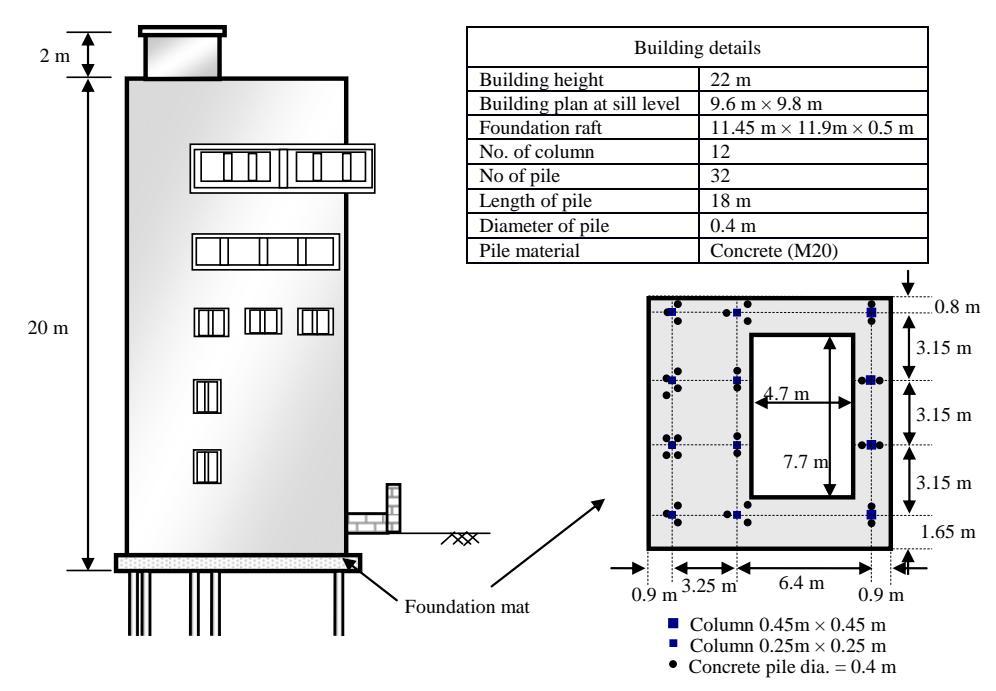
The building was founded on 32 short cast-in-place concrete piles. Each pile was 18m long and 0.4m in diameter. The piles were passing through 10m of clayey crust and then terminated in a sandy soil layer. The loads from superstructure are transferred to the piles through the foundation mat, which eventually acts like a pile cap. Major structural details of the building are shown in Figure 2. The service load of the building is estimated to be 10749kN. The details of the calculations can be found in Dash et al (2008). Assuming equal sharing of the vertical loading, the static axial load per pile is about 336kN.

Figure 2: Major details of the Kandla Port and Customs Office tower

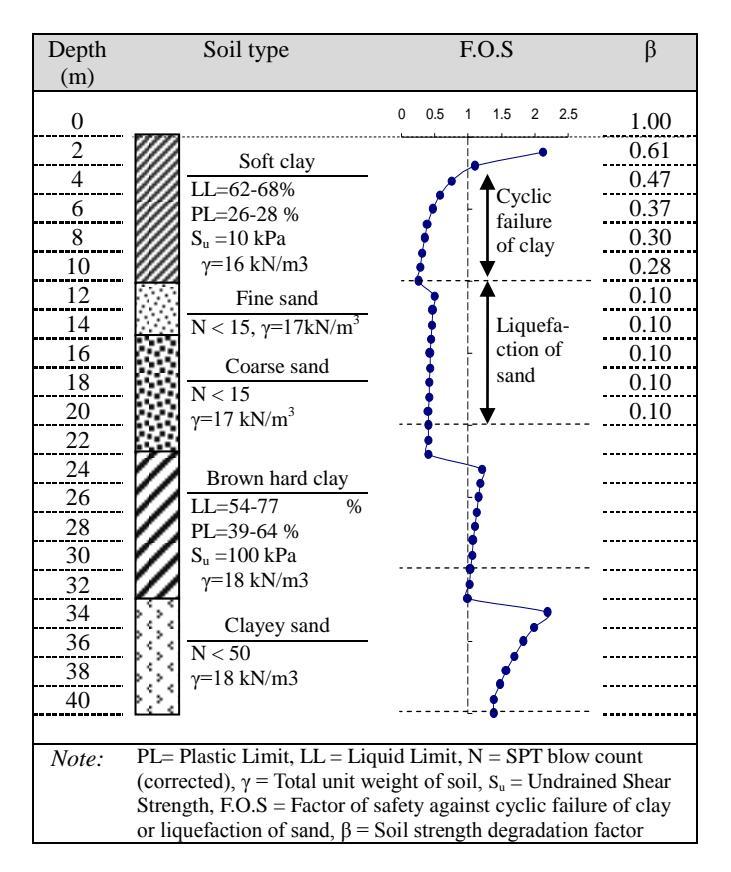
The Port of Kandla is built on natural ground comprising of recent unconsolidated deposits of interbedded clays, silts and sands. The water table is about 1.2 - 3.0m below the ground level. Figure 3 shows the borehole profile (taken from EERI, 2002) of the natural ground near to the building. Post earthquake observations indicated that the ground in the vicinity of the tower settled by about 30cm (one foot), resulting in the settlement of the floating mat floor of the building. There were evidences of extensive liquefaction with ejection of sand through ground cracks in the vicinity of the building. Post earthquake observations also reveal lateral spreading in many places in the Kandla port area.

For the soil at building site, the potential for liquefaction of sandy soils has been evaluated based on the method recommended by Idriss and Boulanger (2004). Further, cyclic failure in clays has been evaluated based on the new procedure proposed by Boulanger and Idriss (2005). The results of these analyses give factor of safety (F.O.S) against liquefaction potential and cyclic failures with depth as presented in Figure 3. It is evident from the figure that most part of the clay layer except the top 2m undergoes cyclic failure that may result in ground deformation and cracking. Furthermore, the entire sandy stratum between 10m to 22m is likely to have experienced liquefaction which may result in ground settlement and flow failure.

clayey soil, the strength degradation factor (β) is calculated by using the computer program SHAKE. The PGA at site is considered to be 0.33g. The degraded strength for liquefied sandy soil is taken as 10% of the strength of non-liquefied sand as suggested by AIJ (2001) code. The strength degradation factors for the soil at the site for different depths are presented in Figure 3.

Figure 3: Soil profile at site, liquefaction potential and cyclic mobility analysis results

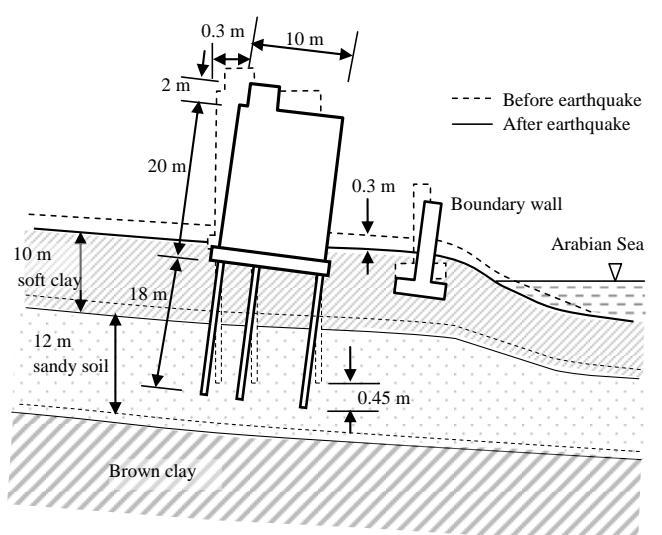
Based on the surface measurement, the pre and post earthquake configuration of the building is schematically drawn in Figure 4. From the soil-pile configuration, with an assumption that there was no structural failure of the piles, it can be inferred that the pile tip could have settled about 45cm (30cm ground settlement + 15cm building settlement) from its original position. As there were very little damage to the superstructure and all the damages were in the foundation, a numerical model has been developed using SAP (CSI 2005) to study the seismic response of the foundation during earthquakes. The modeling details are described below.

Figure 4 Schematic showing the tilting of the building assuming no structural failure in it.

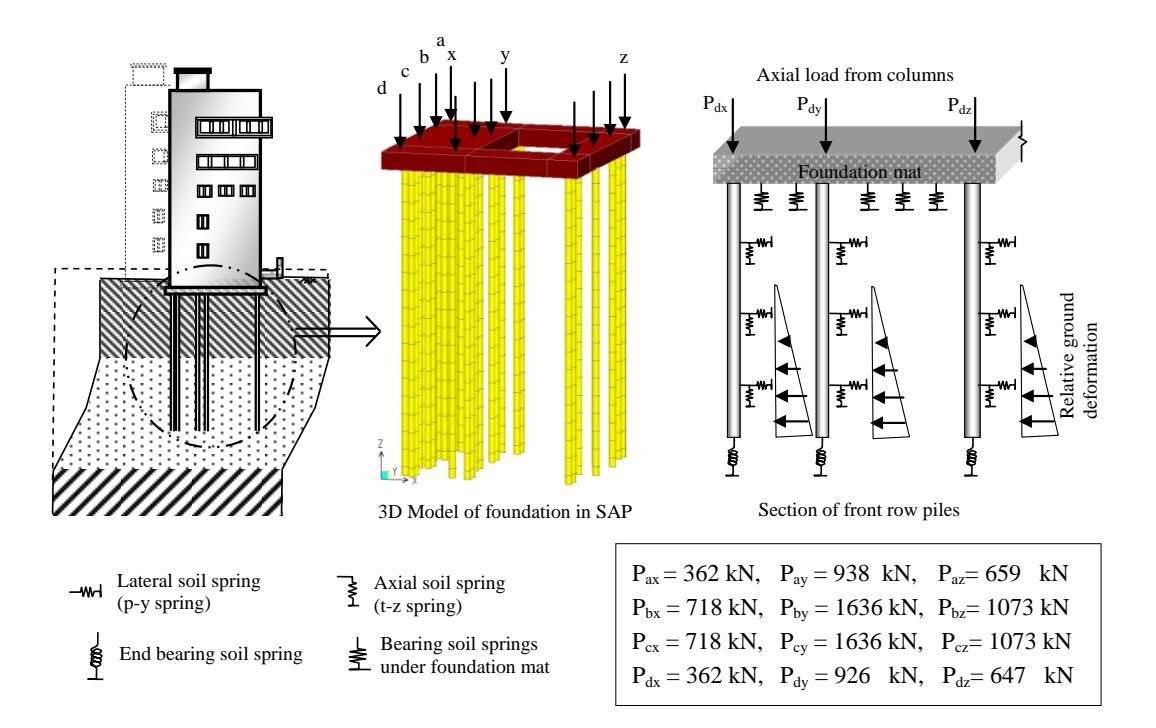
Figure 5 details the mat-pile-soil interaction model of the foundation system. The column loads are applied at the foundation mat level at their locations. The analysis is carried out by applying the superstructure load as well as the lateral spreading simultaneously to investigate the combined response of settlement and lateral spreading. The superstructure is assumed to be rigid and the dynamic effects have been ignored. The bottom 8.5m of the piles were ending in the liquefied zone having very less or no confinement during liquefaction and hence behaves like hanging piles. As discussed in section 5.2, these piles are subjected to negative relative ground displacement in the bottom 8.5m zone. In the present study, a pushover type of analysis is carried out applying the relative ground movement to the piles along with the axial load coming from superstructure. The analysis is carried out for both service condition (i.e., response before earthquake) and seismic condition (i.e., response during earthquake), and the results are discussed in the following section.

Figure 5: Detailed model description of the foundation system including mat-pile-soil interaction

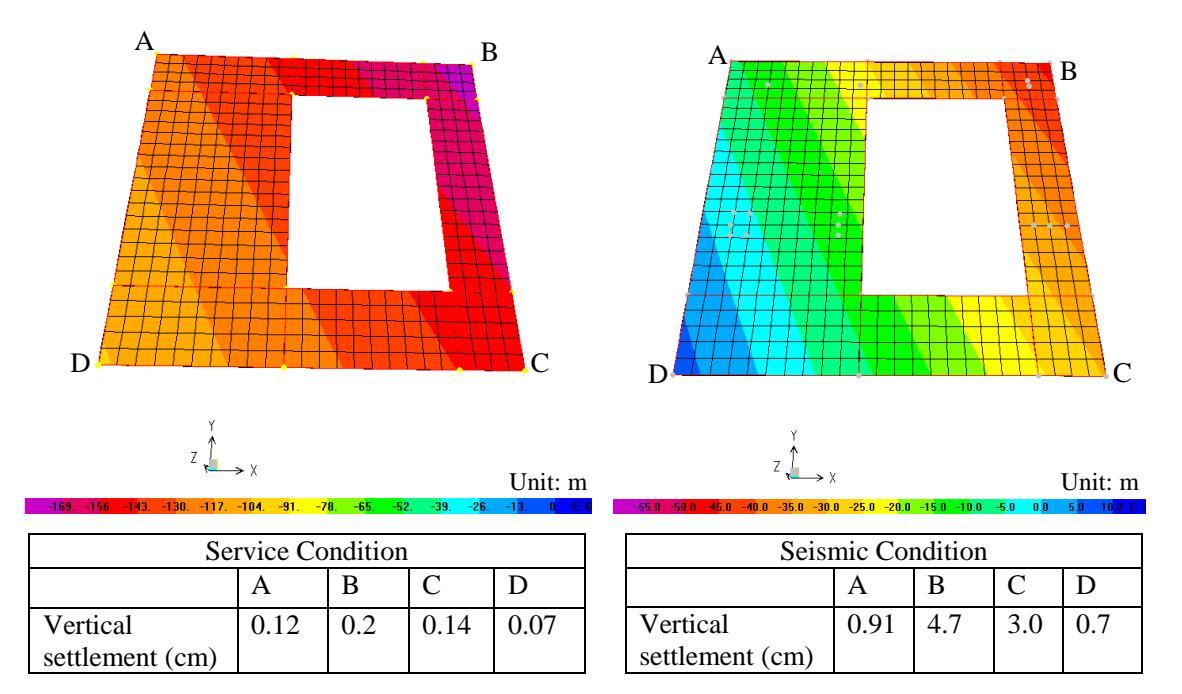
The analysis for service condition of the building shows that the maximum settlement of the building at service condition is about 0.2cm, which is within the permissible limits as suggested in most of the codes of practice. Figure 6(a) shows the deflection profile of the foundation mat for the service load. The analysis shows that the distribution of mass and stiffness of the structural system is such that the building tilts towards the sea side with more inclination towards the north end.

Figure 6(b) shows the pattern of foundation mat deflection obtained from the analysis for seismic condition. The figure shows the deflection contours of the foundation mat in the direction of gravity. The analysis shows that the foundation raft settled about 4.7cm at B. The mass distribution of the superstructure would hint that the building would tilt away from the creek (i.e. towards the eccentric building mass or towards the left in Figure 4) as the centre of mass (CM) is on the left of the geometric centre of the building. However, the cut-out in the foundation mat shifts the centre of resistance (CR) even left of the centre of mass causing the building to lean towards the Kandla creek i.e. towards right in Figure 4.

Figure 6: Deflection profile of foundation mat at: (a) service condition and (b) seismic condition
