SEISMIC EVALUATION AND RETROFIT PLAN OF EXISTING REINFORCED CONCRETE BUILDINGS OF ALGIERS IN ALGERIA

Akira INOUE¹, Mehani YOUCEF²

¹OYO International Corporation, Tokyo, Japan, ²National Earthquake Engineering Research Center (CGS), Algiers, Algeria Email: inoue@oyointer.com

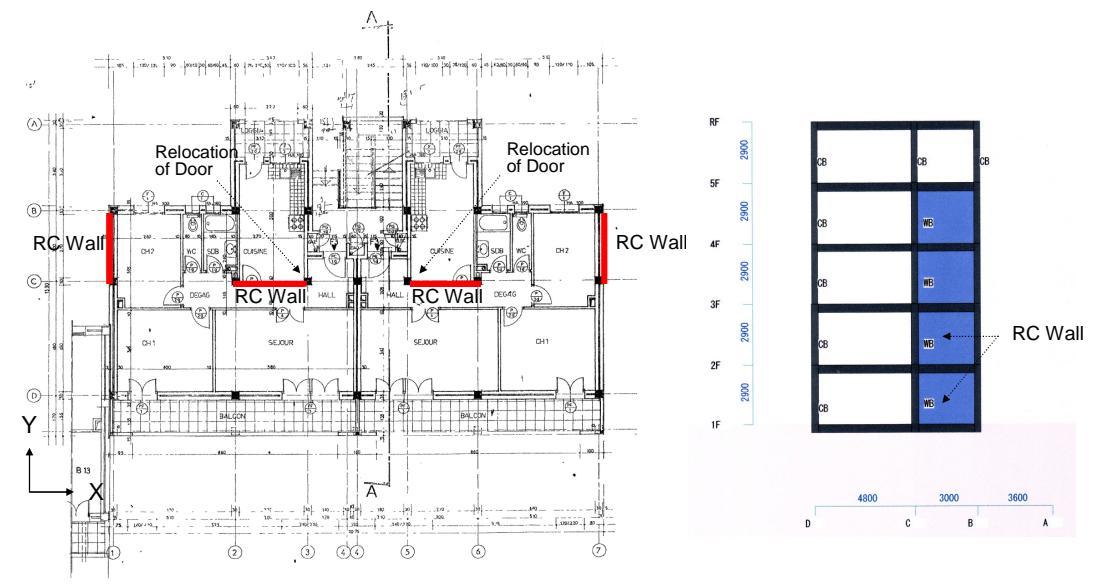
Figure 1 Framing Plan (Left) and Framing Elevation of Grid 1 & 7 (Right) for Retrofit

This building is a typical apartment house of reinforced concrete moment frame with cast-in- place concrete, and was designed based on "The Algerian Paraseismic Regulations RPA 88". Typical column sizes are 35cmx35cm, and 30cmx30cm at the 1st storey. Concrete strength by the core sampling was 27.5 N/mm². Hoops are $\phi 8mm@100mm$. All walls are hollow brick works. The Seismic Index of Structure, *Is*, was 0.40, and C_TS_D was 0.18 and were not satisfactory. It is noted that columns were evaluated as flexural columns but the ductility index of columns was low because of the high axial force ratio at the 1st storey.

The method that providing RC walls for the 1^{st} storey to the 4^{th} storey was planned to increase strength, as shown in Figure 1. These were evaluated as flexural walls with the ductility index of 2.0. The value of *Is* of the 1st, 2nd, 3rd and 4th storey were increased to more than 0.50 as shown in Table 1. The relationship of the ductility index and the strength index at the 1st storey is shown in Figure 2. Typical detail for retrofit of reinforced concrete wall is shown in Figure 3.

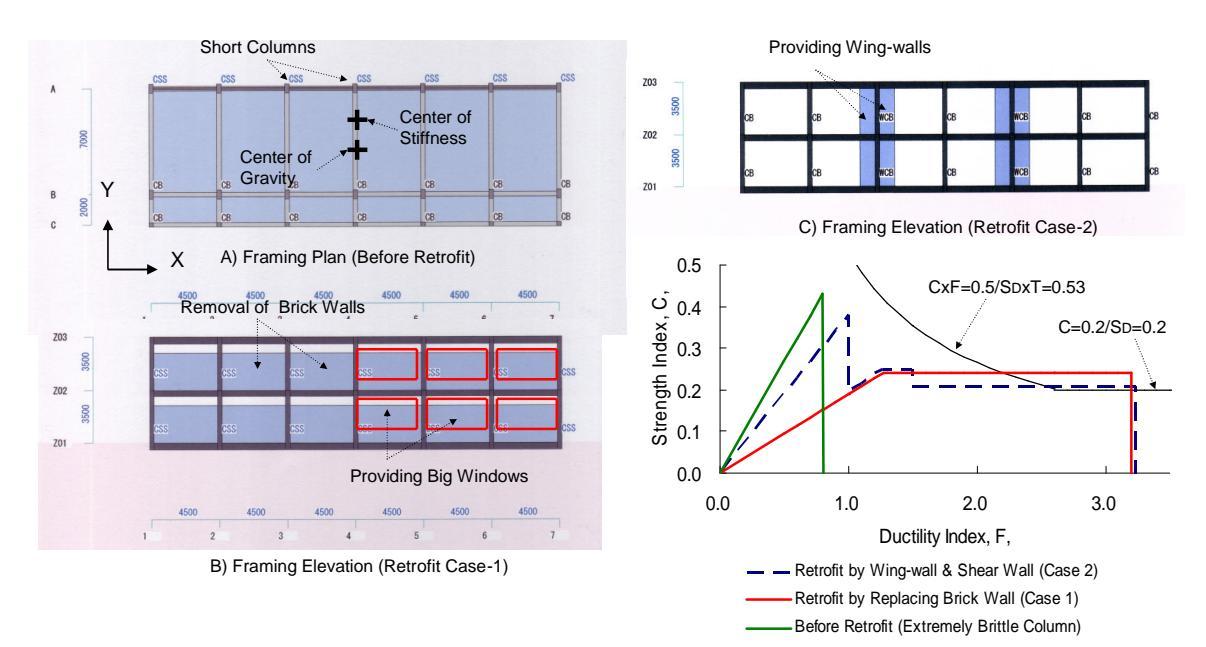
Figure 4 Framing Plan (A) and Elevation (B, C)

This building is a typical school of reinforced concrete moment frame, and was designed based on RPA88. It was supposed that columns were short columns due to solid brick walls at the Grid A in the X direction. The value of *Is* in the X direction was low before retrofit, because of the extremely brittle columns and the eccentricity caused by the brick walls as shown A) of Figure 4. Refer to Figure A2 of Appendix 3 for shear failure of short columns for reference. Typical column sizes are 60cmx30cm and 30cmx30cm. Hoops are ϕ 8mm@100mm at top and bottom. The value of *Is* before retrofit in the X direction of the 1st storey is as follows. *Is*=*EoS*_D*T*=0.34x0.80x0.95=0.26 < 0.5

Columns at grid A are modified from extremely brittle columns to flexural columns by replacing the walls and windows as shown B) of Figure 4. Another method is to provide slits at walls, but the reinforcement of the walls against out of plane overturning will be required. The value of *Is* after retrofit at X direction of 1^{st} storey is as follows.

Columns with wing-walls as shown in C) of Figure 4, were estimated as flexural columns with the ductility index of 1.5. The ductility index and the strength index relation for both cases in the X-direction of the 1st storey before and after retrofit is shown in Figure 5.

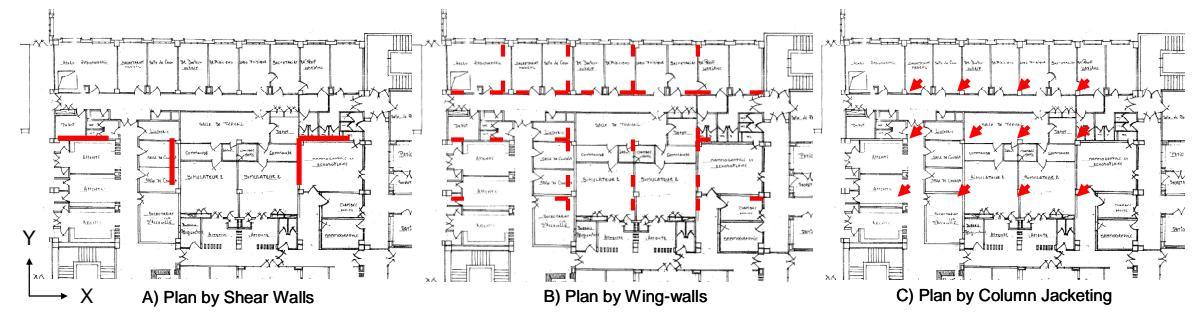
Figure 6 Retrofit Plans for 3 Cases of A, B and C

Column sizes were 50cmx50cm. Design concrete strength was $27N/mm^2$. Hoops were $\phi 10mm@100mm$. Horizontal strength at the 1st storey only was requested to increase for both directions as shown in Table 2.

The value of *Is* for Case 1 was decreased because of the shear walls with the ductility index of 1.0. The value of *Is* for Case 2 was decreased because of the columns with wing-walls with the ductility index of 1.5. The value of Is for Case 3 was increased to 1.06 with maintaining the original ductility index. CTSD was increased to 0.35. The value of S_D has increased from 1.0 to 1.1 due to the stiffness increase for Case 3. The relationship of the strength index and the ductility index in the X direction of the 1st storey before and after the retrofit is shown for 3 Cases in Figure 7. The standard detail for the column jacketing is shown in Figure 8.

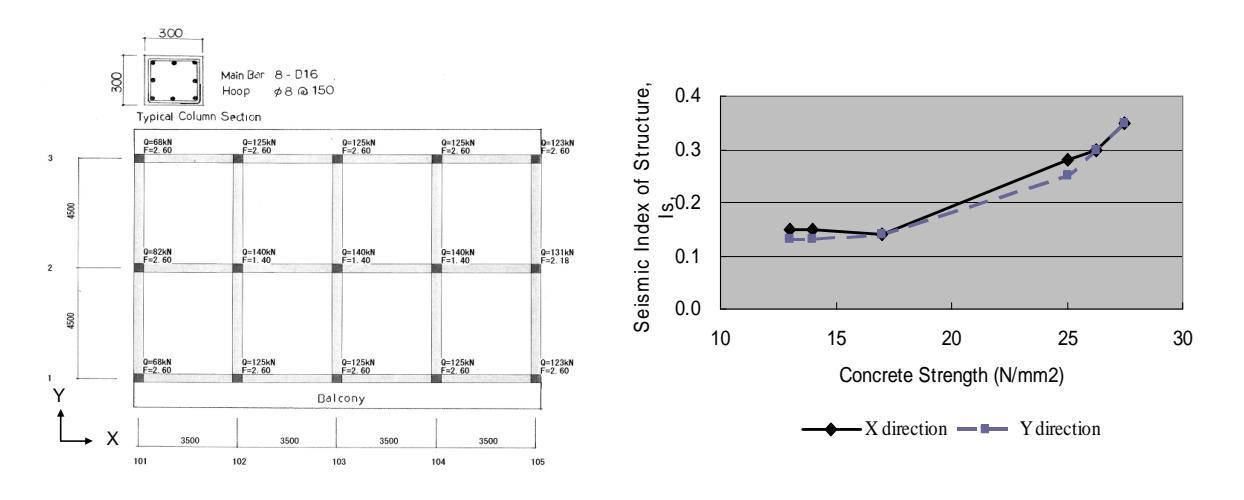
Figure 10 Concrete Strength and Seismic Index of Structure

- a) The value of Is with standard strength concrete was 0.25 or more.
- b) The value of *Is* with low strength concrete was in the range of 0.13 to 0.15. This was caused by the combination of the low strength index, and the low ductility index subject to the high axial force ratio of the columns.
- c) It can be said that apartment houses with the value of *Is* not more than 0.15 were collapsed by the 2003 Boumerdes earthquake, and the seismic intensity by EMS-98 was 8 and more at the areas of these collapsed buildings in Algiers and Boumerdes.

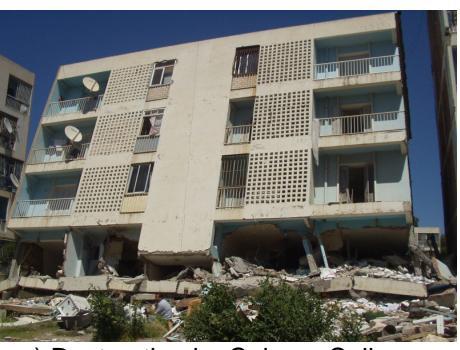
a) Destruction by Column Collapse

Typical destruction of apartment houses by column collapse by 2003 Boumerdes Earthquake, and shear failure of short column of a school by 1994 Mascara Earthquake in Algeria are shown in Figure A2.
