THE MARCH 29, 1999 EARTHQUAKE AT CHAMOLI, INDIA

Manish SHRIKHANDE¹, Durgesh C RAI², Jayprakash NARAYAN³ And Josodhir DAS⁴

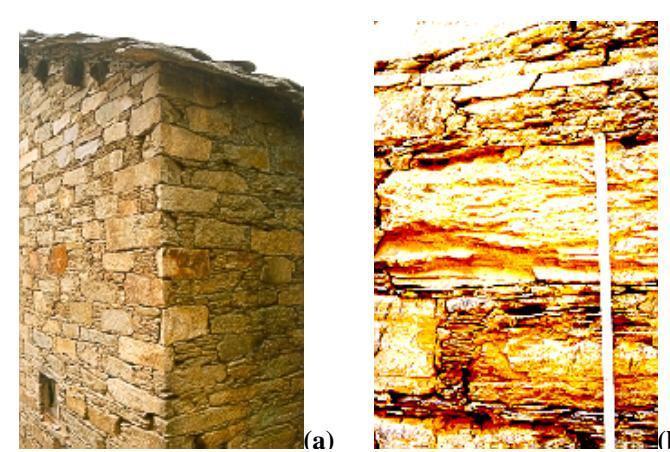
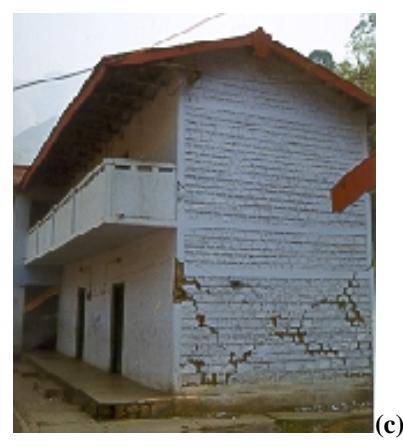
Figure 4. (a)Traditional stone and slate masonry wall and (b) a close-up view of stone boulder and thin layers of slates

Figure 5. R/R masonry plastered & decorated to give an impression of dressed stone masonry

The damage to such masonry has been moderate to less depending on the quality of masonry and workmanship. Many layers of jointing material provide relatively large area for accommodating relative movements between masonry units (stone boulders and large number of thin slates) during the ground shaking thus, dissipating energy through friction and material hysteresis. However, its use has been declining because it is very time consuming to lay thin layers of slate. As a result, very few and thicker slates are being used with larger pieces of stones and in some cases, the mud mortar is being replaced with weak cement-sand mortar. These masonry walls have experienced more damage, however, the use of cement-sand mortar has helped in many cases.

Random Rubble (R/R) stone masonry has undressed stones arranged in two wythes to give a total wall thickness varying from 450 to 750 mm. Stones are laid in mud mortar and exterior surfaces are often plastered in cementsand mortar which can be "decorated" to give a false impression of dressed stone masonry (Figure 5). Old government buildings, hospitals, schools, jails, etc., built in R/R masonry suffered heavy damage. The stone masonry walls which did not have throughstones to hold the both wythes together failed by splitting along the length of the wall jeopardizing its vertical load carrying capacity. Such out-of-plane failures arising from the dynamic instability of tall unsupported walls are evident in the collapse of gable end wall (Figure 6a). In a number of cases this deficiency has caused separation of wythes leading to partial collapse of the wall (Figure 6b). This deficiency of R/R stone masonry was responsible for majority of the observed damage in the affected areas. In-plane shear failures were also observed of solid (Figure 5) as well as perforated walls (Figure 6c).

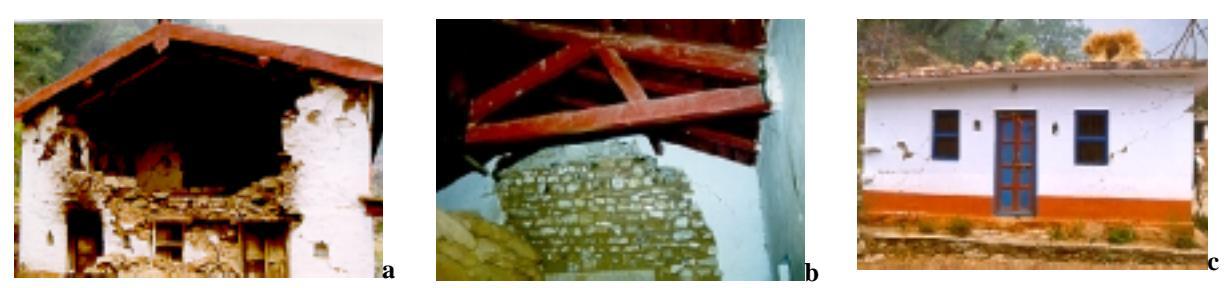
Figure 6. Failures of R/R masonry walls (a) Gable ends and cross walls (b) Separation of wythes and (c) Inplane shear failure of newly built wall weakened by openings.

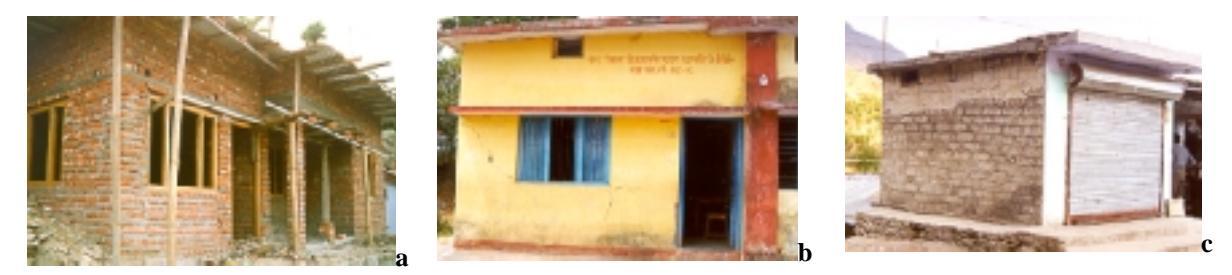
The usage of burnt clay brick masonry is a recent phenomenon in hilly areas and appears to be encouraged by Uttarkashi (1991) and Latur (1993) earthquakes where collapsed stone masonry walls were responsible for large number of deaths. Bricks are generally laid in cement-sand mortar and walls are often provided with lintel and roof bands and RC slabs (Figure 7a). In general, clay bricks are weak compared to stones and shear failure of brick walls was noticed with familiar X or diagonal cracks (Figure 7b). In addition to clay bricks, concrete blocks are recently being used a replacement for stone masonry (Figure 7c). Many factors have contributed to its growing usage such as unavailability of new quarries, time consuming and labour intensive stone masonry transportation of clay bricks from the plains, and in general, poor performance of stone masonry. Concrete blocks are made from cement, sand/fine stone powder, crushed stone in various sizes with typical dimension being 300 mm x 225 mm x 150 mm. Very minor damage to such masonry walls was observed.

Figure 7. Brick & block masonry (a) brick house built with lintel bands (b) In-plane shear failure of brick masonry wall and (c) Concrete block masonry construction

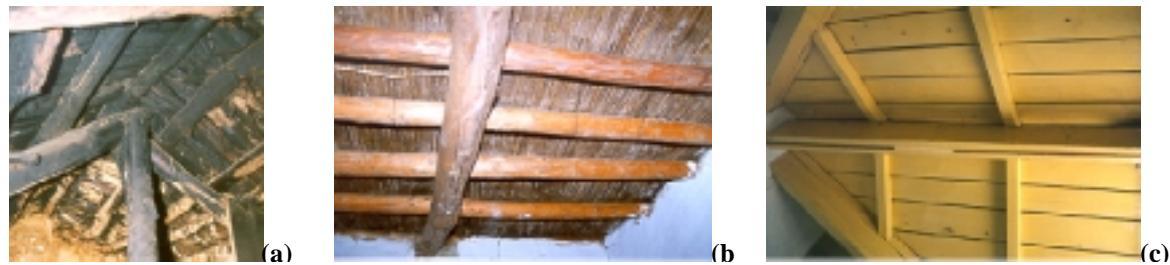
Pitched roofs and its variants have been the most popular choice for roofing in the region which have performed with varying degree of success. In rural areas, the roofs are either composed of simple wooden trusses or a frame work of wooden logs (Figures 8a & 8b). In government buildings, either timber trusses (Figure 6b) or joists (Figure 8c) along with wooden planks are generally used to support the roofing material. Galvanized corrugated iron (GCI) sheets are widely used roofing material for cheaply built school and government buildings, whereas slates are common for low cost dwellings. These roofs are inherently weak in shear and can not tie the walls together to provide the necessary "box action" for seismic resistance. Moreover, they are flexible resulting in deflections so excessive that walls are pushed out-of-plane Slate roofs are heavy attracting large inertia forces and slates can be easily dislodged causing a falling hazard. Most of roof failures can be attributed to either loss of support of roof trusses and joists or collapse of roof truss itself due to failure of joints and/or truss members

Figure 8. Typical roof construction (a) Vertical post supporting ridge rafter (b) Framework of wooden logs & twigs and (c) Wooden joist and plank system

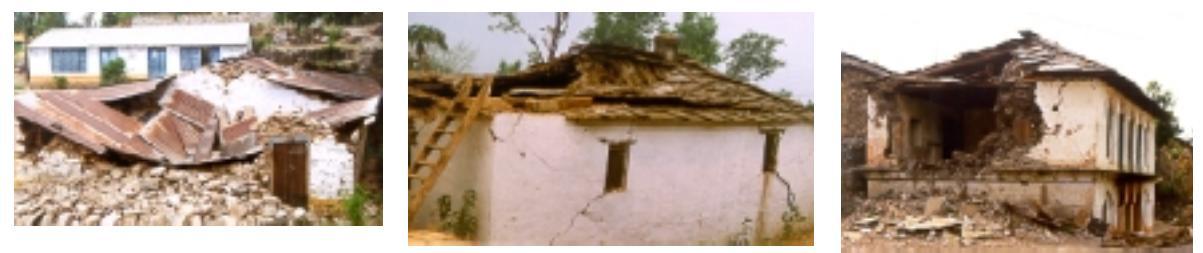
(Figure 9). Flat RC slabs are recent substitute for old fashioned pitched roofs and wooden flooring systems. These slabs are relatively rigid and have sufficient strength and stiffness. No failure of such slabs was noticed, however, lack of positive connection between the slab and wall diminishes the beneficial effect of rigid diaphragms in enhancing the overall structural integrity.

Figure 9. Collapse of roof structures (a) wall supporting the roof collapsed (b) partial collapse of double pitched roof truss and (c) collapse of wall supporting the roof truss

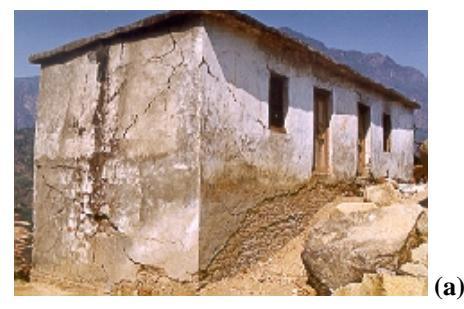
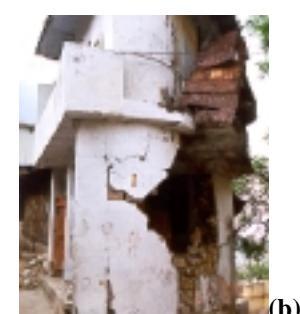
Configuration-induced failures arising from substantial plan and vertical irregularities have also been observed with masonry structures. The most common configuration problems were: overstress resulting from torsional effects, accumulated damage in lower storeys of houses on slopes (Figure 10a), non-parallel vertical systems for corner buildings (Figure 10b), incompatible distortions at reentrant corners, and pounding, etc. Lack of proper connection capable of withstanding compression and particularly tension at the following locations have been responsible for damages to number of buildings: between the perpendicular walls at corners for peripheral walls, between walls and cross-walls or return walls and between the walls and the diaphragms (Figure 10c).

Figure 14. (a) Vertical irregularity of hill-slope house (b) Non-parallel walls for a corner house and (c) Lack of connection between wall and floor and between exterior and cross walls
