CYCLIC BEHAVIOR OF DOUBLE ANGLE BRACING
MEMBERS WITH BOLTED CONNECTIONS

A. Astaneh-Asl (I)
S. C. Goel (II)
R. D. Hanson (II)
Presenting Author: A. Astaneh-Asl

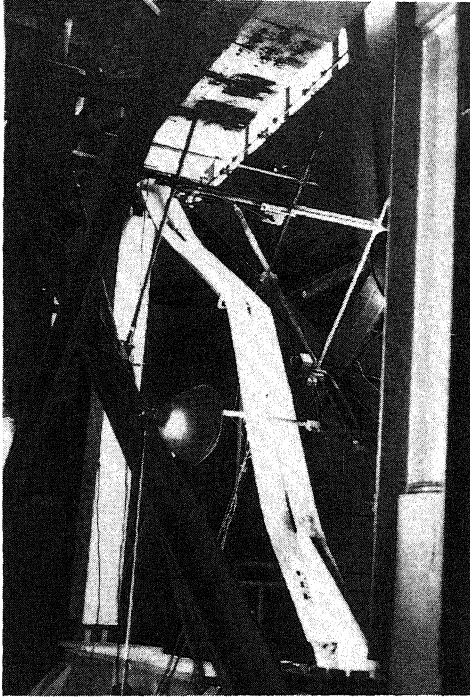
Specimens having short legs of angles back-to-back buckled in plane of the frame (vertical plane), Figure 4, whereas, specimens having long legs back-to-back buckled out of plane of the frame, Figure 5. Hysteresis loops (axial force - axial deformation curves) were recorded during the tests for all test specimens. Figure 6 shows hysteresis loops for specimen AB1.

In-plane buckling specimens showed severe local buckling in their back-to-back legs at plastic hinge locations. Out-of-plane buckling specimen AB2 showed severe buckling in outstanding leg on concave side of the buckled member. Other out-of-plane buckling specimens showed minor local buckling at midspan.

Figure 4 In-Plane Buckling Specimen

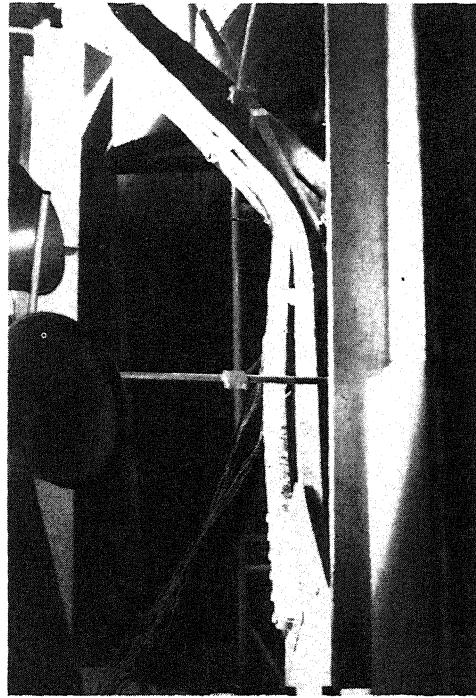
Figure 5 Out-of-Plane Buckling Specimen

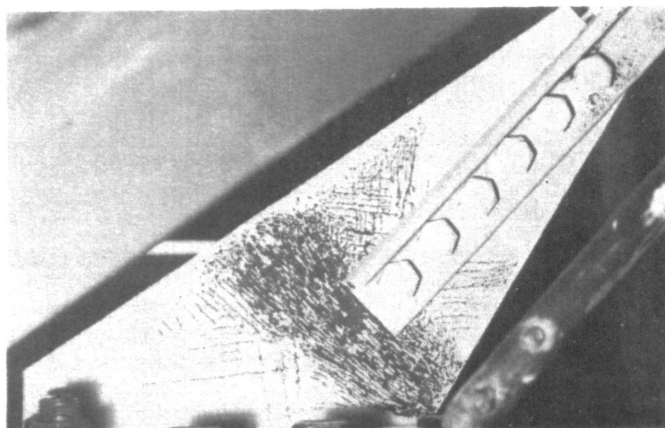
In specimen AB7 gusset plates did not show any significant yielding. This specimen buckled in the plane of gusset plates. However, in the other in-plane buckling specimens (AB1, AB3, AB5), which did not have friction bolts, some yielding occurred in gusset plates. The yielding was attributed to single angle buckling which occurred in these specimens. In specimens AB2, AB4, and AB6, which buckled out-of-plane, end plastic hinges formed in gusset plates in the space just beyond the end of the angles, Figure 7. As a result of study of welded specimens (reported in Ref. 2) it was known that a length of gusset plate equal to at least twice the thickness of gusset plate should be provided for plastic hinge formation. This criterion was followed in design of out-of-plane buckling bolted specimens. As a result, despite formation of plastic hinge in gusset plate and severe yielding, no fracture occurred in gusset plates of these specimens.

Figure 7 Typical Plastic Hinge in Gusset Plates of Out-of-Plane Buckling Specimens

5. In in-plane buckling specimens gusset plates remained almost elastic. In out-of-plane buckling bracing members an adequate free length of gusset plate beyond the angles is necessary to prevent premature fracture in the gussets.

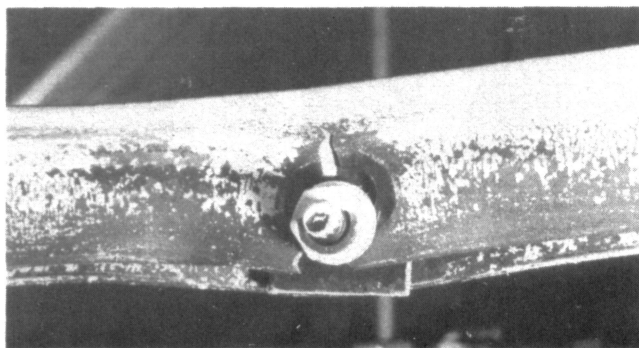
Specimen AB3 had one stitch at midspan as was required by AISC Specification (Ref. 3). The specimens could only survive 8 cycles of deformation and fractured through bolt hole at midspan, Figure 8. Specimen AB5 was fabricated similar to AB3 with the only difference that it had 2 stitches at 1/3 points. This specimen lasted 16 cycles of deformation. The analysis and comparison of the behavior of these two specimens clearly indicated negative effect of stitch at midspan in in-plane buckling members.

Figure 8 Fracture at Location of Stitch at Midspan in In-Plane Buckling Specimen AB3

6. Bolted stitches should be avoided at midspan where plastic hinge forms especially for in-plane buckling bracing members.
7. Net section at first bolt hole in connections of in-plane buckling specimens fractures in early cycles. It can be reinforced such that plastic hinge forms in gross section of the angles.

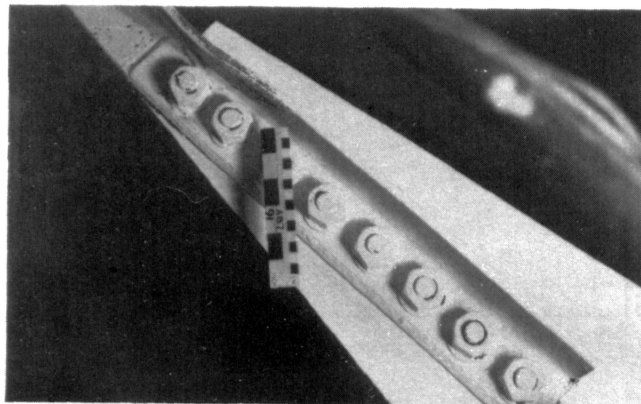
In out-of-plane buckling specimens, due to formation of plastic hinge outside the connection area in gusset plate, no significant yielding occurred in this region. In in-plane buckling specimen AB1 end plastic hinges formed in the net area of the first bolt. The net area fractured during the sixth cycle. In the remaining in-plane buckling specimens net area was reinforced by welding a plate on the back-to-back leg of angles, Figure 9. The detailed criterion for the reinforcement is given in Reference 1. The major aim of reinforcement was to force plastic hinges to form in gross area instead of net area. Behavior of connections in reinforced specimens was quite satisfactory.

Figure 9 Reinforcement of Net Area in Speciman AB7
