# March 11, 2011 M=9.0 Great East Japan earthquake: The story of a retrofitted building damaged and repaired

**M. Çelebi.** Earthquake Science Center, USGS, Menlo Park, Ca. 94025, USA

I. Okawa & T. Kashima Building Research Institute, Tsukuba, Japan

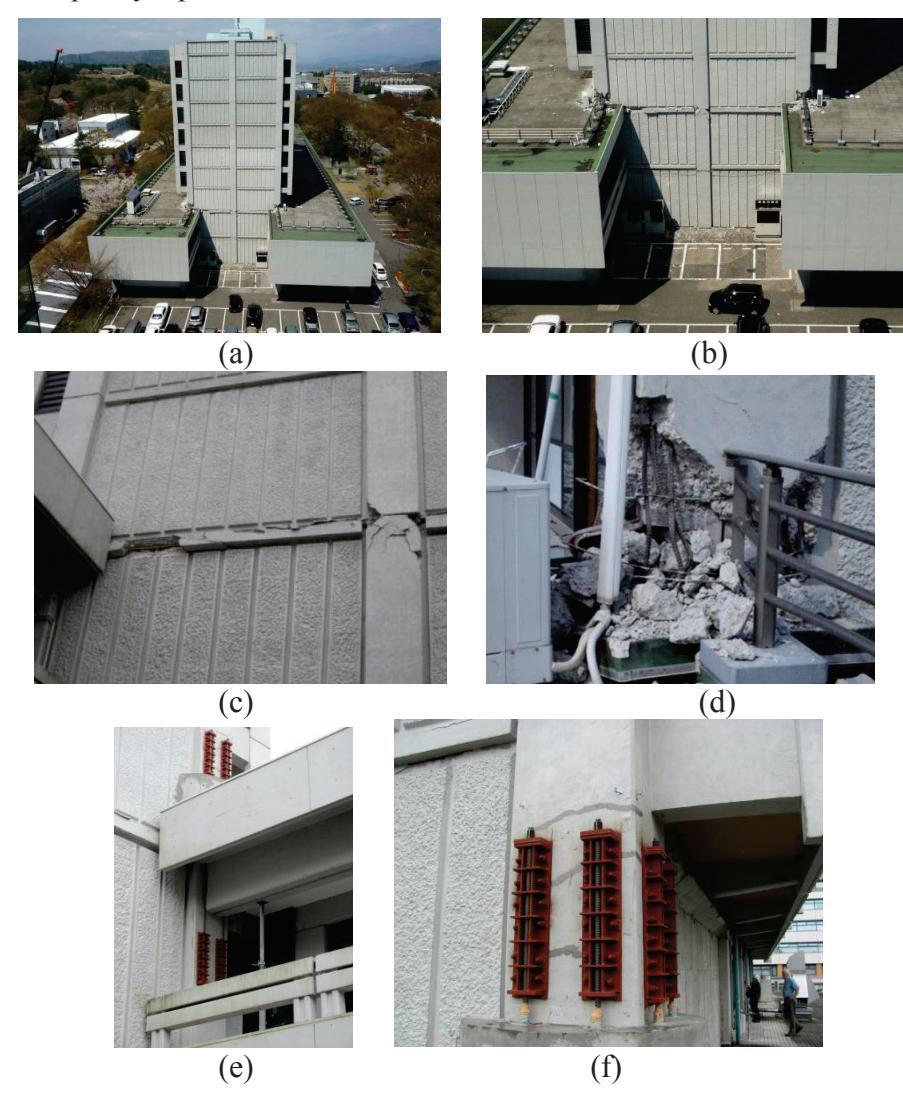
In Figure 3, the first four pictures show general views of the building and also damage to a column and end walls. The visible damage is at the 3<sup>rd</sup> floor level where the plan area and therefore the stiffness of the floor changes. Unfortunately, lack of seismic sensors at that and neighboring floors negated direct recording of the effect of change of stiffness on the behavior and performance of the building. The last two pictures (e,f) in the figure depict the part of visible temporary repair performed in May 2011 using tension-steel bars. Motosaka (*written communication*, 2011) described the repair as "the damaged part of the 3rd floor was reinforced by adding concrete pier-like bases with tension steel bars to resist axial forces induced by bending vibration. Also, four shear walls have been constructed next to the damaged four corner columns to resist LN (longitudinal [282]) direction force". Therefore, one of the five events studied herein is deliberately selected to identify the changes in structural frequencies due to the post-mainshock temporary repair.

Figure 3. (a) General view of the building and (b) damage to a column and end wall (top row photos: courtesy of T. Kashima), center row: (c,d) adopted from Motosaka (2011), bottom row: (e,f) post-mainshock repairs.

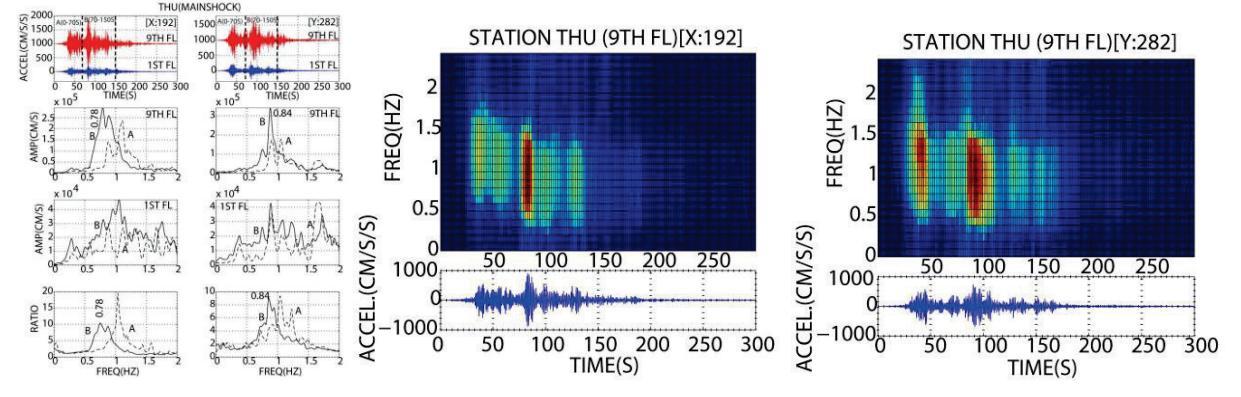
Event 1 in Figure 5, Figure 7 (left) reveals a sizeable shift of the frequencies of significant peaks to below 1Hz. However, it is clear that there is even a shift of frequencies in the time period A when compared to the frequencies of Event 1. This indicates that significant damage occurred within each of the time windows. That the shift in structural frequencies, in this case due to documented and observable physical damage to the structure, occurred during the specified time windows is also clearly demonstrated in Figure 7 (center and right) by the moving-window amplitude spectra of the 9th floor accelerations. From Figure 7(left), the frequencies of the damaged building are determined to be 0.78 and 0.84 Hz in the X and Y directions, respectively.

Furthermore, the spectral peaks between 0.5-1 Hz are much larger than unity – indicating that they are frequencies of the damaged building - since the possibility of site resonance was ruled out earlier. From the frequencies of Event 1 and Event 2 (mainshock), absent any other nonlinearities besides the physical damage inflicted on the building, one simple way of approximating reduction of overall stiffness is from ratios of  $f_1=(1/2\pi)(k_1/m)^{0.5}$  and  $f_2=(1/2\pi)(k_2/m)^{0.5}$ . This yields  $k_2=k_1(f_2/f_1)^2$ . Thus, in the X direction  $k_2(X)=k_1(X)(0.78/1.26)^2 ~0.383k_1(X)$ , and in the Y-direction  $k_2(Y)=k_1(Y)(0.84/1.22)2\sim0.474k_1(Y)$ . These are very significant reductions in stiffnesses (~61% and ~52% in the X and Y directions respectively).

Figure 7. (Left) Acceleration time-histories of the two orthogonal horizontal accelerations recorded during the mainshock at the 9th floor, their amplitude spectra and ratios showing the changes in the frequencies from those within the first 70 second period to those between the 70-150 seconds into the record. Note the shift of the significant peaks after 70 seconds into the record. (Center and Right) Moving window amplitude spectra indicates the clear shift of predominant frequencies for both horizontal components.

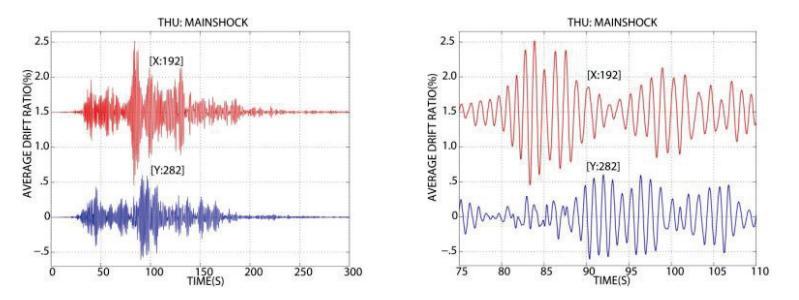
Damage that occurred is also confirmed by quantified drift ratios presented in Figure 8. However, as stated earlier, due to sparse instruments, it is only possible to compute average drift ratios using relative displacements between the 9th and 1st floors divided by 3290 cm which is the height between 1st floor and 9th floor (Figure 2). This evaluation is presented with the understanding that it is very likely that the average drift ratio of the building above the third floor (where the plan area decreases significantly) was most likely significantly larger than the first 2 floors of the building. It is noted that, in the X-direction, ~1% average drift ratio is experienced at about 83-84 seconds into the record, and 0.5% and above average drift ratio persists between 82 to 88 seconds and then between 97-102 seconds. In the Y-direction, 0.5% average drift ratio is experienced between 90-98 seconds into the record.

Figure 8. Equiscaled average drift ratios (in %) computed from relative displacements between the 9th and 1st floors.

In summary, the 0.5% and above drift ratios experienced during the main shock were at levels known to cause damage, or at least are indicators of the start of non-linearity due to inelastic behavior. In this case, the threshold is exceeded during multiple cycles in two intervals, as illustrated in Figure 8 (right). This observation is not surprising, since the peak acceleration at the 1st floor of the building is ~0.33 g (Table 1), a level considerably above the 0.2 g ZPA (zero period acceleration) used in the original design of the building that does not reflect the effect of the 2000-2001 retrofit, and is at a level comparable to the ZPA (for Sendai: 0.32 g) for limit capacity design (Table 7.2.5, AIJ, 2004) corresponding to an extremely rare earthquake. Furthermore, the 1% drift ratio is the maximum limit for design of buildings in Japan for the collapse protection (level 2) motions (The Building Center of Japan, 2001a and 2001b). In the United States, the comparative maximum drift ratio for similar buildings for Risk Category 1 or 2 is 2% (Table 12.12, ASCE7-10, 2007).

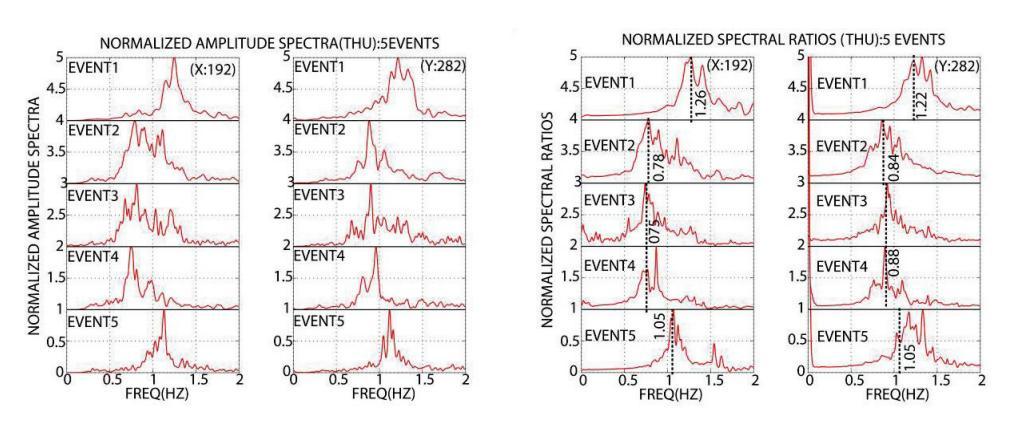
Figure 10 shows both normalized amplitude spectra of 9th floor accelerations in the two orthogonal horizontal directions for all 5 events, and normalized spectral ratios of 9th floor accelerations with respect to 1st floor accelerations. Clearly, the chronological shifts in the fundamental frequencies are displayed. It is again noted that damage occurred during the mainshock (Event 2) and temporary reinforcement was implemented after event 4 but before event 5. Table 2 summarizes the changes and compares them with analyses by Motosaka and others (2011).

Figure 10. (Left) Normalized amplitude spectra of 9th floor accelerations and (Right) Normalized spectral ratios of 9th floor accelerations with respect to 1st floor accelerations for all five events. These plots depict the changes in the dominant frequencies in the building response which most likely are due to physical changes in the lateral stiffness of the building.
