# Performance of masonry buildings during the 2011 Lorca earthquake

**L. Hermanns, A. Fraile, E. Alarcón & R. Álvarez** *Universidad Politécnica de Madrid, España*

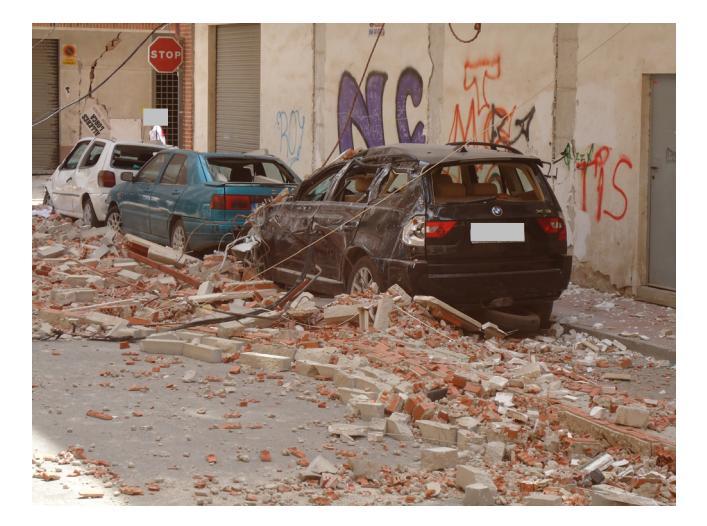
Figure 3. Street covered with rubble of damaged buildings

The situation on the streets was quite similar throughout the whole town. Figure 3 displays the situation of one of the streets in Lorca immediately after the main event took place.

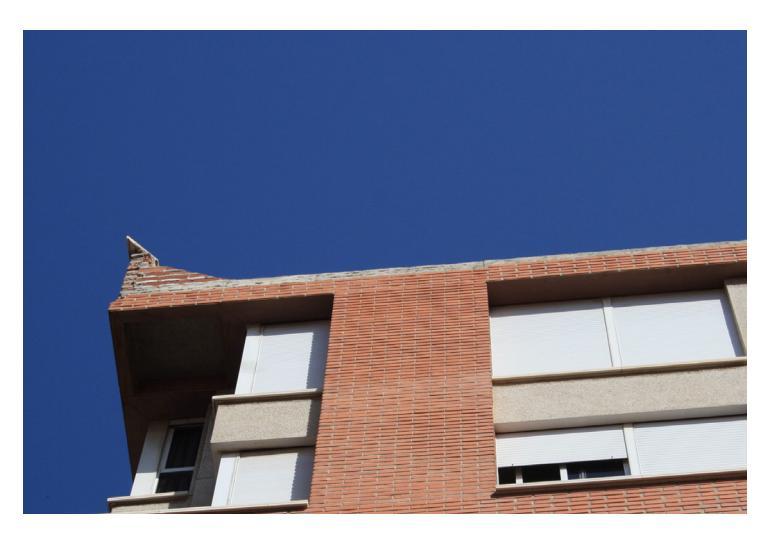
In the case of roof parapets, chimneys and to a minor extent infill panels at upper floors the failure was caused by inertia forces acting out-of-plane. It is well known that the resistance of masonry walls to out-of-plane moments is much lower than that of R.C. frames. As a consequence the interaction between the frames and the infill panels is very limited in this particular loading scenario as the failure of the infill panel changes the structural properties at a very low load level. Regarding unreinforced roof parapet walls some codes (FEMA 2011) point out the significant falling hazard related to this type of architectural components. Figure 4 shows one of the parapets that partially collapsed confirming thereby the importance of studying the seismic behaviour of non-structural components. The structure of this particular building did not suffer significant damage whereas the roof parapet almost completely collapsed.

Figure 4. Building with a almost completely collapsed parapet wall

This type of incoherence in terms of the seismic behaviour of different components of the same building should be avoided. It is important to note that the acceleration at roof level may be significantly higher than that at ground level due to the dynamic properties of the building. In addition, the bending moment capacity at the contact surface at roof level is usually quite small if the parapet wall is not adequately anchored. Not only parapet walls failed at this load level but also chimneys on flat roofs.

The falling hazard of damaged parapet walls is well known and addressed in several guidelines like (FEMA 2011). The importance of non-structural elements in the context of a seismic analysis should be evaluated taking into account their damage potential, not their cost.

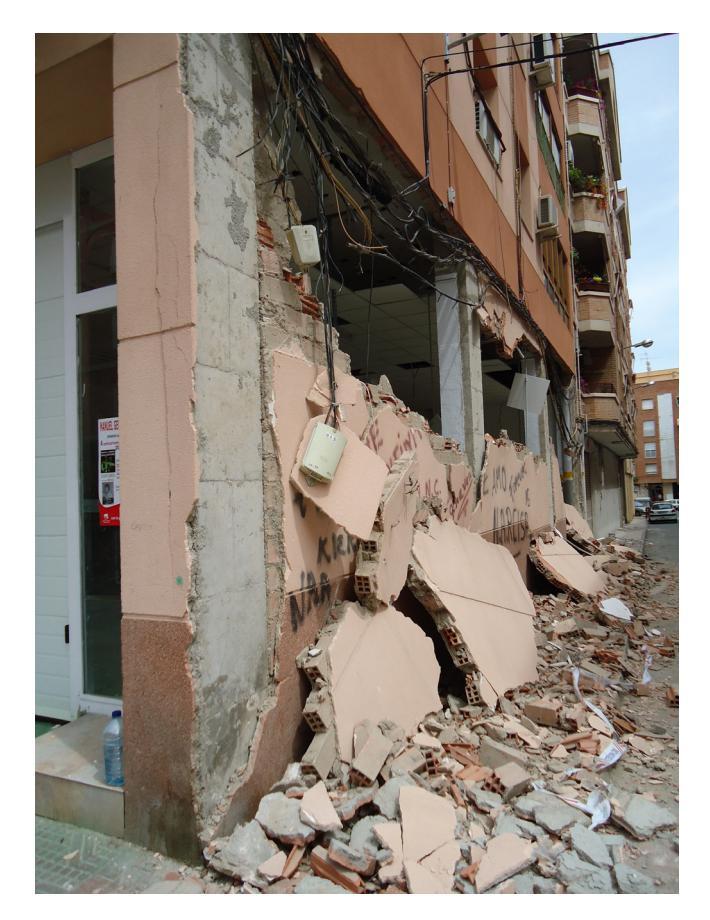
On lower floors the failure of masonry infill panels was caused by excessive in plane loads, displacements of the frame structure (see Figure 5) and in some cases by pounding of adjacent buildings. The interstory height at ground floor level is usually higher than that of the upper floors as the ground floors are usually occupied by shops. In these cases both the stiffness of the framing structure and that of the masonry infill are comparable and the resistance of the infill panels is significant permitting thereby important interactions like a force transfer from the slightly cracked masonry wall to the surrounding frame structure. Although in some cases a combination of the two different failure mechanisms described above was observed, in general, the first one was more often observed on upper floors and the second one on lower floors.

Figure 5. Damaged masonry infill walls at ground floor

If the masonry infill panels are not included in the structural model that is used to study the seismic behaviour of the building, the non-structural infill walls should be designed and built with gaps to accommodate frame drifts; this solution is also known as isolated infill.

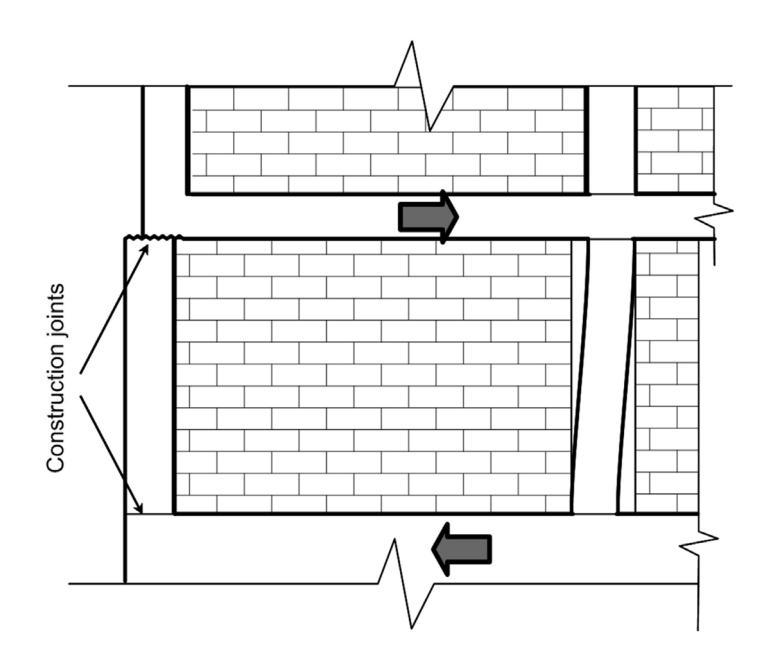
Joints are usually critical points in structures and many efforts have been put into the study of its behaviour. The importance of an adequate design is widely recognized however, quality control during construction is also very important. Construction joints in columns are usually located at the undersides of the slabs and beams as shown in Figure 9.

Figure 9. Failure at the construction joint of beam-column connection

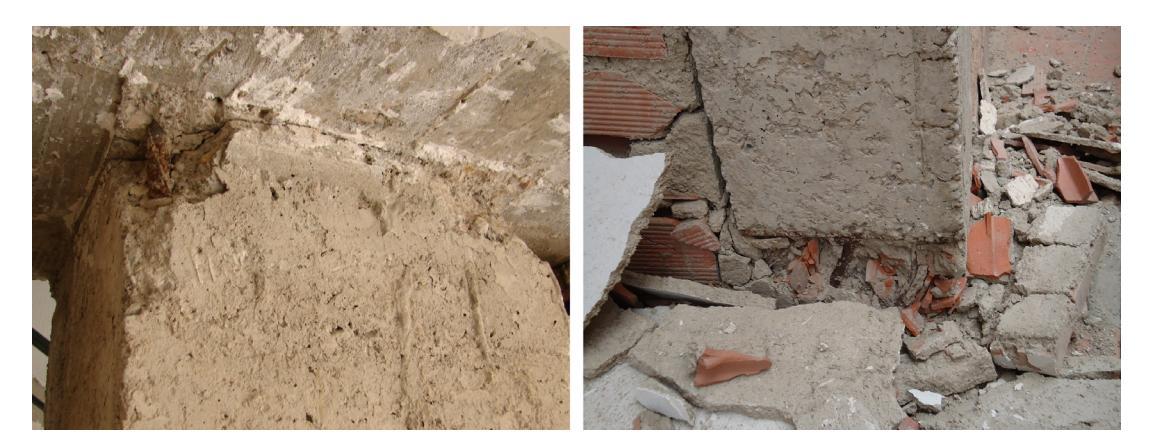
Failures of the contact surface were observed in several occasions (see Figure 10).

Figure 10. Examples of failure at the construction joint of a beam-column connections

This type of failure was observed particularly often in end bays of the exterior R.C. frames.

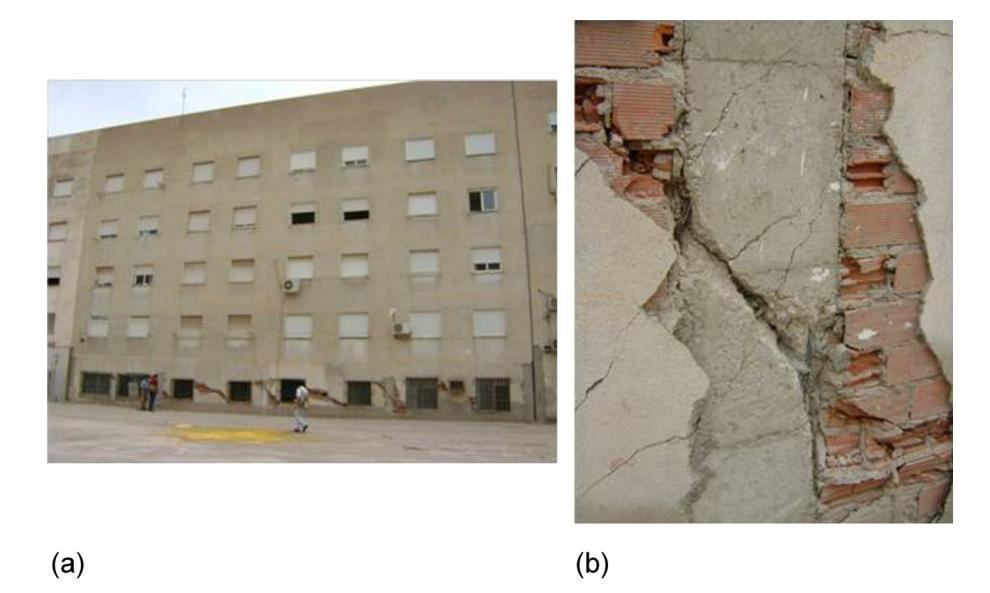
In general crack propagation in the infill panels indicates the position of the traction diagonal that connects two beam-column connections however, in some cases the cracks in the infill panels developed laterally displaced crossing the column at mid height like in Figure 12 b.

Figure 12. Example of cracks crossing a column at mid-floor height. Building (Fig. 12 a) Detail (Fig. 12 b)
