# **Review of transect of Christchurch CBD Following 22 February 2011 earthquake**

**L.M. Moon & M.C. Griffith** University of Adelaide, Australia

J.M. Ingham University of Auckland, New Zealand

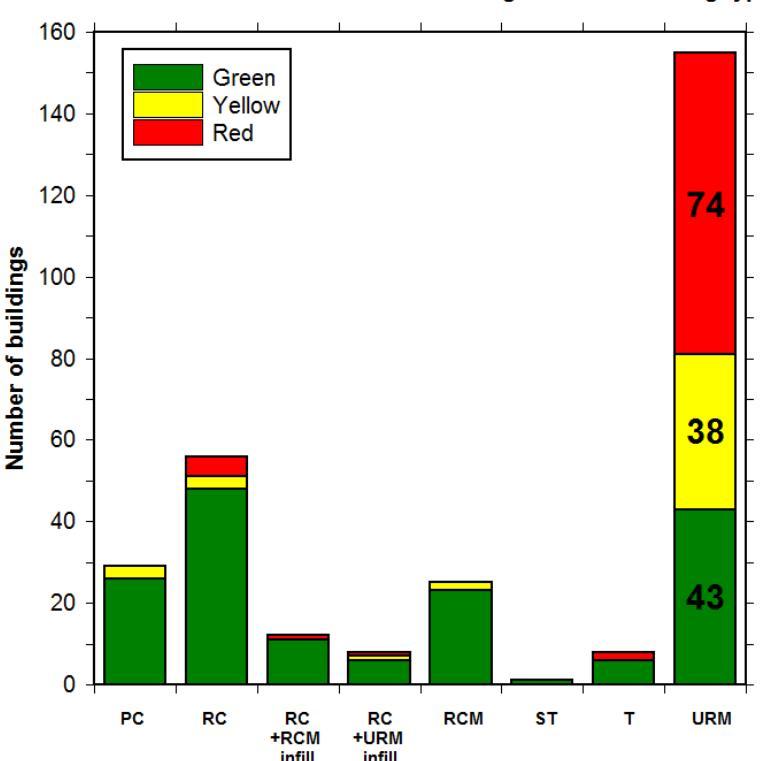
Figure 3.1. Damage breakdown of buildings observed on 24 February 2011 [source: Ingham et al., 2011]

The results of the transect observations are shown in Figure 3.1. The graph shows the number of each building type surveyed, and the breakdown of each building type into the different placard colours. In total 295 buildings were surveyed, of which 145 were URM buildings.

The results of the transect clearly showed that URM buildings performed were the building class which performed the worst during the earthquake. Almost half of all URM buildings were assessed as being red, compared to less than 10% for all other building types. This finding is to be expected as URM buildings are known to behave poorly when subjected to large lateral loads, and the URM buildings tended to be older and therefore have a lower seismic capacity than newer buildings. From the transect data, it was estimated that approximately one-third of all buildings in the CBD would need to demolished. This determination was based on the assumption that all of the red tagged buildings and 50% of all the yellow tagged buildings would be uneconomic to repair or would need to be demolished urgently for safety reasons, and that the transect was a good representation of the distribution of and damage to building types throughout the CBD.

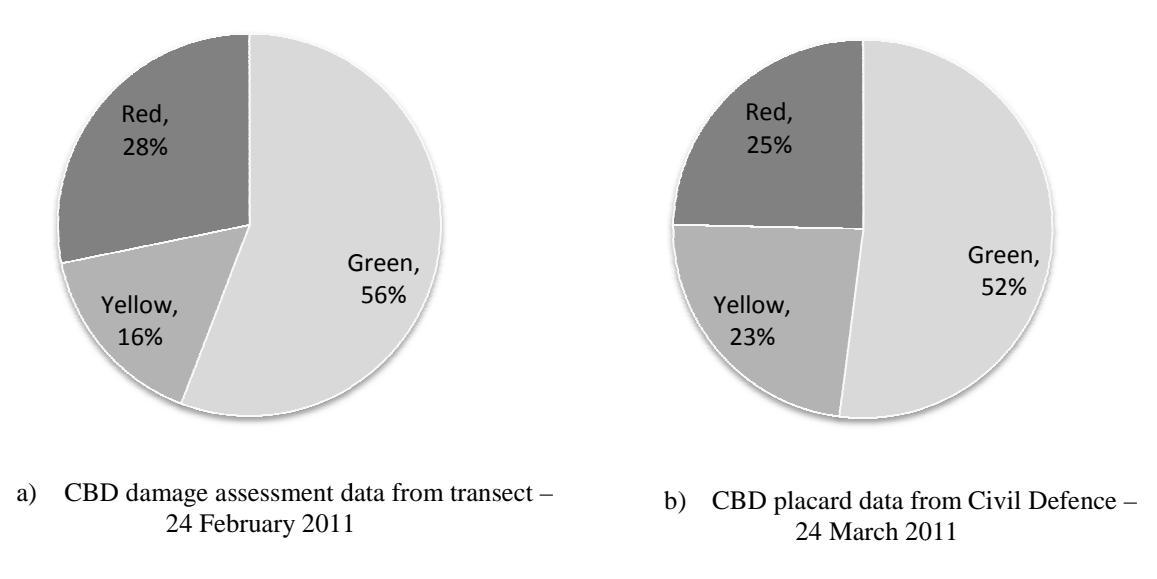
Figure 3.2. Assessment data from Christchurch CBD, February and March 2011

At the time when the transect was performed the focus by authorities was on search and rescue, and engineering assessments in the CBD were limited to an 'as-needed for emergency assessment' basis with most other engineering resources assigned to assessing suburban residences. Rapid building assessments in the CBD had not begun, and therefore the estimates from the transect were the first overall study of the damage levels of buildings within the CBD. Figure 3.2 shows the overall distribution of damage classifications assigned during the transect (Figure 3.2(a)) and those assigned by the Civil Defence volunteers in the following month (Figure 3.2(b)). The Civil Defence data, published by the Christchurch City Council (2011), covers over 4000 buildings within the CBD, and shows an overall damage distribution that is strikingly similar to that obtained from the transect.

The similarity in overall damage levels between the estimate based on the transect and the official data published the following month occurs despite the fact that the surveying conducted as part of the transect was limited to rapid external visual inspections, usually of the front face of the building only. This survey type can be compared to Level 1 type external inspections, and was not intended to be

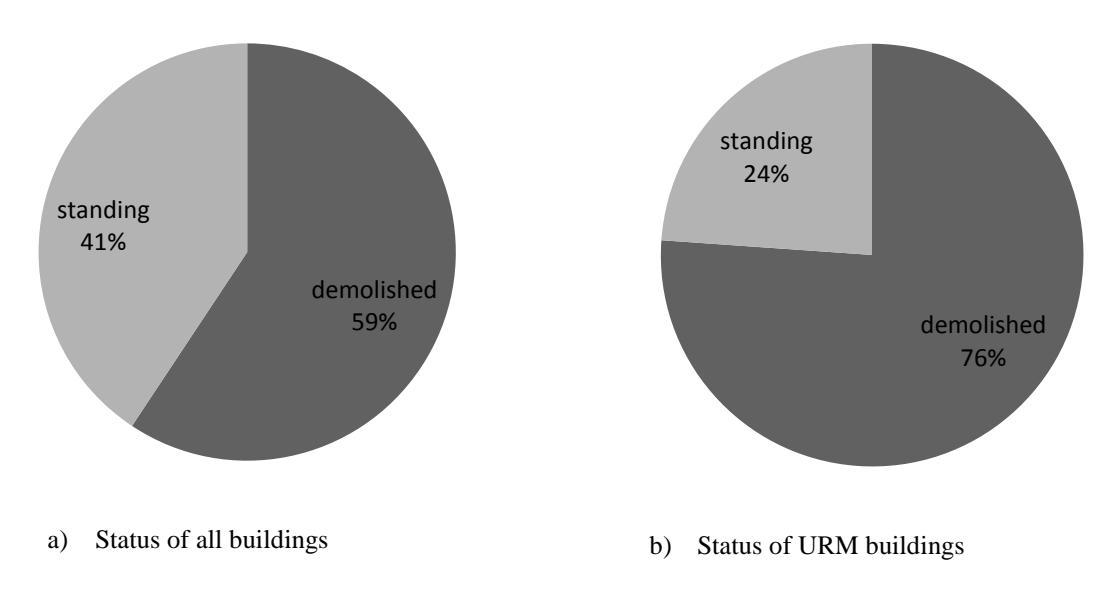
Figure 4.1. Fate of buildings along transect current at April 2012

In the 12 months following the 22 February 2011 earthquake, Christchurch was subjected to over 5000 aftershocks (Nicholls, 2012), including two events on 13 June 2011 and 23 December 2011each having a magnitude greater than 6.0. The epicentre of both later earthquakes was within 10 km of the CBD (GNS, 2011), and both resulted in the evacuation of suburban malls and many public buildings (Stuff.co.nz, 2011a; 2011b). Many buildings that appeared to have sustained only minor structural damage or were considered repairable following the 22 February 2011 earthquake were required to be demolished following the additional aftershocks. Figure 4.1 shows the status, where known, of all the buildings was obtained from the demolition list published by CERA (Canterbury Earthquake Recovery Authority) (2012) and from personal observation. The CERA demolition list is updated about once a month. Buildings which are currently on the demolition list but which have not yet been demolished are included in the chart as demolished. As can be seen in Figure 4.1(a) and Figure 4.1(b) respectively, in April 2012 less than half of all the buildings and 24% of URM buildings from the transect remain or are likely to remain. From previous results this estimate is likely to be indicative of the entire CBD.

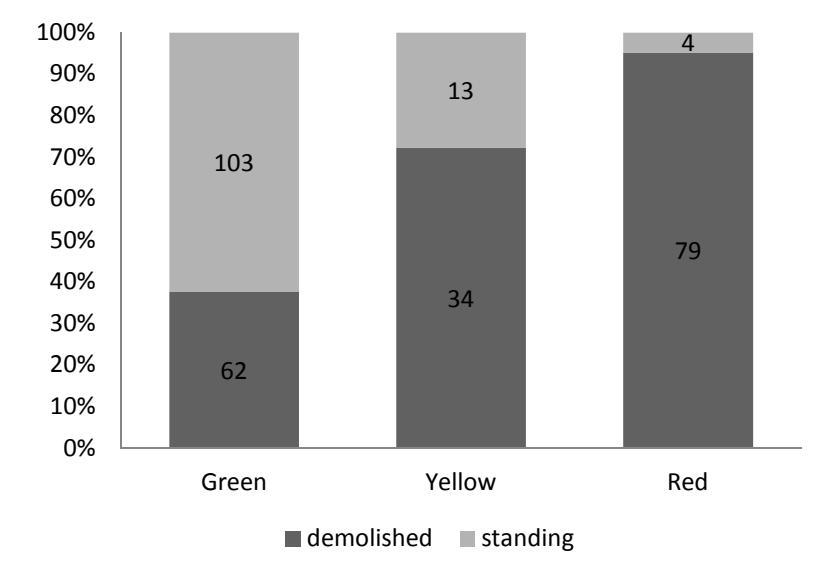
Figure 4.2. Status of buildings compared to the original assessments, current April 2012

Figure 4.2 shows the status of the transect buildings based on their original assessment level. The percentage of demolished buildings is greatest for buildings originally assessed as red, and smallest for buildings previously assessed as green. The greatest percentage of buildings still standing occurs for buildings initially assessed as green, and only 5% of buildings initially assessed are standing. In the initial estimate of demolitions it was assumed that 50% of buildings assessed as yellow would need to be demolished, whereas this figure now stands at around 70%. In addition nearly 40% of buildings that were assessed at the time of the transect as green are to be demolished. Despite this it appears that the initial assessments are consistent with the current status of buildings.

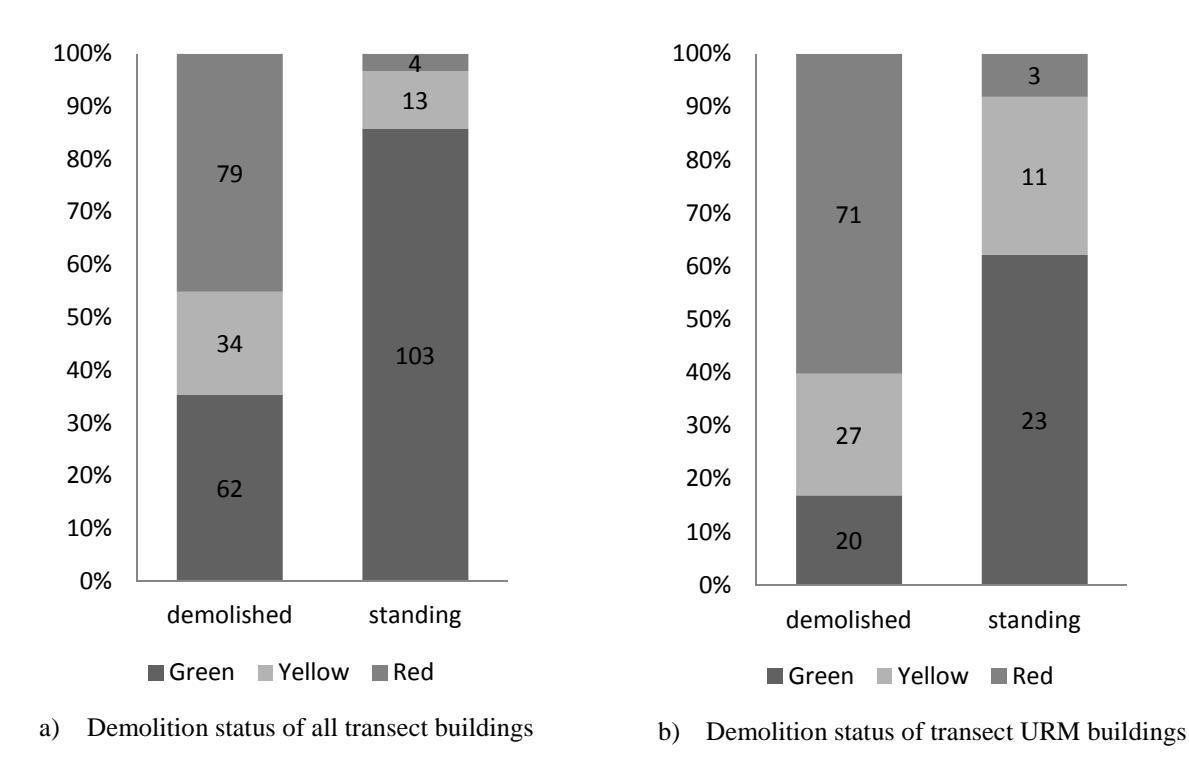
Figure 4.3. Initial assessments of buildings disaggregated into demolition status, current April 2012.

Figure 4.3 shows the breakdown of the current demolition status by initial assessments for all the buildings along the transect (Figure 4.3(a)) and for URM buildings along the transect (Figure 4.3(b)). Both graphs show that most of the buildings now demolished, or to be demolished, were originally assessed as red or yellow, and that less than 5% of buildings assessed as red are known to remain standing. The graphs also indicate that URM buildings initially assessed as green are more likely to remain than all buildings assessed as green. In part this may be due to the fact that the authors collectively had greater familiarity with the URM buildings, however it is also possible that damage to URM buildings is more likely to be visible from initial external inspections.

The current demolition status in April 2012 of buildings initially assessed during the 24 February 2011 transect consistently indicates that buildings initially assessed as red are mostly, if not all, demolished, and that buildings initially assessed as green are the most likely to still be standing. Of the buildings originally assessed as yellow over 70% have since been or are to be demolished. Although the initial estimate of 33% demolition of CBD buildings appears to now be closer to 60% it must be remembered that since the transect the buildings have been subjected to continuing fatigue and damage from thousands of aftershocks, including two further events having a magnitude greater than 6.0.
