Earthquake Damage – Intensity Relationship Based on Sumatran 30 September Earthquake

A Hakam, Fauzan, FA Ismail, Zaidir, OF Nur Andalas University

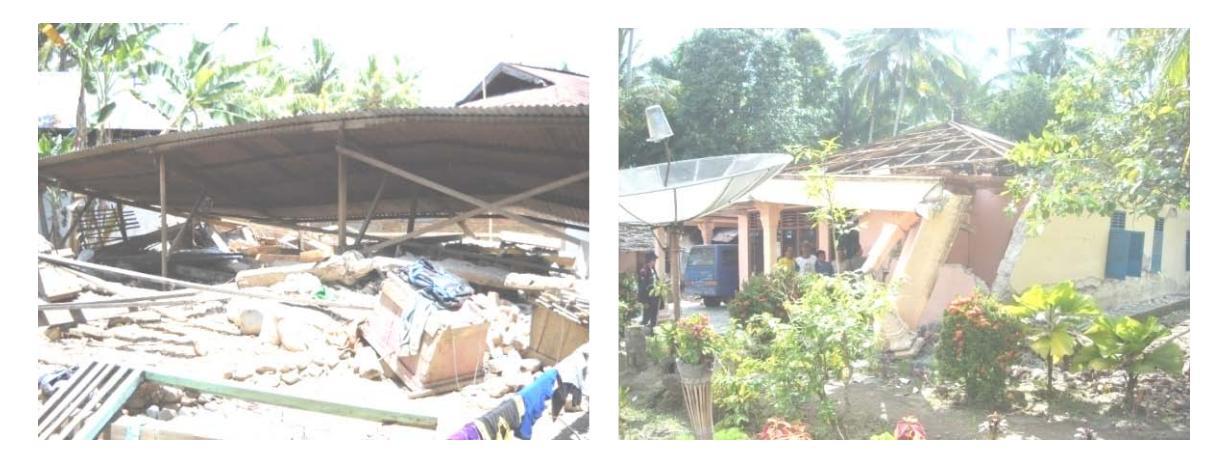
Figure 3. A heavily damage houses

Determination of the extent of building damage was done by visual observation. Based on the visual observation, the affected buildings can be classified according to three level of damage. There are also three initial given for the building: RB for a heavily damaged building/house, RS for a house with a level of moderate and RR for the slightly damaged house. For the example, the condition of a house that referred to be suffering from heavily damage is shown in Figure 3.

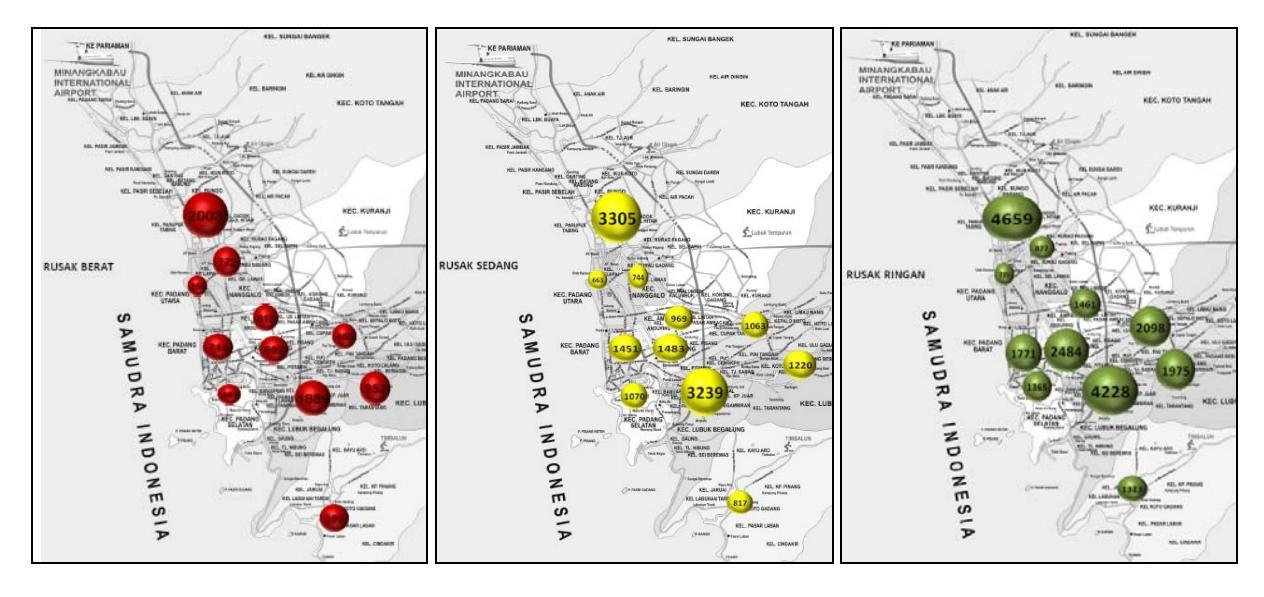
This paper shows the plot results of survey of the damage homes in Padang. The results are displayed in the term of map which is divided by districts in the city. Figure 4 a, b and c show damage to the houses with the category of heavily, moderate and slightly for the city. In every figure, the number that indicated the damaged houses is displayed. The size of the bubble also presents of the ratio damage in each district. It seems that there is quite diverse spread of damage to the house. However this spreading data may be figuring the seismic ground condition that has been reported by Sengara et al (2009) as shown in Figure 5.

a. Heavily damage

b. Moderately damage

c. Slightly damage

Figure 4. Damage houses in Padang

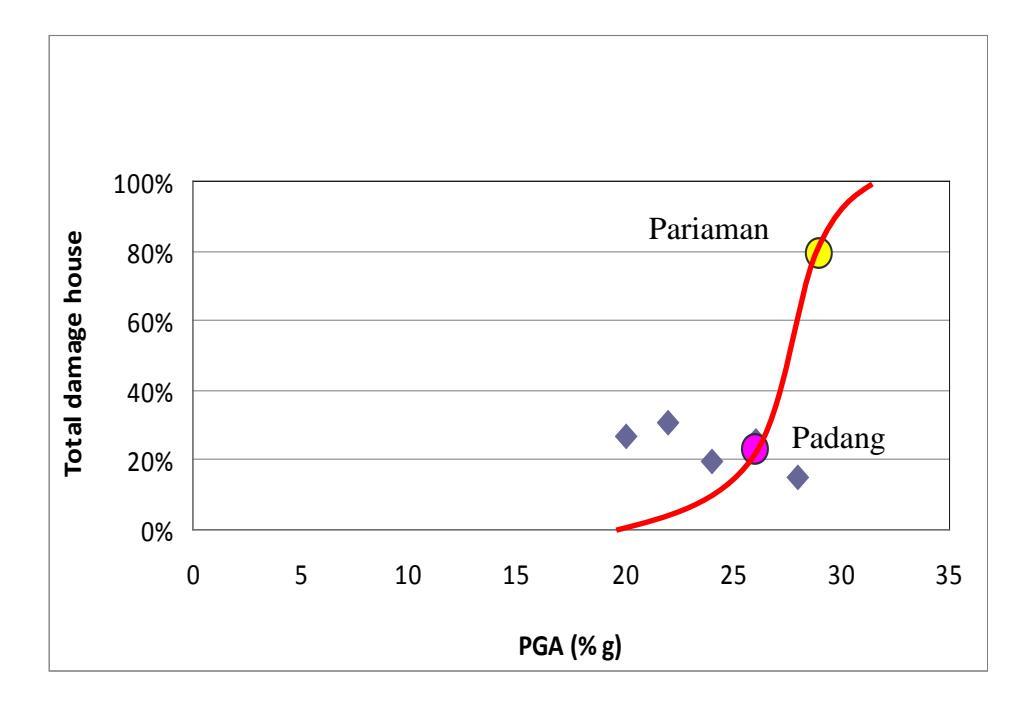
Furthermore, by dividing the area based on the level of earthquake intensity, it can be displayed a graph of the distribution of damage to houses related to the peak ground acceleration. In the figure 6 can be seen that there may a relationship between the PGA with the distribution of the damage. In the figures also plotted the percentage of damaged houses in the city of Pariaman where located only a teens kilometres from the epicentre. The straight line curve is built in figure 6 to fit the relation between the damage level and the earthquake intensity in West Sumatra.

Figure 6. Damage house and the peak earthquake acceleration
