Damage due to 24 March 2011 M6.8 Tarlay Earthquake in Northern Thailand

A. Ruangrassamee

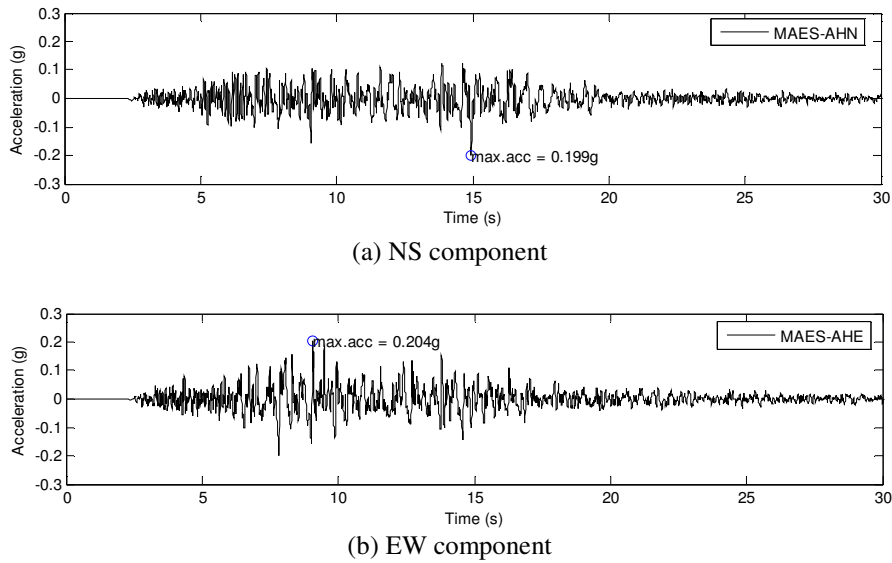
Figure 2. Strong ground motion record at Maesai District

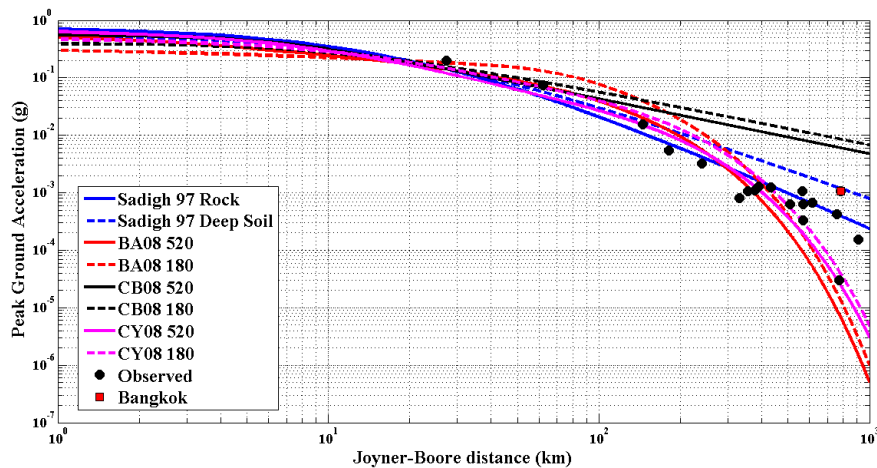
Figure 4. Comparison of observed PGA with NGA and Sadigh et al. (1997) equations

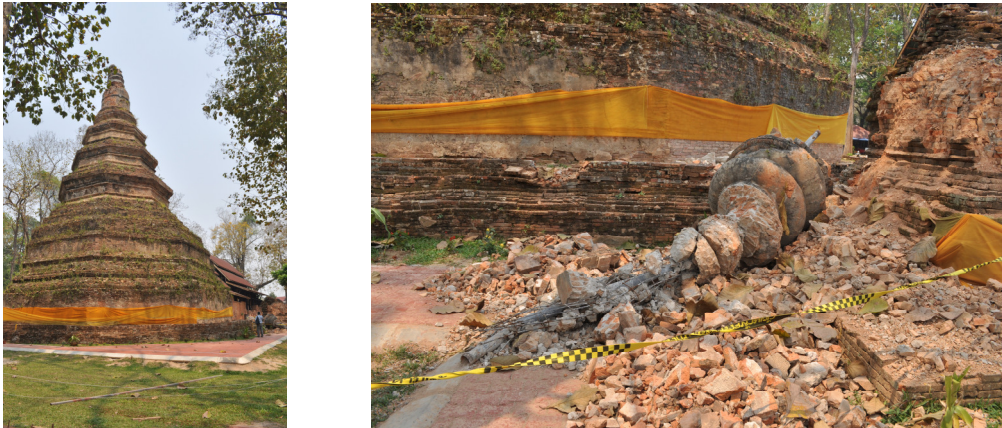
Figure 5. Damage to a pagoda in Chiang-saen District

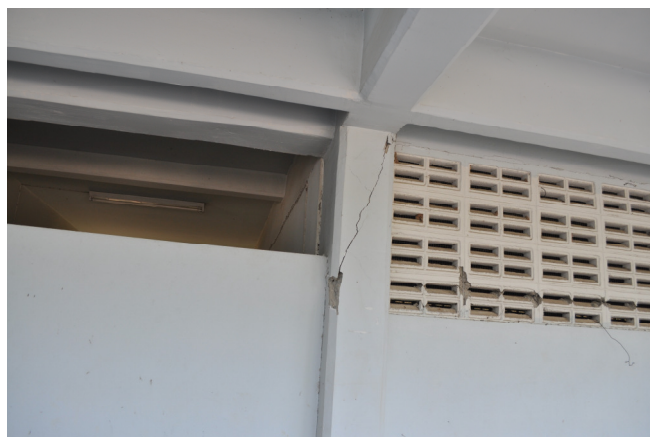
Figure 6. Shear failure of a short column

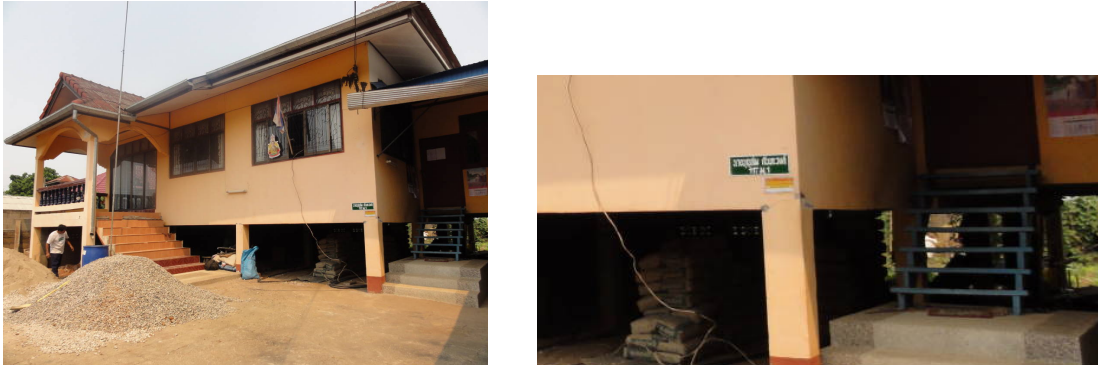
Figure 7. Damage of a building with small columns in Chiang-saen District

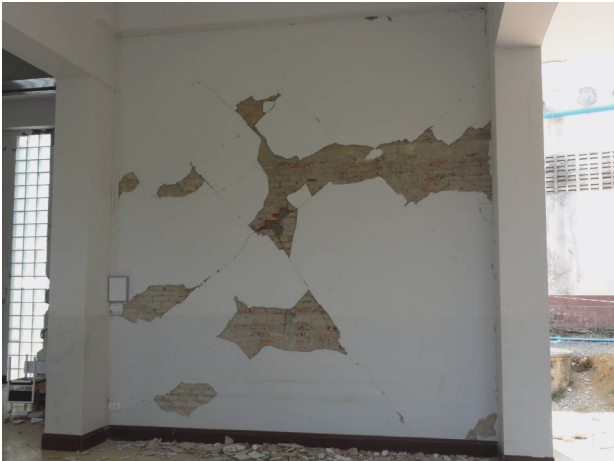
Figure 8. Diagonal cracks in a masonry wall

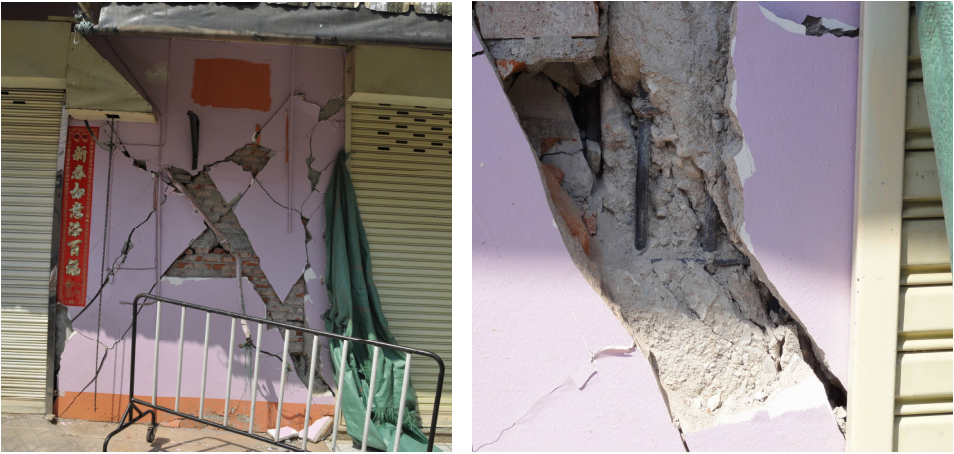
Figure 9. Damage due to load transfer from masonry walls

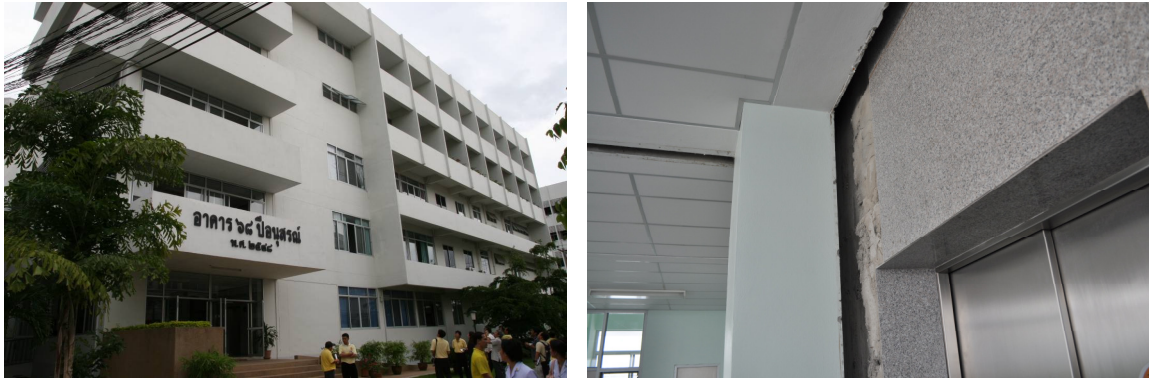
Figure 10. Damage due to pounding

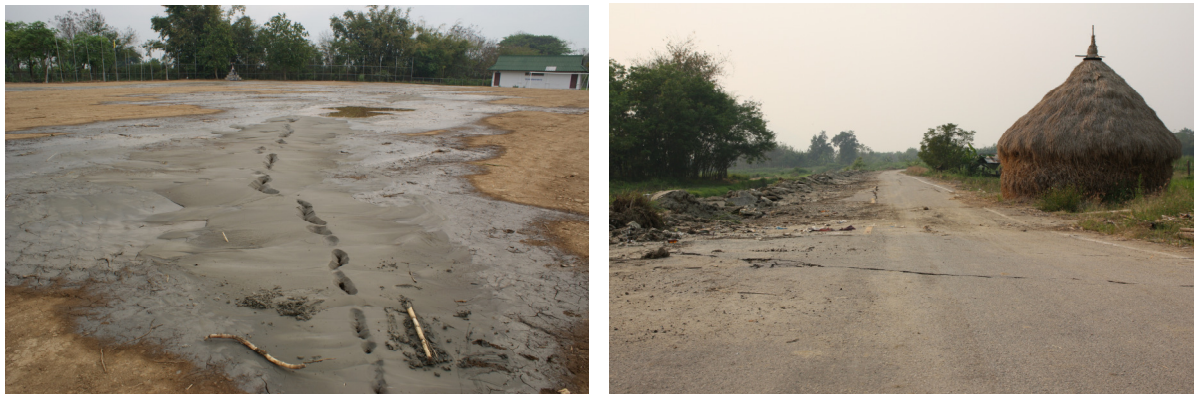
Figure 11. Liquefaction and damage to a road
