Landscape changes in Andaman and Nicobar Islands (India) due to *M_w 9.3* tsunamigenic Sumatra earthquake of 26 December 2004

A reconnaissance survey was undertaken in the A&N Islands after the 2004 Sumatra earthquake. The overall pattern of geomorphological changes was captured by aerial surveys over most of the A&N Islands. This was augmented by field investigations at four of the Andaman Islands (namely North, Middle, South and Little) and two of the Nicobar Islands (namely Car and Great).

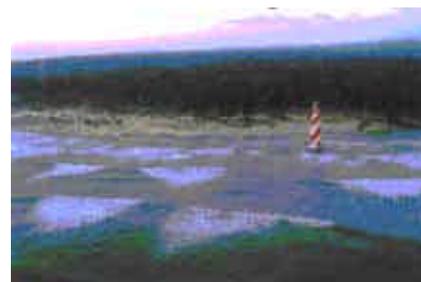
Figure 1. Flooding of lighthouse base due to land subsidence at Indira Point, southernmost tip of India at Great Nicobar Island. Submergence is about ~3 m caused by the *M_w 9(3)* megathrust earthquake (Photo courtesy: Flight Commander Rajesh Makwana, Indian Coast Guard, Port Blair.)

ported by changes in the natural water levels. At the Coastguard Headquarters Building in Campbell Bay, the average water level has increased after the earthquake by about 2 m, as demonstrated by the ocean water lashing the floor of the building located a few metres from the sea. According to the Coastguard Officer, during the high tides prior to the earthquake, at least 25–30 m of beach used to be exposed in front of the building, and during low tide, it was more than 100 m. In contrast, now no beach can be seen. Such submergence is also observed at Indira Point, the southernmost tip of India. Here, the 23 m high lighthouse tower is now standing submerged by at least about 3 m at its base; several houses, the helipad and vegetation near the light house have been washed away by the tsunami (Figure 1).

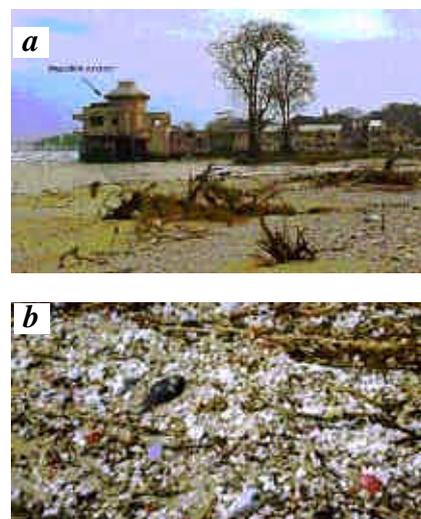
Figure 2. *a*, Two-storey RC frame Inspection Bungalow at east coast of Car Nicobar Island, located about 100 m from the shoreline under high tide conditions. This building now remains exposed with sea water lashing right up to the individual footings of the front side columns, suggestive of the subsidence of the coastline along the eastern side of Car Nicobar. Present-day exposed beach shows gravel transported and deposited by tsunami on 26 December 2004. *b*, Close-up of poorly sorted coral deposit at Car Nicobar. Clasts of coral fragments range in size from 25 to 350 mm.

Evidence of subsidence was also observed at the Car Nicobar Island (N9.2° lat.), the northernmost among the Nicobar group of islands. Topographically, this island is characterized by almost flat terrain to the east and an elevated terrain with maximum elevation of about 70 m to the west. This island was worst affected in terms of damage and loss of life. The eastern coast was destroyed; the Indian Army and Air Force township adjacent to the airstrip and the civilian township at Malacca were swept away. The most remarkable evidence signature was that of the MES Inspection Bungalow, a two-storey RC frame structure with hollow block masonry infills earlier located about 100 m from the shoreline under high tide conditions. This building now remains exposed with sea water lashing right up to the individual footings of the front side columns (Figure 2 *a* and *b*).
