## North Kashmir earthquake — Reconnaissance survey

Civil Engineering faculty members of IIT Kanpur, Prof. Durgesh C. Rai and C.V.R. Murty undertook a reconnaissance survey of the earthquake affected regions in Kashmir during October 14 to 19, 2005 and visited worst affected major Indian towns Uri, Kupwara and Baramulla.

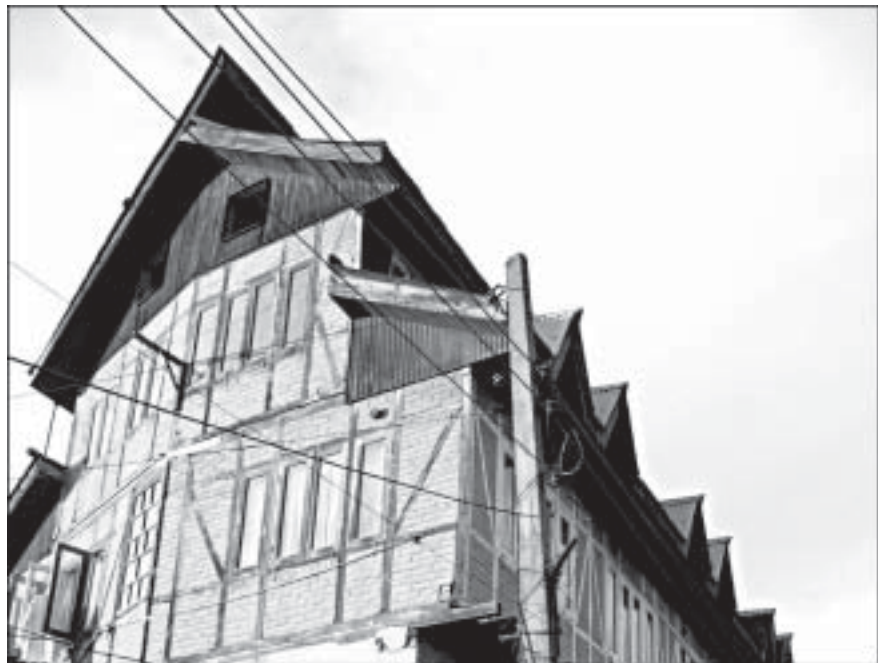
**Fig 1** *Dhajji-dewari* system of timber-laced masonry for confining masonry in small panels withstood the earthquake without serious damage

In Kashmir, traditional timber-brick masonry construction consists of burnt clay bricks filled in a framework of timber to create a patchwork of masonry. The resulting masonry referred as *Dhajji-dewari* (meaning patch quilt wall)

Conventional unreinforced masonry laced with timber performed satisfactorily as expected. There is an urgent need to revive these traditional masonry practices which have proven their ability to resist earthquake loads, in contrast to contemporary colonial-style masonry buildings. Modern bridges, roads, water tanks, etc., which have been constructed without due consideration of high seismic activities of the Himalayan region make such civil infrastructure extremely vulnerable for future earthquakes.

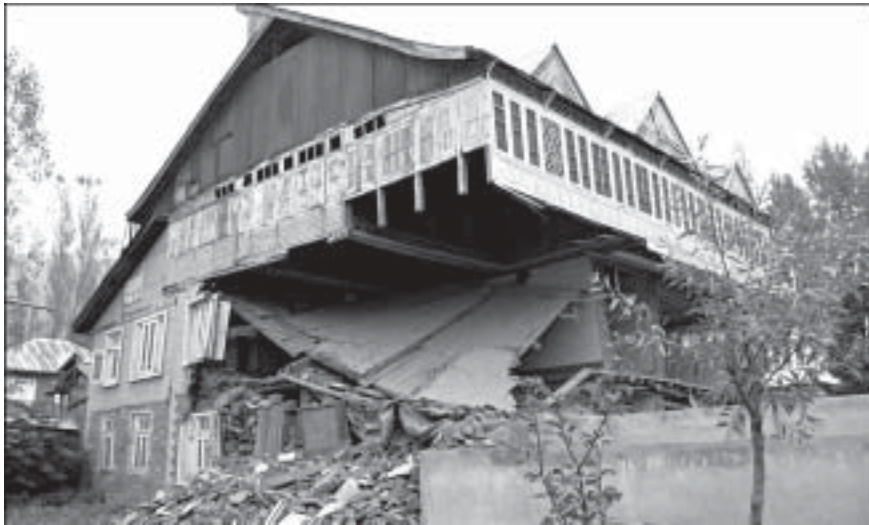
**Fig 2** Timber frame and timber-laced masonry held on as stone masonry walls in lower storeys collapsed

age even when the walls in bottom stories have collapsed, Fig 2.

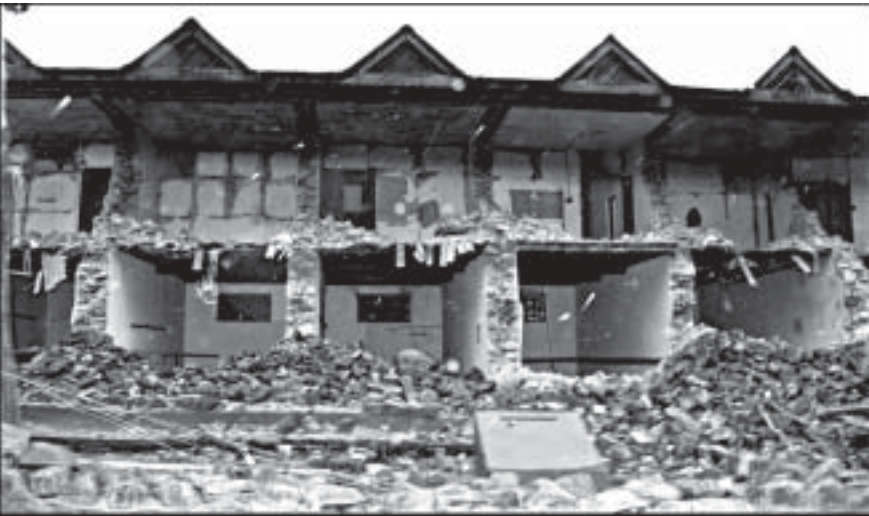
**Fig 3** Collapse of stone masonry walls

Undressed random rubble type masonry was responsible for the majority of the deaths and injuries. Most of government buildings, hospitals, schools, jails, etc., built in random rubble masonry without any seismic features suffered heavy damage, especially when the structure was old, Fig 3. This was primarily due to the fact that the walls could not maintain their integrity during the shaking.

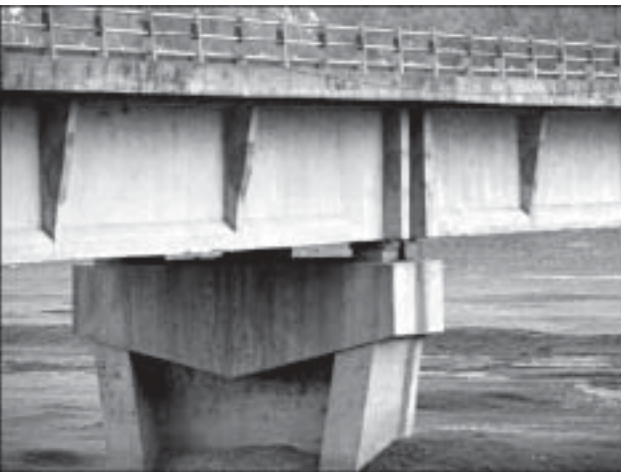
**Fig 4** Prestressed concrete girder bridge lacks restrainers to prevent unseating during earthquakes at this bridge in zone V

The affected region has a number of major bridges which are extremely vulnerable due to inadequate seating and absence of other provisions to prevent unseating, Fig 4. Roads closer to epicentral area in the mountainous region suffered extensive landslides which resulted in the closure of traffic for many days. The road to Tangadhar from Kupwara was not open even a week after the quake. Pipelines for drinking water supply broke at several places causing severe hardships.
