14

Hospitals and Schools

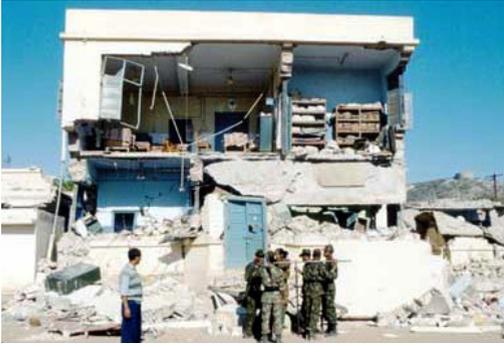
Figure 14-1. Collapse of the Bhuj General Hospital impaired medical emergency response (www.rediff.com). One hundred seventy-two people were killed.

A 300-bed hospital is now under construction in Bhuj to replace the collapsed civil hospital. The new hospital will be the first major building in India designed with base isolation.

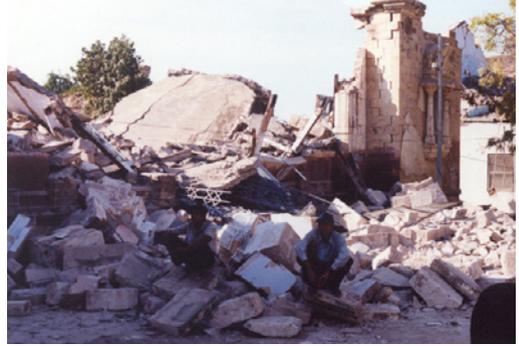
Figure 14-2. Collapsed Jubilee Hospital in Bhuj.

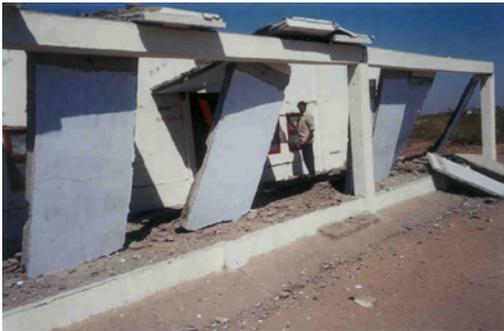
- Type A – Major damage to structure (Figure 14-9)
- Type B – Slipping of roof planks (Figure 14-10)
- Type C – Minor dislocation of roof planks (Figure 14-11)
- Type D – Minor opening of grouted joints (Figure 14-12)

It is clear from observed damage patterns that the weakest links in the precast school buildings were the connections between the structural elements. Roof planks resting on the beam slipped, indicating that the bearing area was inadequate and no positive anchorage was provided. Because of the poor connections, the provided roof slab system did not act as one unit to develop necessary diaphragm action, and the frames in the building system acted mostly independently. The building frames had different column heights, and therefore the displacement at roof level for each frame was different.

Columns with isolated footings behaved as if they were hinged at the bottom (the soil might not have offered much rotational restraint), and as a result, the building frames were subjected to excessive lateral deflection. Had a plinth beam been provided, these deformations could have reduced. Moreover, the redistribution of the forces was not possible because of the lack of redundancy in the building system. Even though the individual elements have not shown distress, the precast system could not perform satisfactorily because the elements were not tied together.

Figure 14-9. Type A damage — major damage to structure.

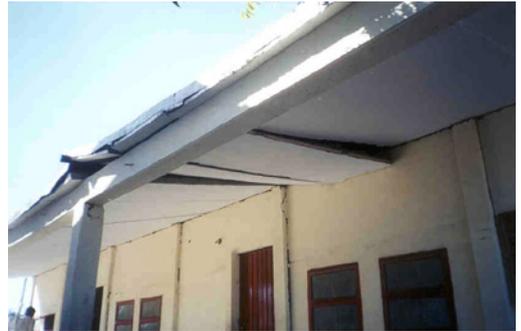
Figure 14-10. Type B damage — roof planks slipped.

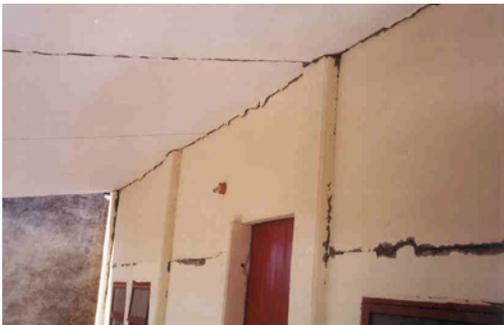
Figure 14-11. Type C damage — minor dislocation of roof planks.

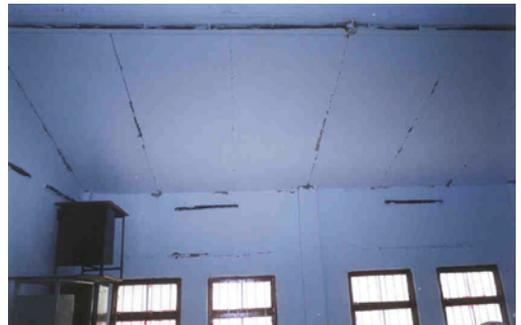
Figure 14-12. Type D damage — minor opening of grouted joints.
