# Landscape Changes in the Andaman and Nicobar Islands (India) after the December 2004 Great Sumatra Earthquake and Indian Ocean Tsunami

Javed N. Malik,<sup>a)</sup> C.V.R. Murty,<sup>a)</sup> M.EERI, and Durgesh C. Rai,<sup>a)</sup> M.EERI

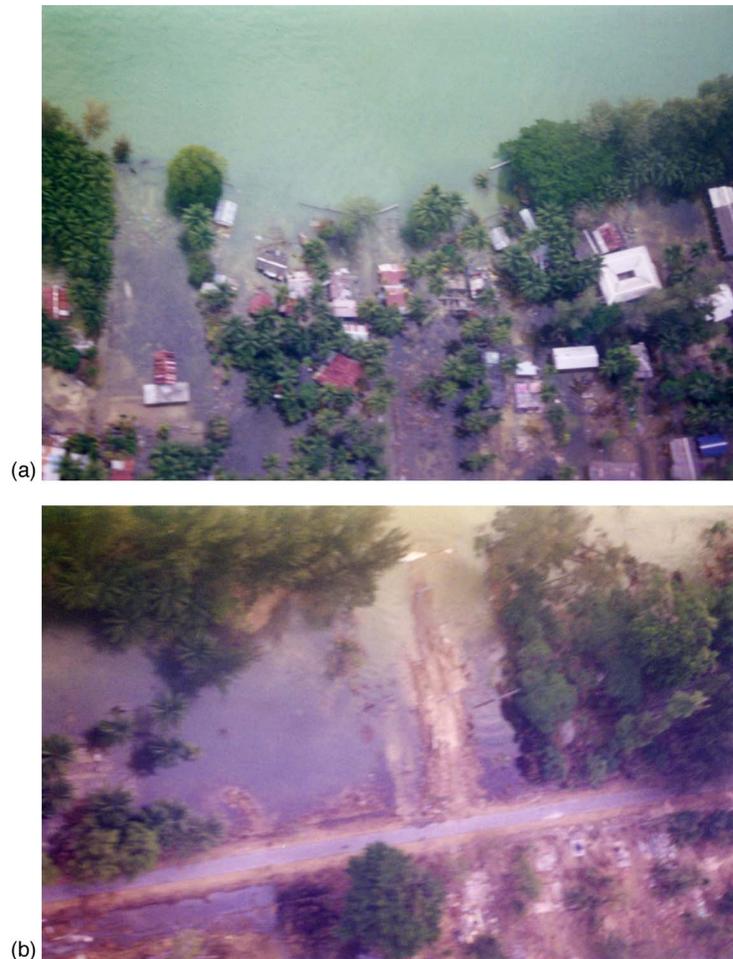
**Figure 6.** (a) Inundation and submergence of the area along the eastern coastline of Great Nicobar Island because of subsidence caused by the 26 December earthquake. (b) A coastal road encircling the island was damaged and submerged due to subsidence (photos: J. Malik).

shaking might have resulted in some liquefaction in the coastal area; however, damage was mainly due to the high-energy tsunami waves. The liquefaction might have also facilitated the easy erosion of concrete and masonry structures, which is well exemplified by the washed-out portion of the jetty and houses at Indira Point. With respect to the high water level around the Coast Guard office area and the submerged lighthouse tower at Indira Point, it seems reasonable to suggest that the coastline has subsided by about 2.5–3.0 m at the southern portion of Great Nicobar Island.

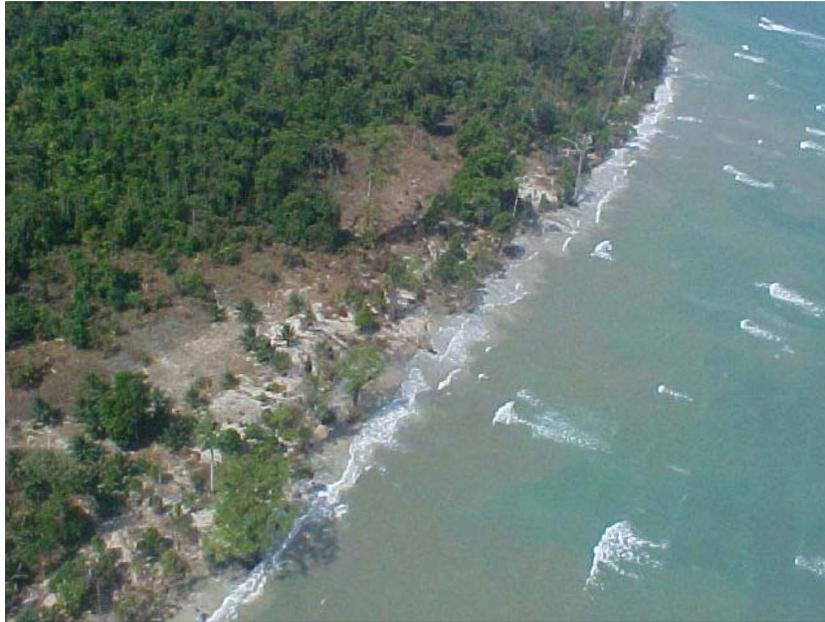
**Figure 7.** The eastern coastline at Campbell Bay (part of Great Nicobar Island) is now permanently inundated; the normal coastal waves cross over the tree line (photo: C. Murty).

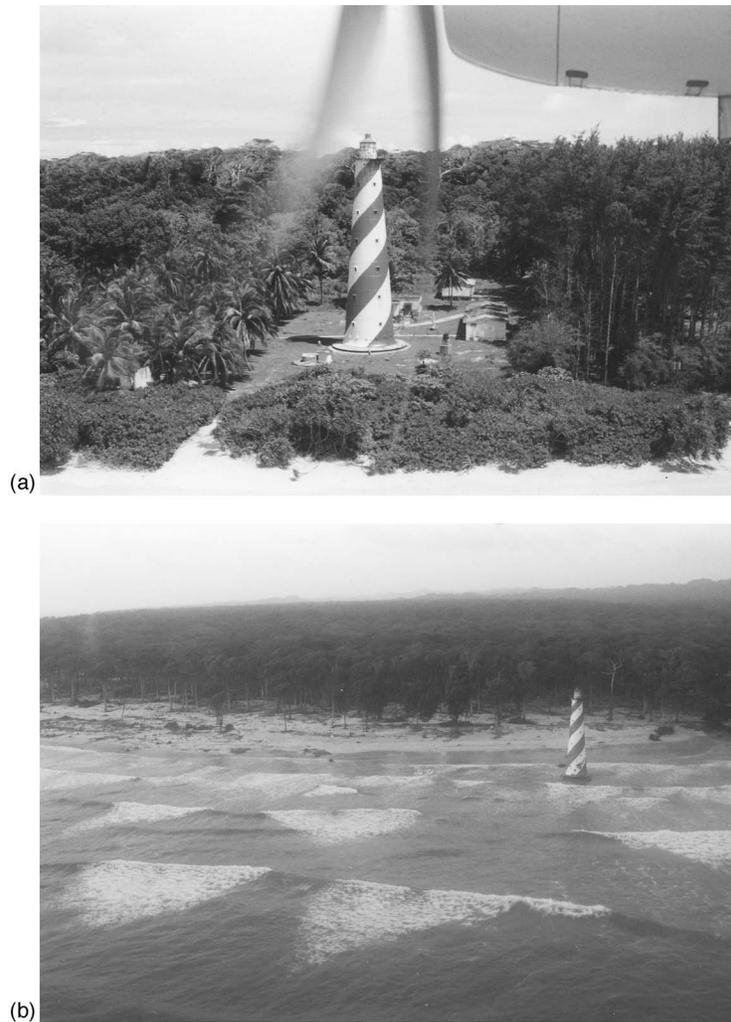
**Figure 8.** (a) The lighthouse tower at Indira Point in Great Nicobar Island before the 26 December earthquake. The tower is surrounded by lavish green grass, residences are at the base, and a sandy beach is in the foreground. (b) Flooding of the lighthouse base because of land subsidence. The submergence of  $\sim 3$  m was caused by the 26 December earthquake (photos: R. Makwana).

The tsunami wave was less than the  $\sim 10$ -m height observed by people in other islands, such as Car Nicobar, Little Andaman, and Main Andaman (including the North, Middle, and South Andaman islands). This could be because of the local topographic variations of the islands and the distance from where the tsunami originated. Great Nicobar is characterized by hilly terrain with a maximum elevation of 600 m. The lower-elevation hills (300–400 m) along the coast might have reduced the impact of the tsunami. The coastal road encircling the island was badly affected—it was damaged and submerged at several locations by the tsunami (Figures 6 and 7). The waves traveled about 1.5–2 km, inundating most of the low-lying areas inland. The effect of the wave as it traveled inland was indicated by the scattered tar barrels that were dragged about 200–300 m away from their original location at the Andaman Public Works Division office, which is  $\sim 1$  km from the coast. Compound or boundary walls encircling several buildings inland were toppled by high-energy tsunami waves. At the Coast Guard Headquarters building in Campbell Bay, the average water level increased after the earthquake by about 2 m, as demonstrated by the ocean water lashing the floor of the building located a few meters from the sea. According to the Coast Guard officer, during the high tides prior to the earthquake, at least 25–30 m of beach used to be exposed in front of the building, and during low tide, more than 100 m was exposed. In contrast, now no beach can be seen. Such submergence is also observed at Indira Point, the southernmost tip of Great Nicobar Island. Here, the base of the 23-m-high lighthouse tower is now submerged in at least  $\sim 3$  m of water; several houses, the helipad, and vegetation near the lighthouse have been washed away by the tsunami (Figure 8).

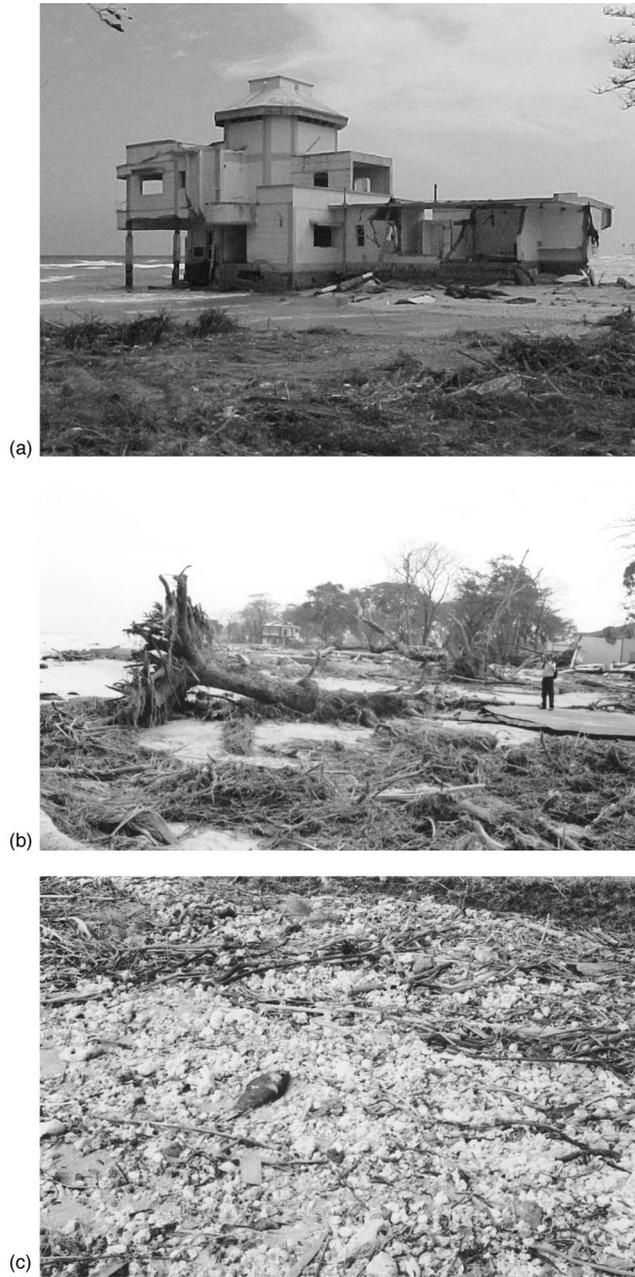
**Figure 9.** (a) MES inspection bungalow on the east coast of Car Nicobar Island, about 100 m from the shoreline under high tide conditions. The exposed beach shows gravel transported and deposited by the tsunami on 26 December (photo: C. Murty). (b) Uprooted tree trunk and deposition of a layer of sand about 10–20 cm thick (photo: J. Malik). (c) Close-up of poorly sorted coral clast and sand deposit at Car Nicobar (photo: J. Malik).

under high tide conditions. This building now remains exposed, with seawater lashing right up to the individual footings of the front, suggestive of the subsidence of the coastline along the eastern side of Car Nicobar Island (Figure 9a). It is suggested that the subsidence in the Car Nicobar area was about 1.5–2 m.

Giant trunks of banyan and coconut trees (with a diameter of  $\sim 1\text{--}3$  m) were toppled and uprooted. Remnants of these uprooted tree logs were lying scattered on the surface, along with debris consisting of cars, motorbikes, dry grass, household items, and so on. Deposition of a thick layer of sand (about 10–20 cm) was noticed at most locations, such as the site in Figure 9b. At some locations, about 300–350 m from the

shoreline, a spread of poorly sorted coarser clasts made of coral ranging in size from 2.5 to 35 cm was observed over the beach (Figure 9c). Scouring of the surface was the common feature noticed near the buildings in the area.

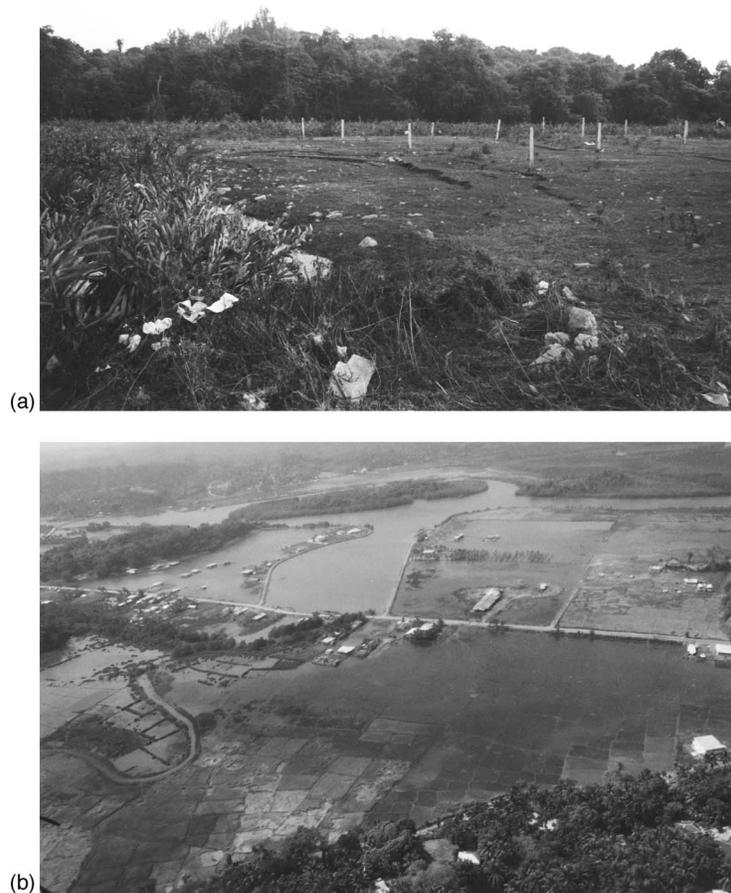
**Figure 11.** (a) Extensional cracks in the Sippyghat area were caused by lateral spreading that was due to ground shaking. (b) Inundation of land and waterlogging in the low-lying areas around Sippyghat, near Port Blair (photos: J. Malik).

wide as 20–30 cm. Along with lateral spreading, inundation of land and waterlogging of up to 0.6 m in the low-lying areas were common. This was evidenced by the 0.6 m of water surrounding the houses in the Sippyghat area.

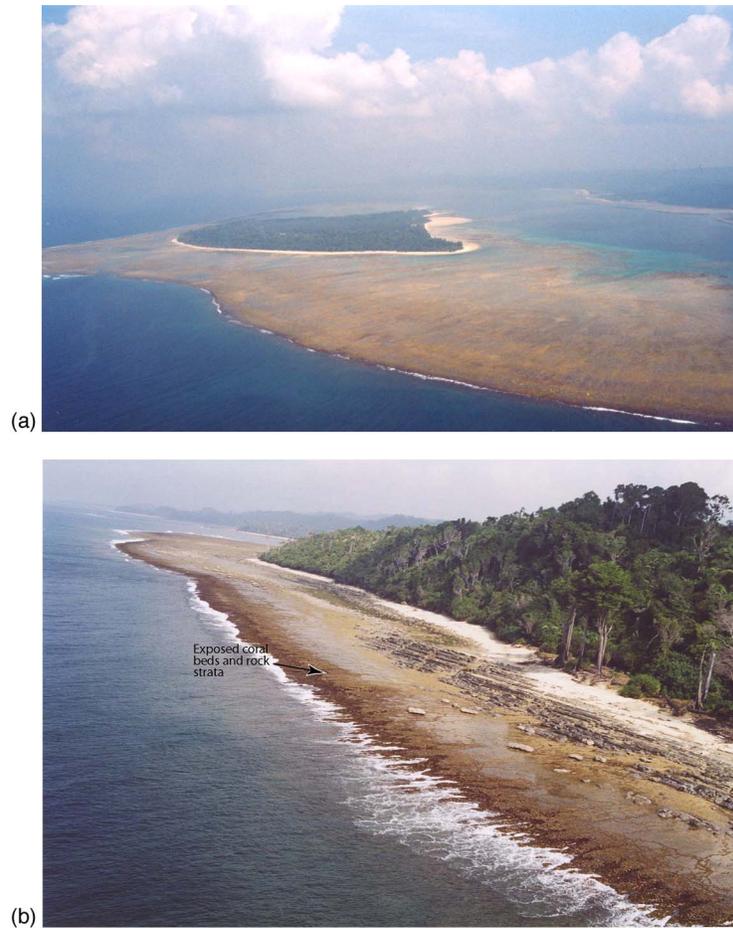
**Figure 14.** (a) Uplift of Flat Island along the western coast of Middle Andaman Island. (b) Upthrow of the coral beds and rock strata caused by uplift on the western coast of Middle Andaman Island near Flat Island (photos: J. Malik).

beds showing inclination toward the east. The evidence of inclination of the strata is a clear indication of tilting that is due to tectonic movement along the Andaman trench, causing uplift of the island and subsequent tilting toward the eastern side. At several locations, the uplift of the smaller islands—namely, the Flat and Sentinel islands along the western coast—was very prominent (Figure 14). Remnants of uplifted coral heads (coral atolls) were noticed along the emerged shoreline of Flat Island. Uplifting of rocky plat-

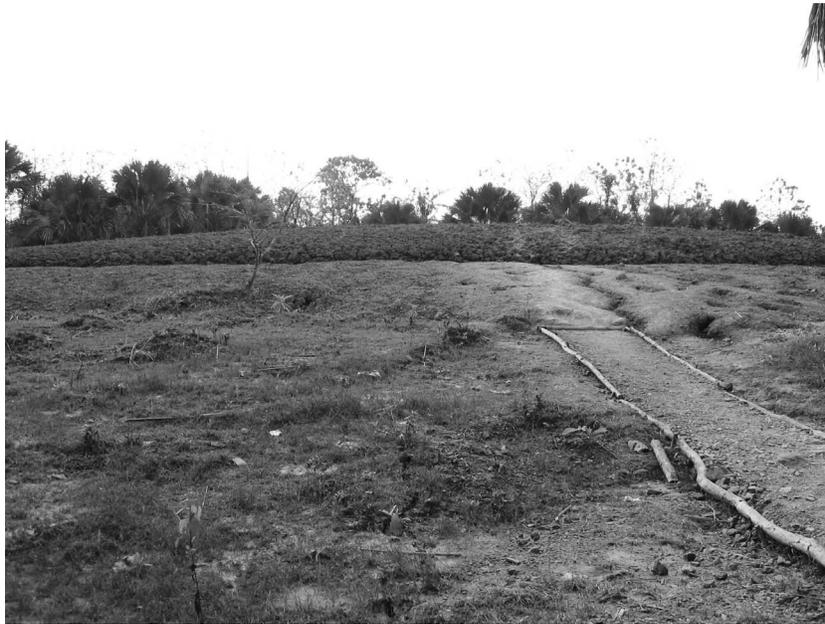
**Figure 18.** Eruption of a mud volcano near Jarawa Creek at Baratang Island near Middle Andaman Island, 105 km north of Port Blair (photo: D. Rai).

A mud volcano in Middle Andaman Island became active after the earthquake, emitting gray mud and colorless gases that formed a subcircular mound about 70 m in diameter (Figure 18). The volcano had also erupted in 1983, 1996, and 2003. A number of other small mud volcanoes have formed in the area since the earthquake. Close to this region, deep and wide cracks in the ground were observed that caused severe damage to road pavements (Figure 19).
